FIGURE 3-5
1960 AERIAL PHOTO OF JUNCTION CITY
PRE-DAM GEOMORPHOLOGY
TRINITY RIVER MAINSTEM FISHERY RESTORATION EIS/EIR

TRINITY RIVER MAINSTEM FISHERY RESTORATION EIS/EIR

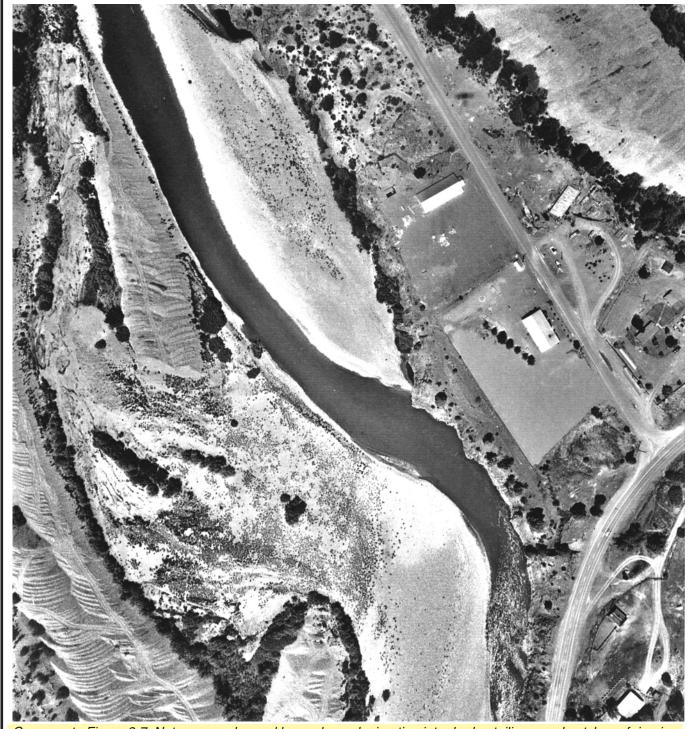
Compare to Figure 3-7: Note exposed gravel bars, channel migration into dredge tailings, and patches of riparian vegetation away from low-flow channel margins.

Compare to Figure 3-5: Note thick band of mature riparian vegetation along low-flow channel and separation of low-flow channel to exposed gravel bars and floodplains.
