THE RIPARIAN FORESTS OF THE SACRAMENTO RIVER ECOSYSTEM

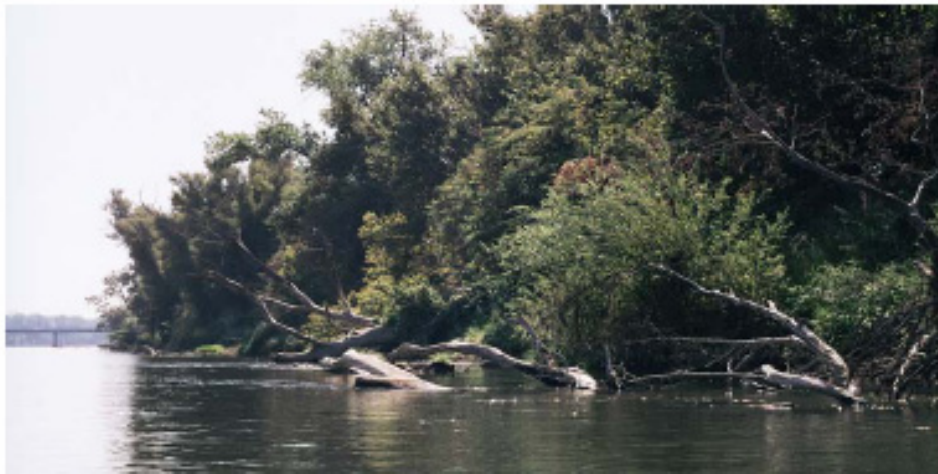
Figure 2-10. Shaded Riverine Aquatic Habitat along the Sacramento River.

Shaded banks are an important component of the Sacramento River ecosystem, created as the river erodes into a bank supporting riparian forests (Figure 2-10). This habitat has an important aquatic component. The U.S. Fish and Wildlife Service has dubbed this

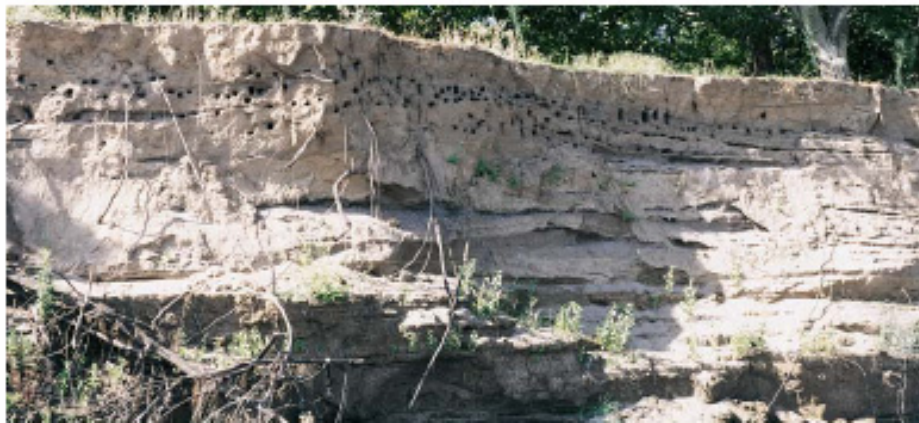
Figure 2-11. Cut bank with bank swallow burrows, Sacramento River, Chico Landing-Red Bluff Reach

Cut banks are another important component of the riparian ecosystem along the Sacramento River. Most often associated with valley oak woodland and high terrace agriculture, cut banks along the Sacramento River also support the majority of California’s bank swallow (*Riparia riparia*) colonies. The migratory bank swallow, which winters in Central and South America, nests in the spring, mostly in steep freshly eroded earth banks (Figure 2-11).
