**COLUSA BASIN  
WATERSHED ASSESSMENT**

**Final**

**Colusa County Resource Conservation District**  
100 Sunrise Boulevard, Suite B  
Colusa, California 95932

15 December 2008

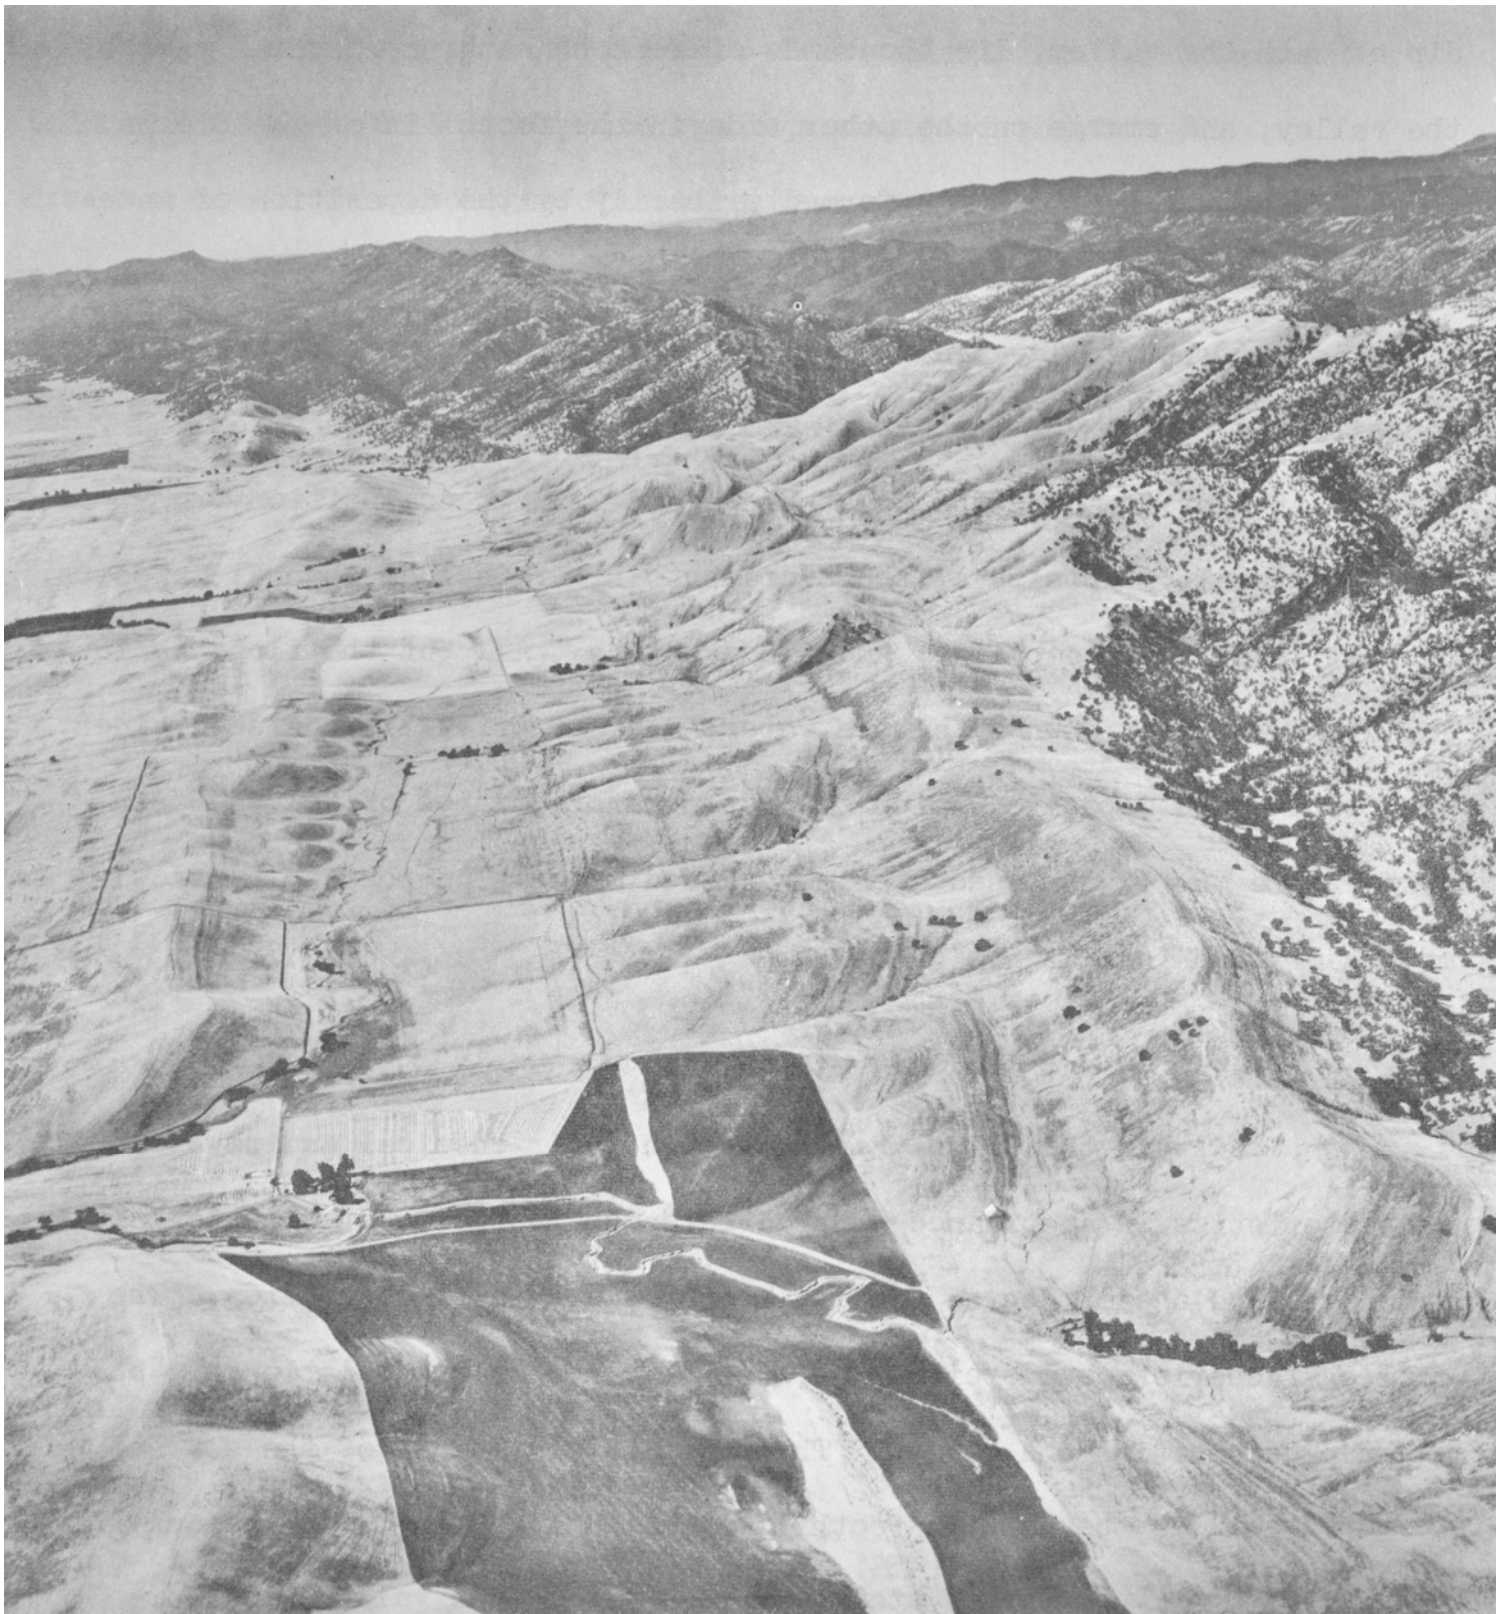
**Figure 3-Geology.** Oblique aerial photo of the dissected Coast Range Foothills in the central portion of the Colusa Basin Watershed. Glenn Valley Slough is in the foreground (adapted from DWR 1962).

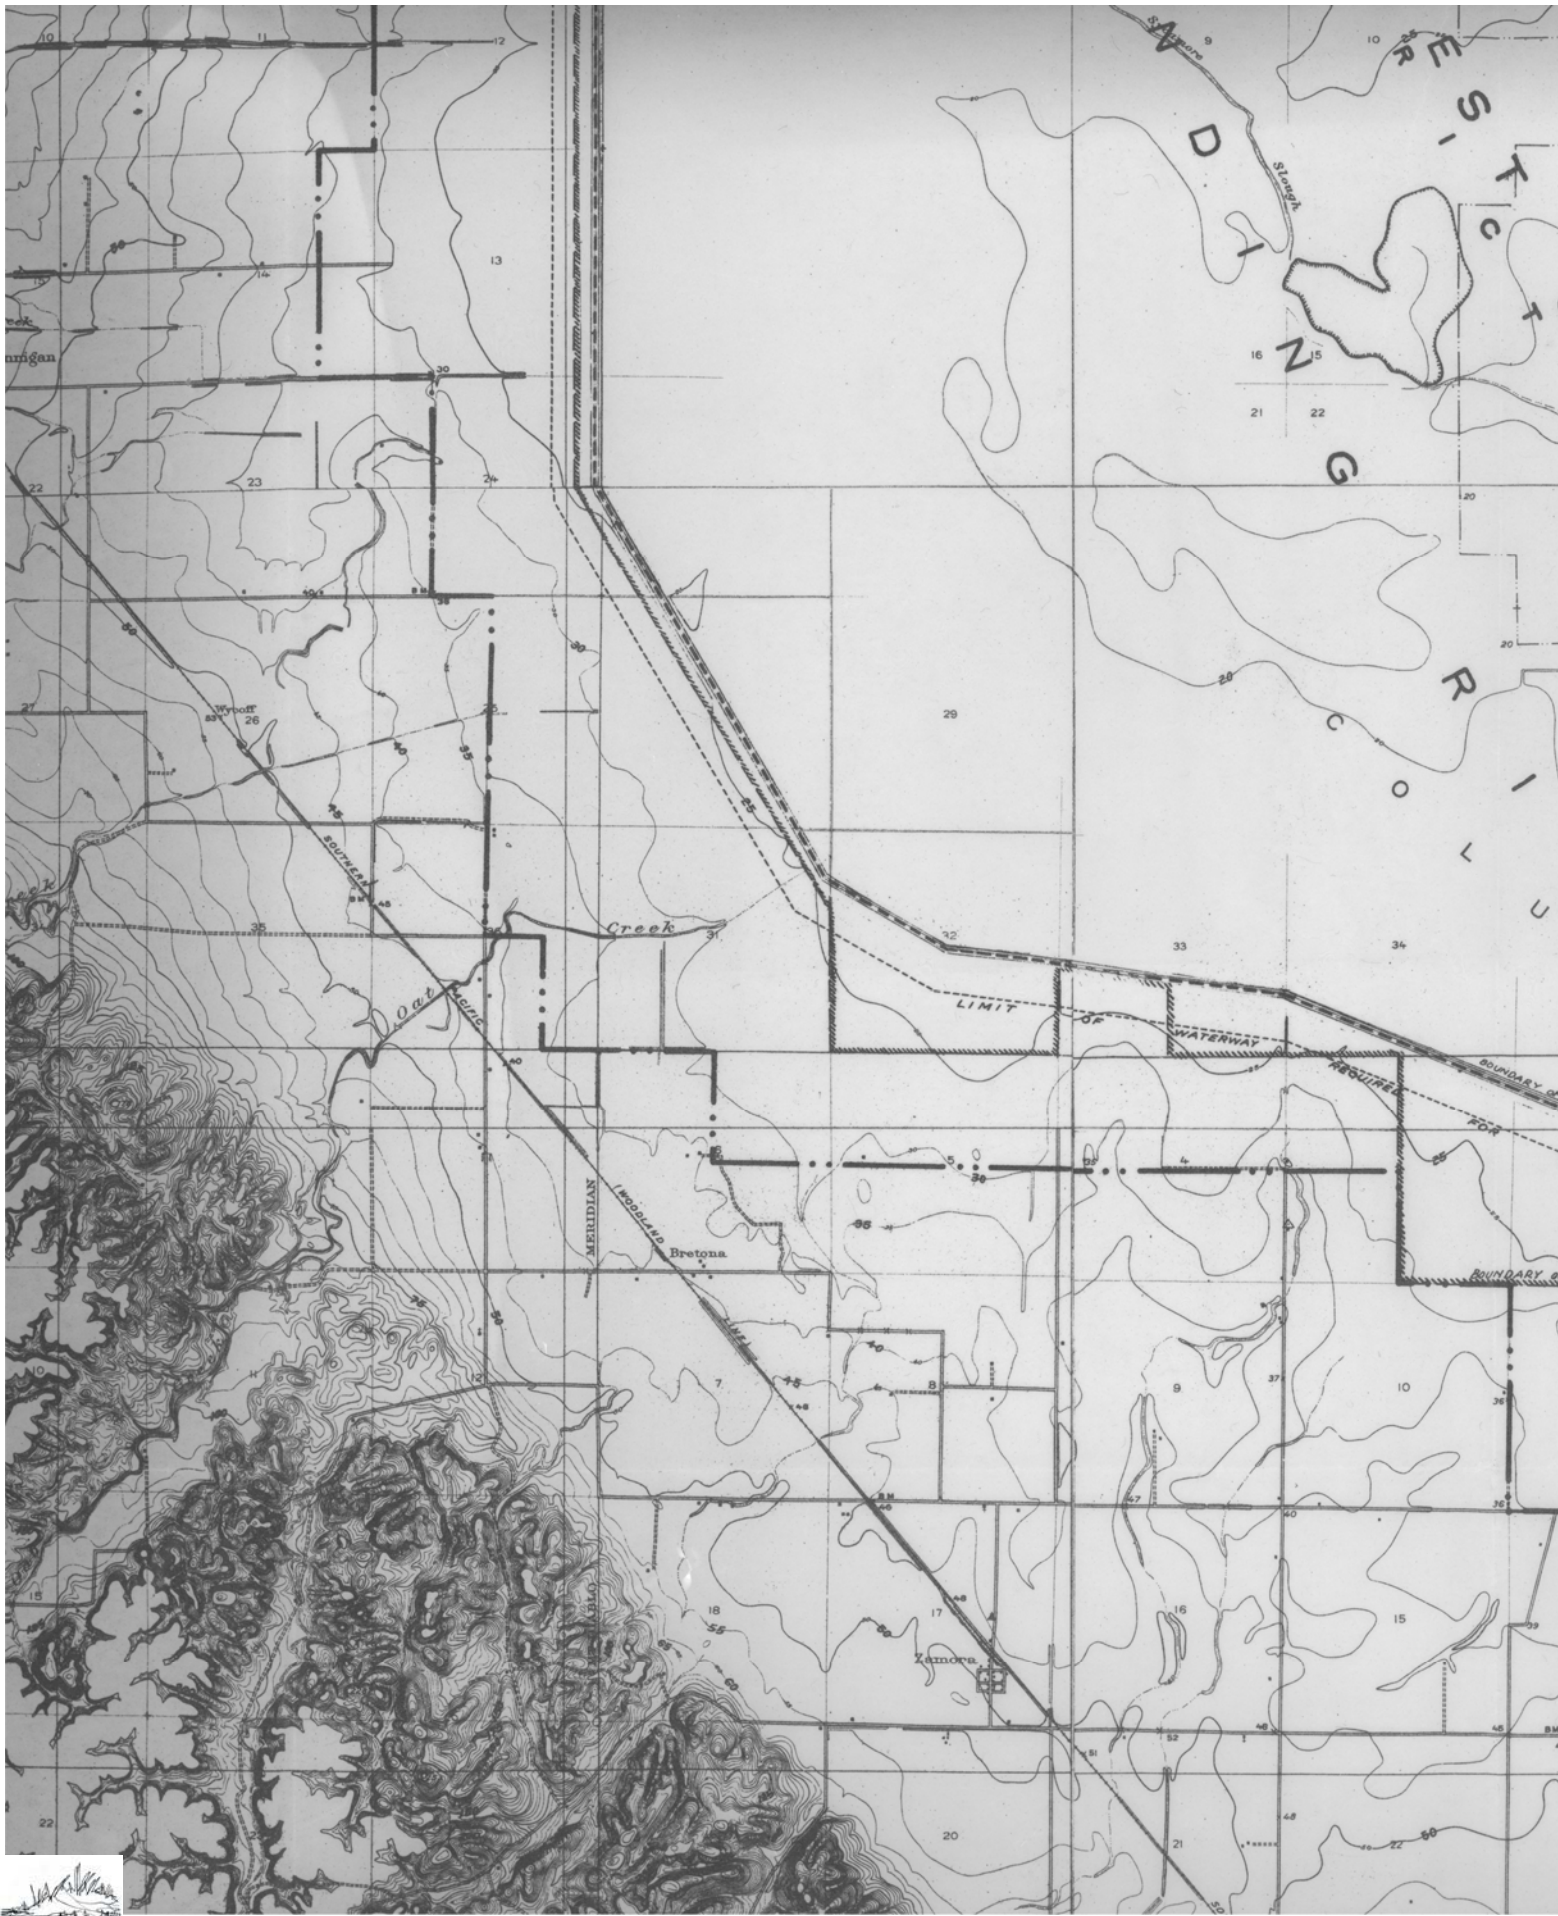
Figure 9a-Geology. Detail of upper part of Lower Colusa Basin reproduced from...

section within the 15-ft contour elevation about 8.5 mi upstream from Knights Landing (**Figure 9-Geology**). One interpretation of a circa 1840s land grant map of the Lands of Jimeno near Colusa also suggests that Sycamore Slough terminated in a densely vegetated wider basin area in at least one location, probably so densely vegetated with 15-ft-high tules as to be unnavigable (**Figure 10-Geology**). Other workers have suggested that Dry Slough may be the channel that the land grant maps shows terminating in dense vegetation. Sycamore Slough was mapped in detail in 1925, suggesting that its navigability was probably improved by vegetation removal or burning.

Under existing conditions, there are only a few remnants of the anastomosed network of very low gradient clay- and silt-bedded “slough” channels which formerly conveyed Sacramento River flood overflow and foothill stream floodwaters into the Colusa Basin and drained those floodwaters down valley (**Figure 9-Geology**). Levee building and drainage works for flood protection and reclamation eliminated routine Sacramento River overflow onto the valley flat, and most of the slough channels have been farmed over.

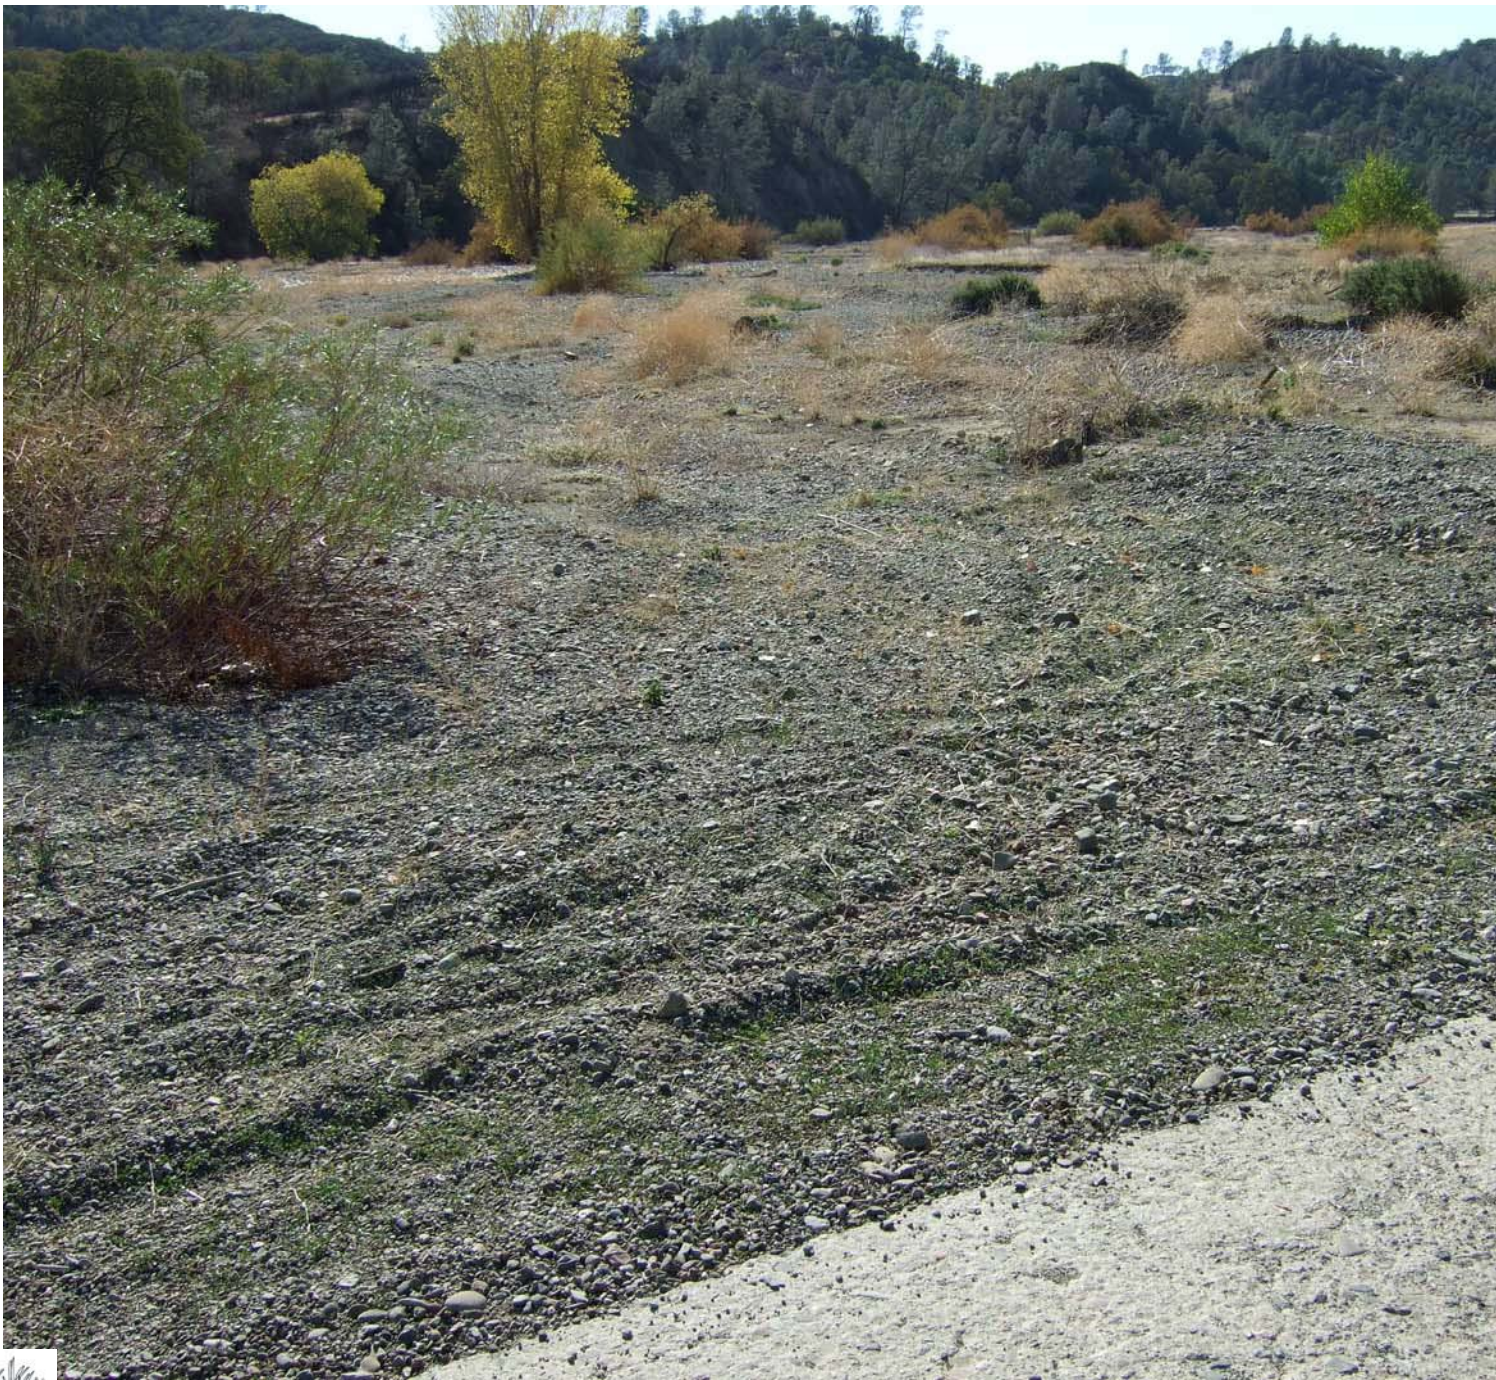
**Figure 11-Geology.** Photo looking approx. southwesterly upstream to Sand Creek Road Crossing. The channel is only a few feet incised in Holocene terrace deposits (Carter et al. 2007).

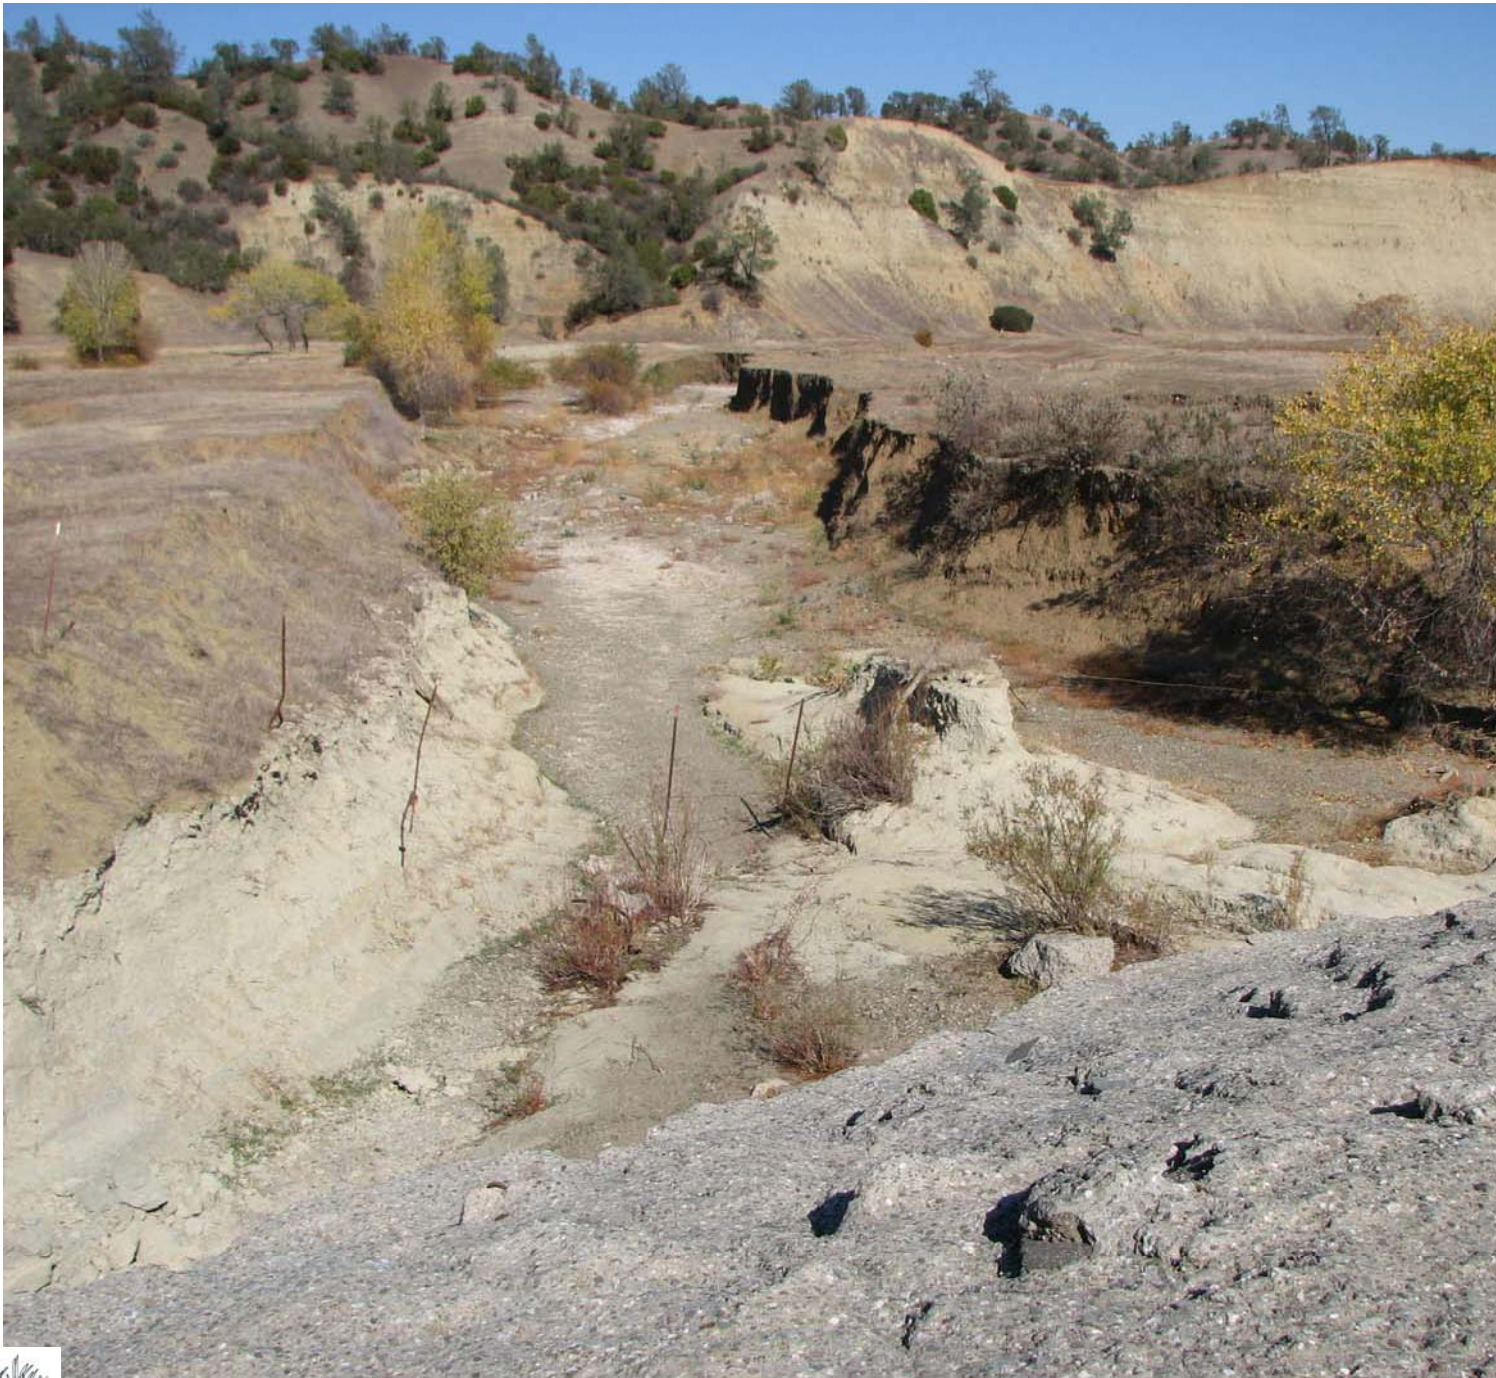
**Figure 12-Geology.** Photo looking approx. north-northeasterly downstream to Sand Creek Road Crossing. Bed is incised approx. 15 ft into Holocene terrace c 6, 2007.

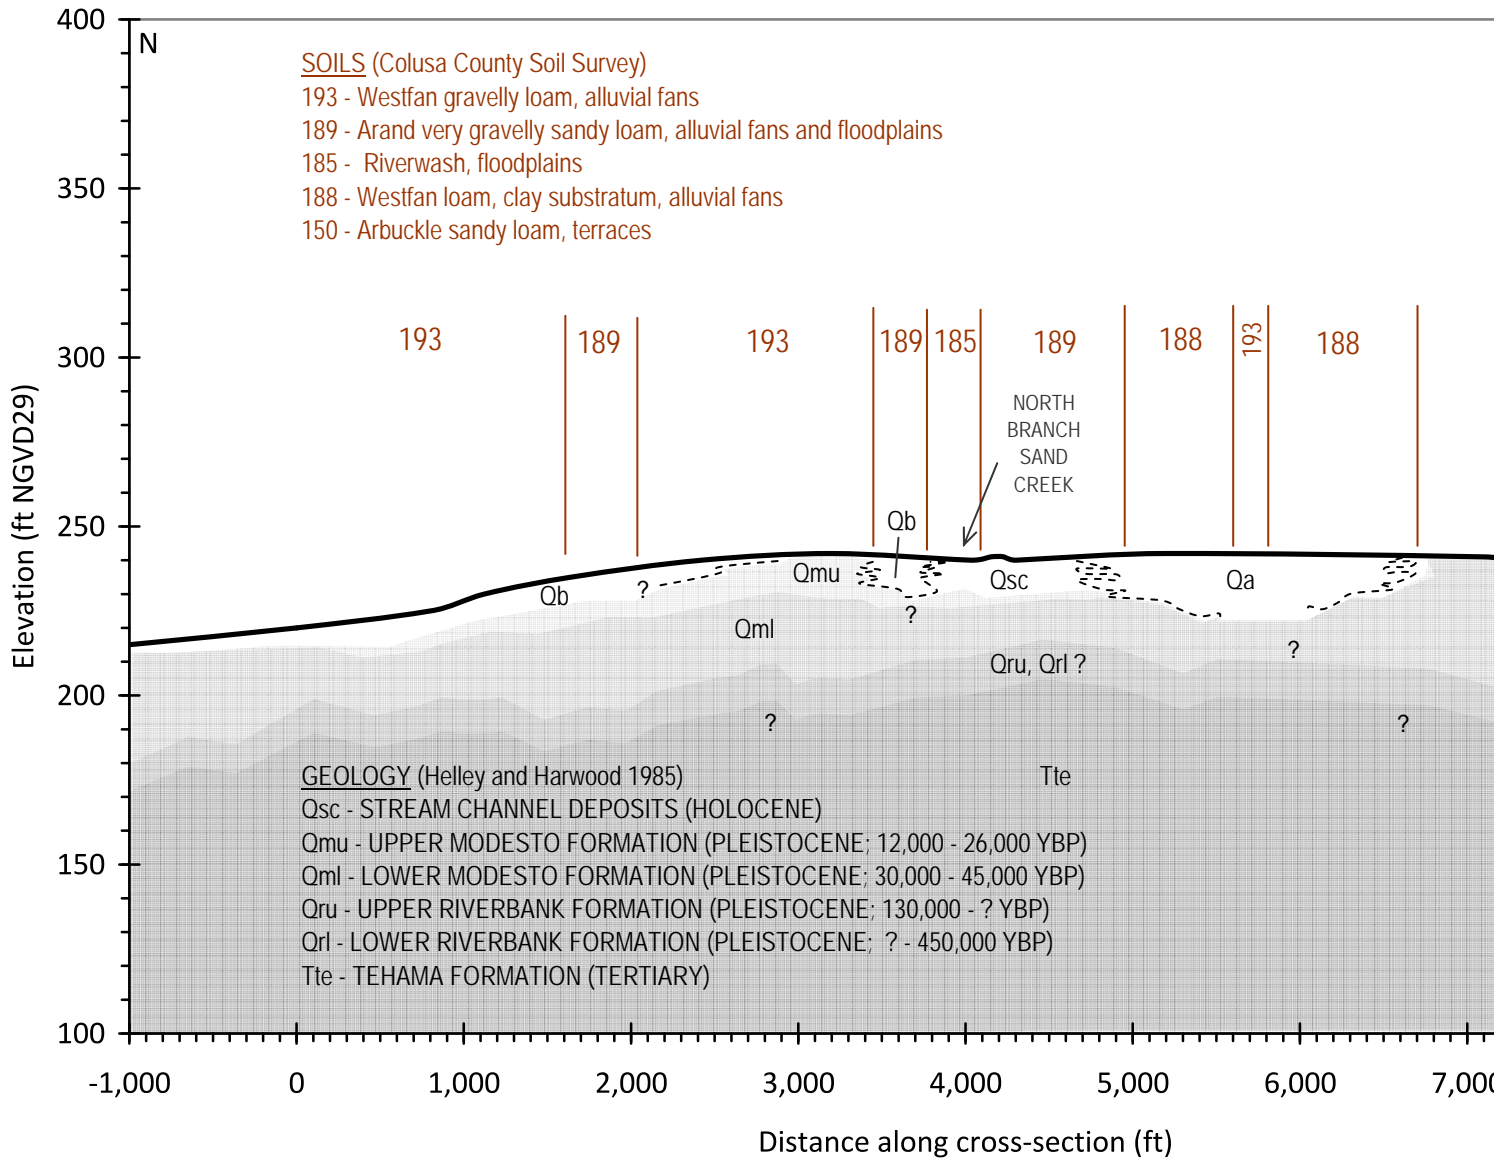
**Figure 16-Geology. North Branch Sand Creek  
Holocene Alluvial Fan Apex Cross-Section**

approximately 4,300 ft downstream from Cortina School Road Crossing  
(source: 5-ft contour interval USGS quadrangle, 1952 topography with 1949 air photo revision)

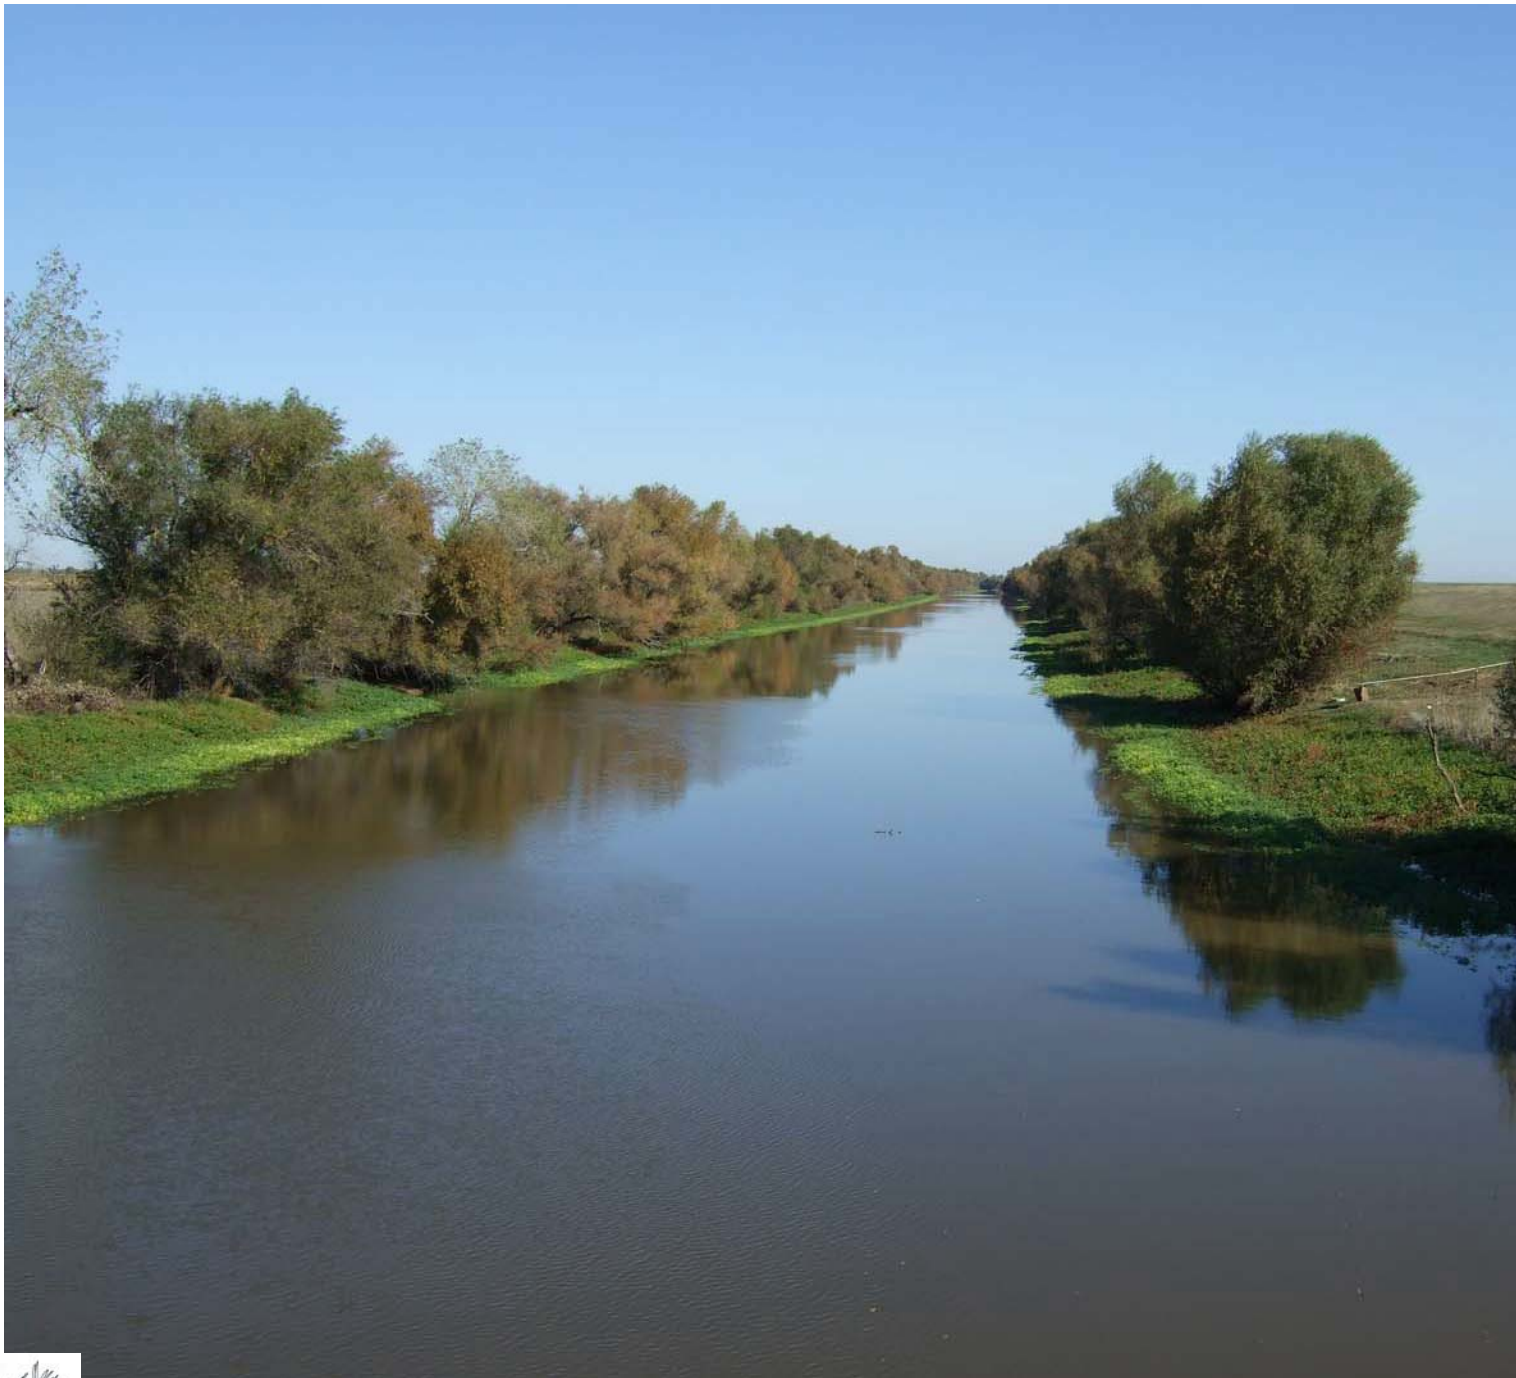
**Figure 1-Geomorphology.** Photo looking approximately northerly upstream from Colusa Basin Drain and Back Levee at right. Remnants of Sycamore Slough lie to the Back Levee. November 6, 2007.

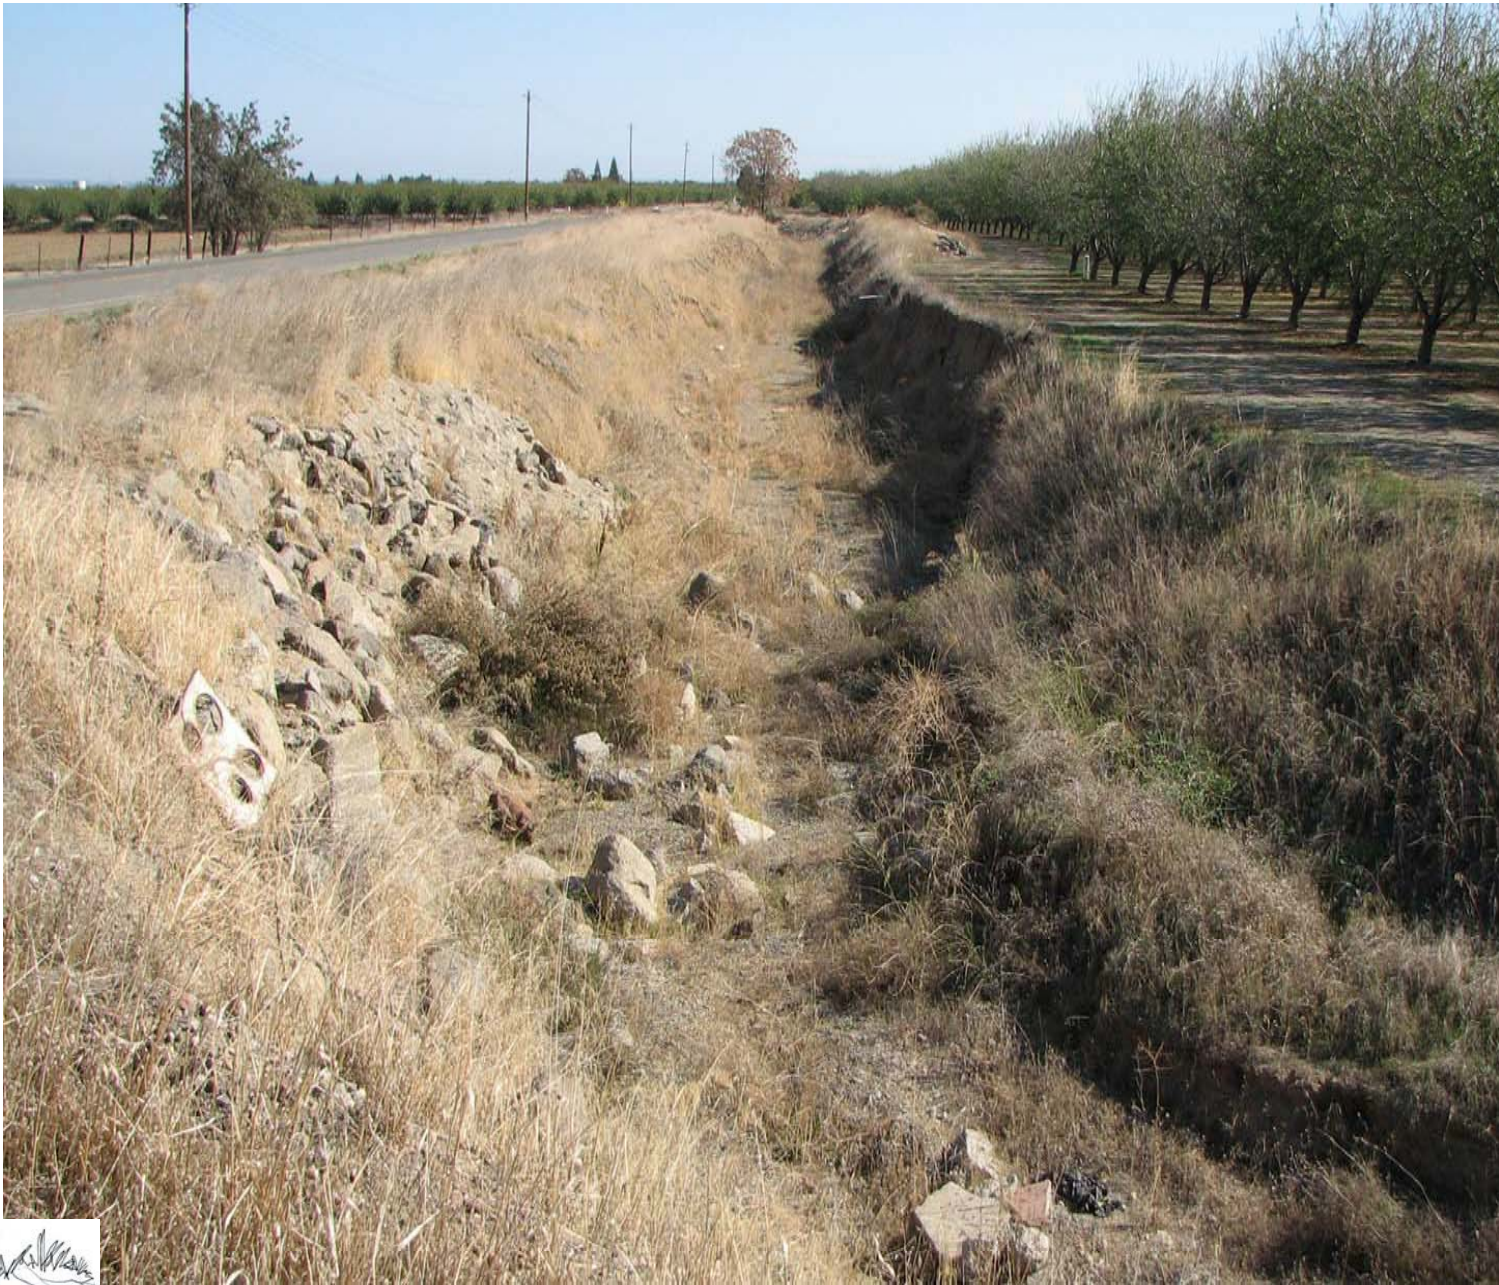
**Figure 2-Geomorphology.** Photo of Whiskey Creek looking approximately east downstream from Whiskey Creek Road. Note the narrow confinement and high banks. Hillgate Road at left. November 6, 2007.

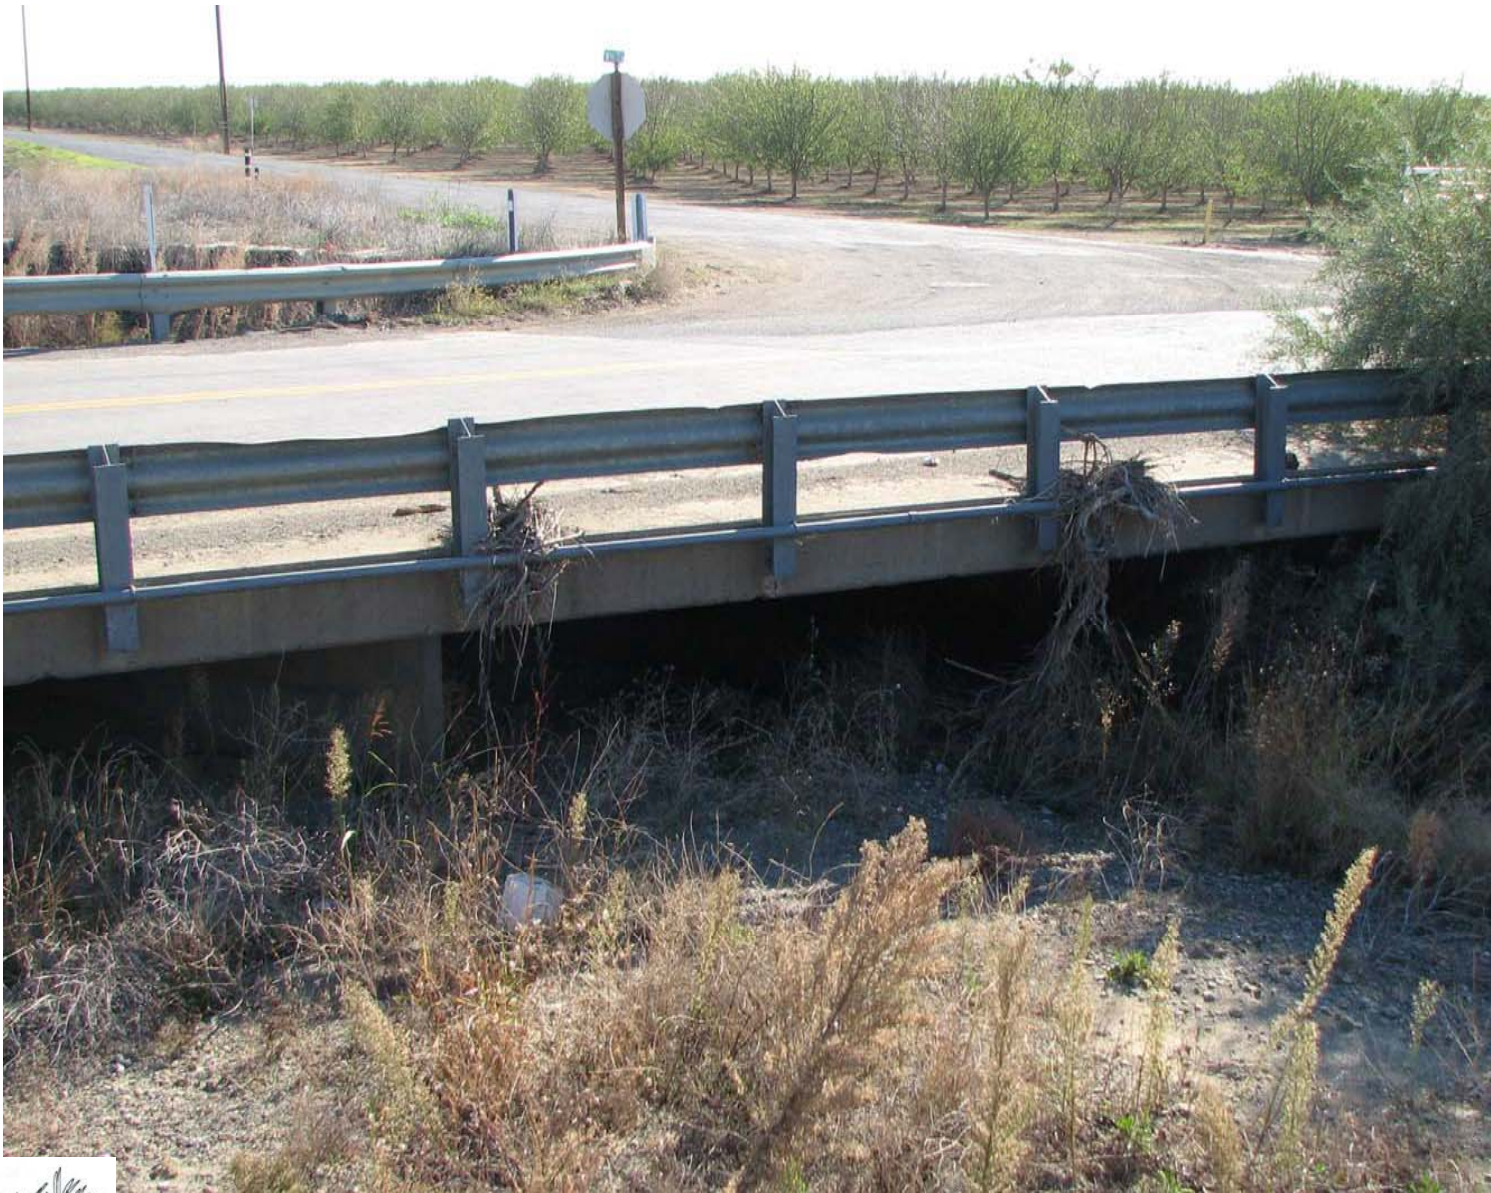
**Figure 3-Geomorphology.** Photo of Clarks Ditch (Petroleum Creek) looking southeasterly and downstream from left bank to College City Road bridge. The headroom beneath the bridge low chord is only 3-4 ft. The bridge deck is at grade. White Road intersection in background. November 6, 2007.

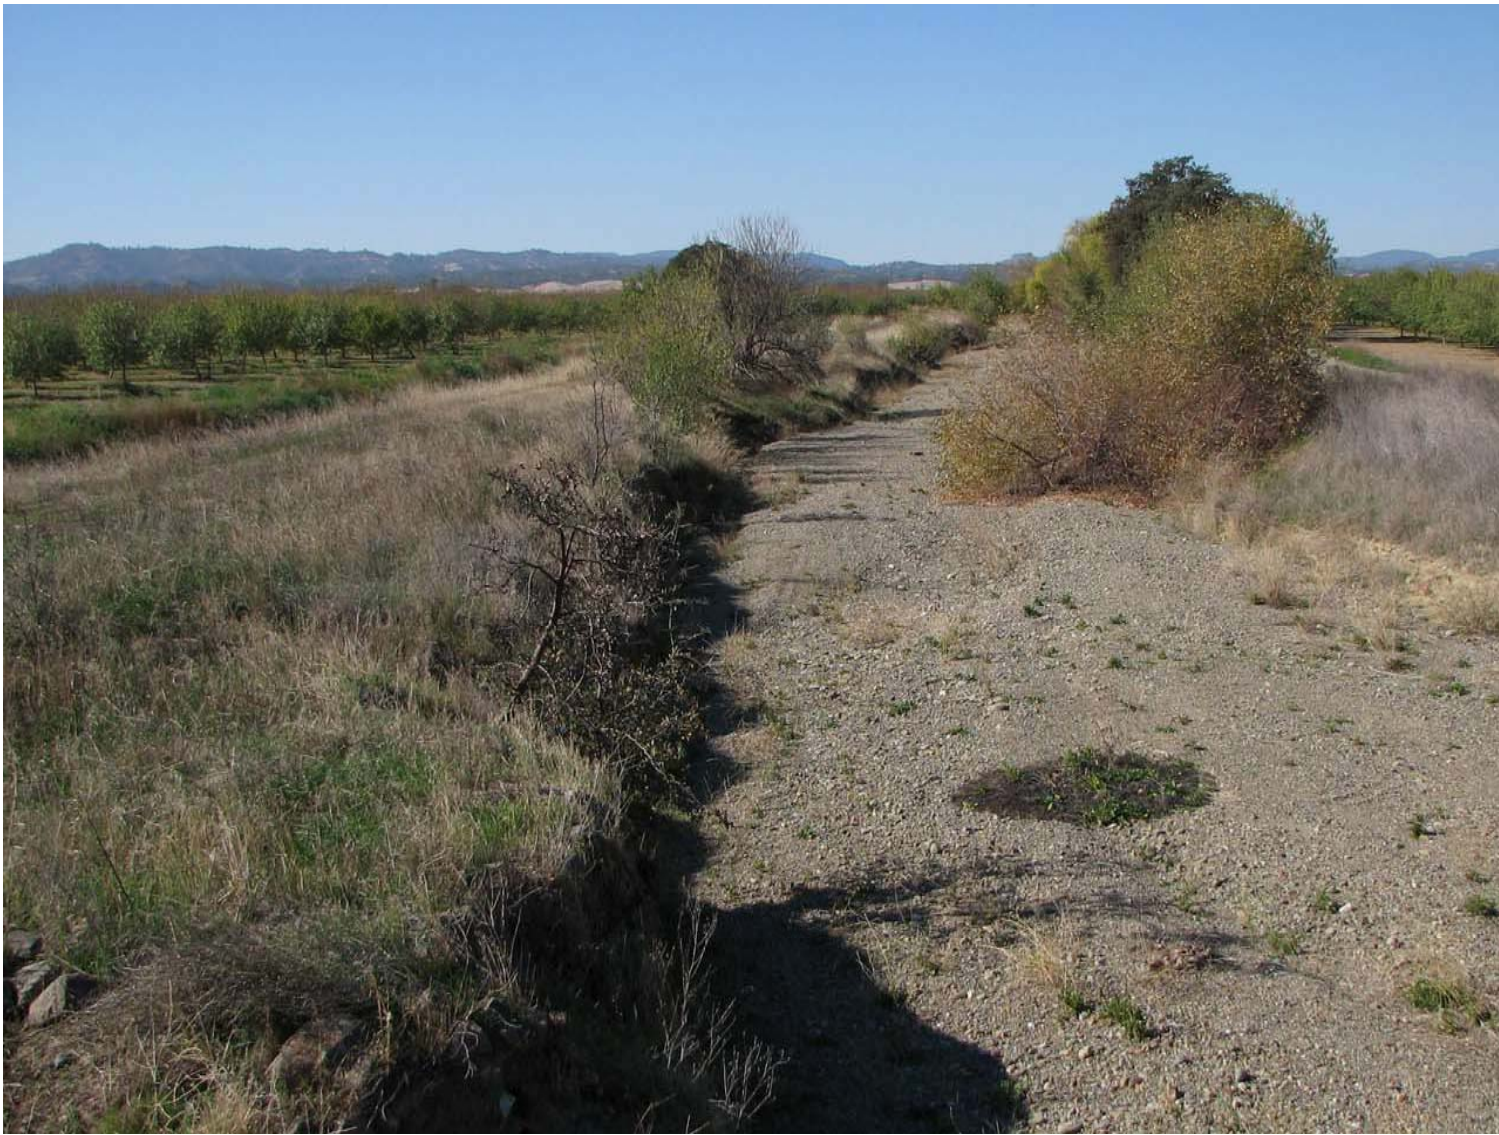
**Figure 4-Geomorphology.** Photo of Petroleum Creek looking approximately from Wildwood Road crossing. Note the gravel-bedded channel devoid of erodible artificial banks and levees. November 6, 2007.

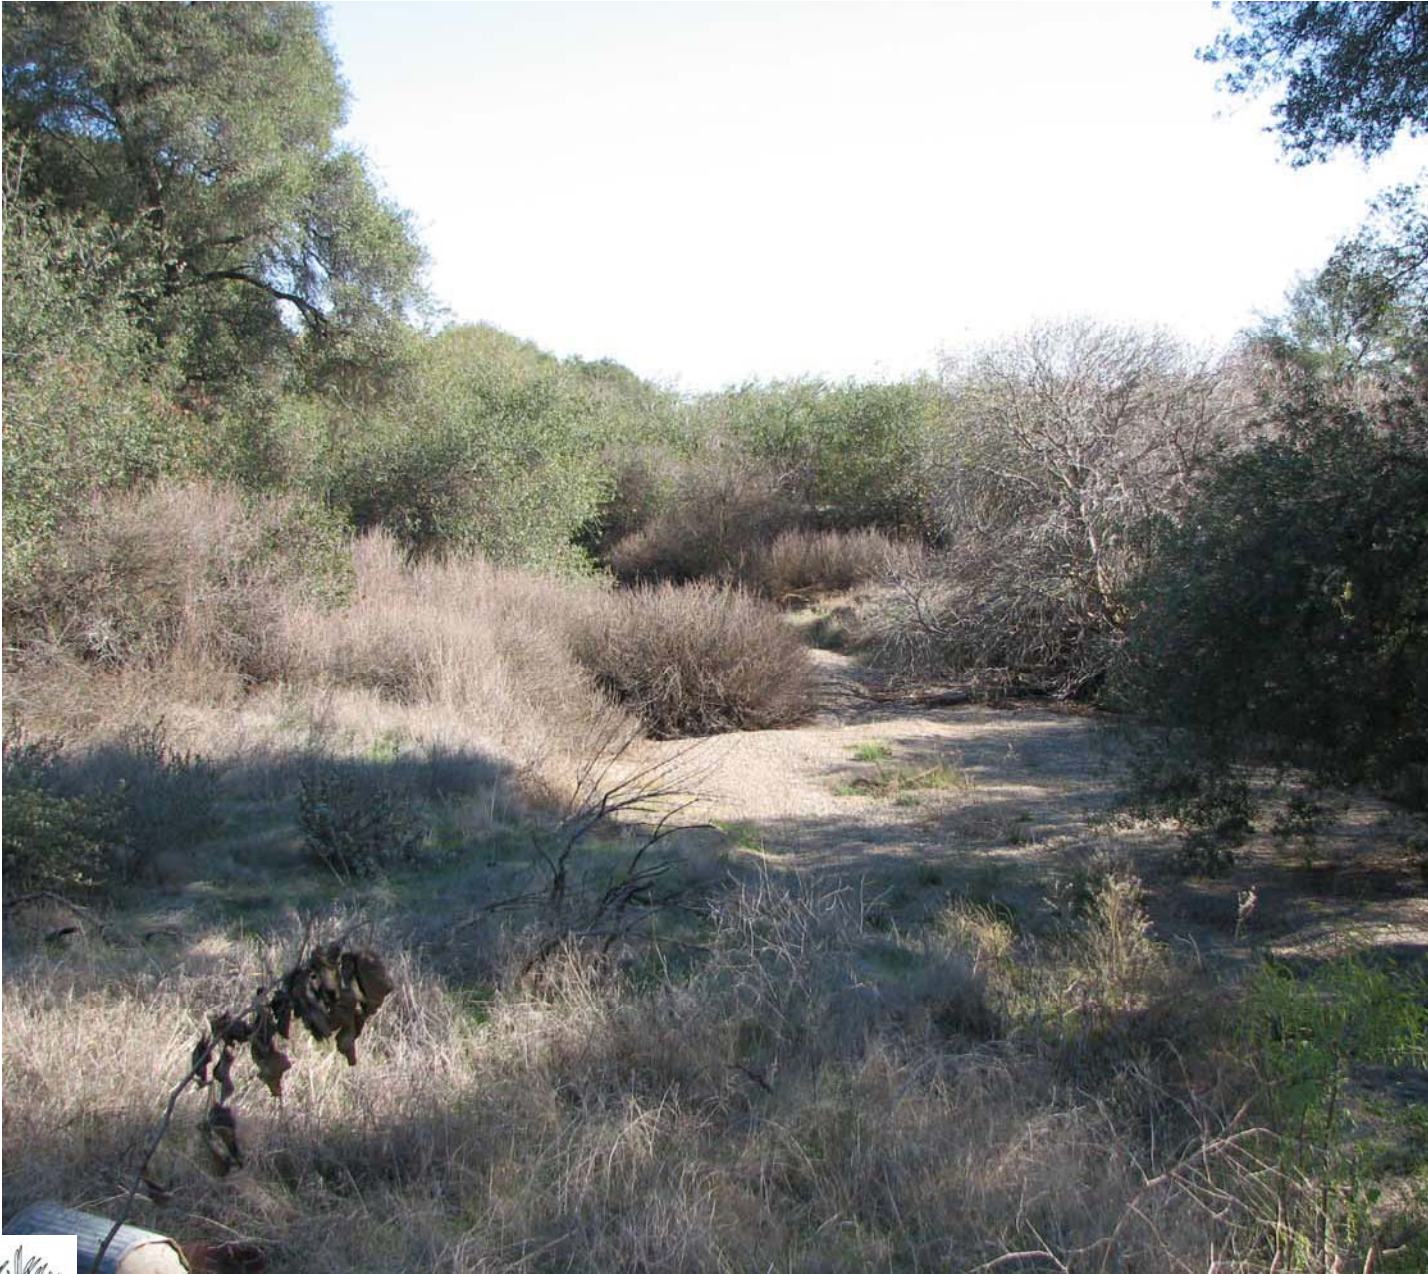
**Figure 5-Geomorphology.** Photo of remnant natural pre-development cha community intact along North Fork Elk Creek looking approximately easte from Whiskey Creek Road crossing. November 6, 2007.
