**COLUSA BASIN  
WATERSHED ASSESSMENT**

**Final**

**Colusa County Resource Conservation District**  
100 Sunrise Boulevard, Suite B  
Colusa, California 95932

15 December 2008

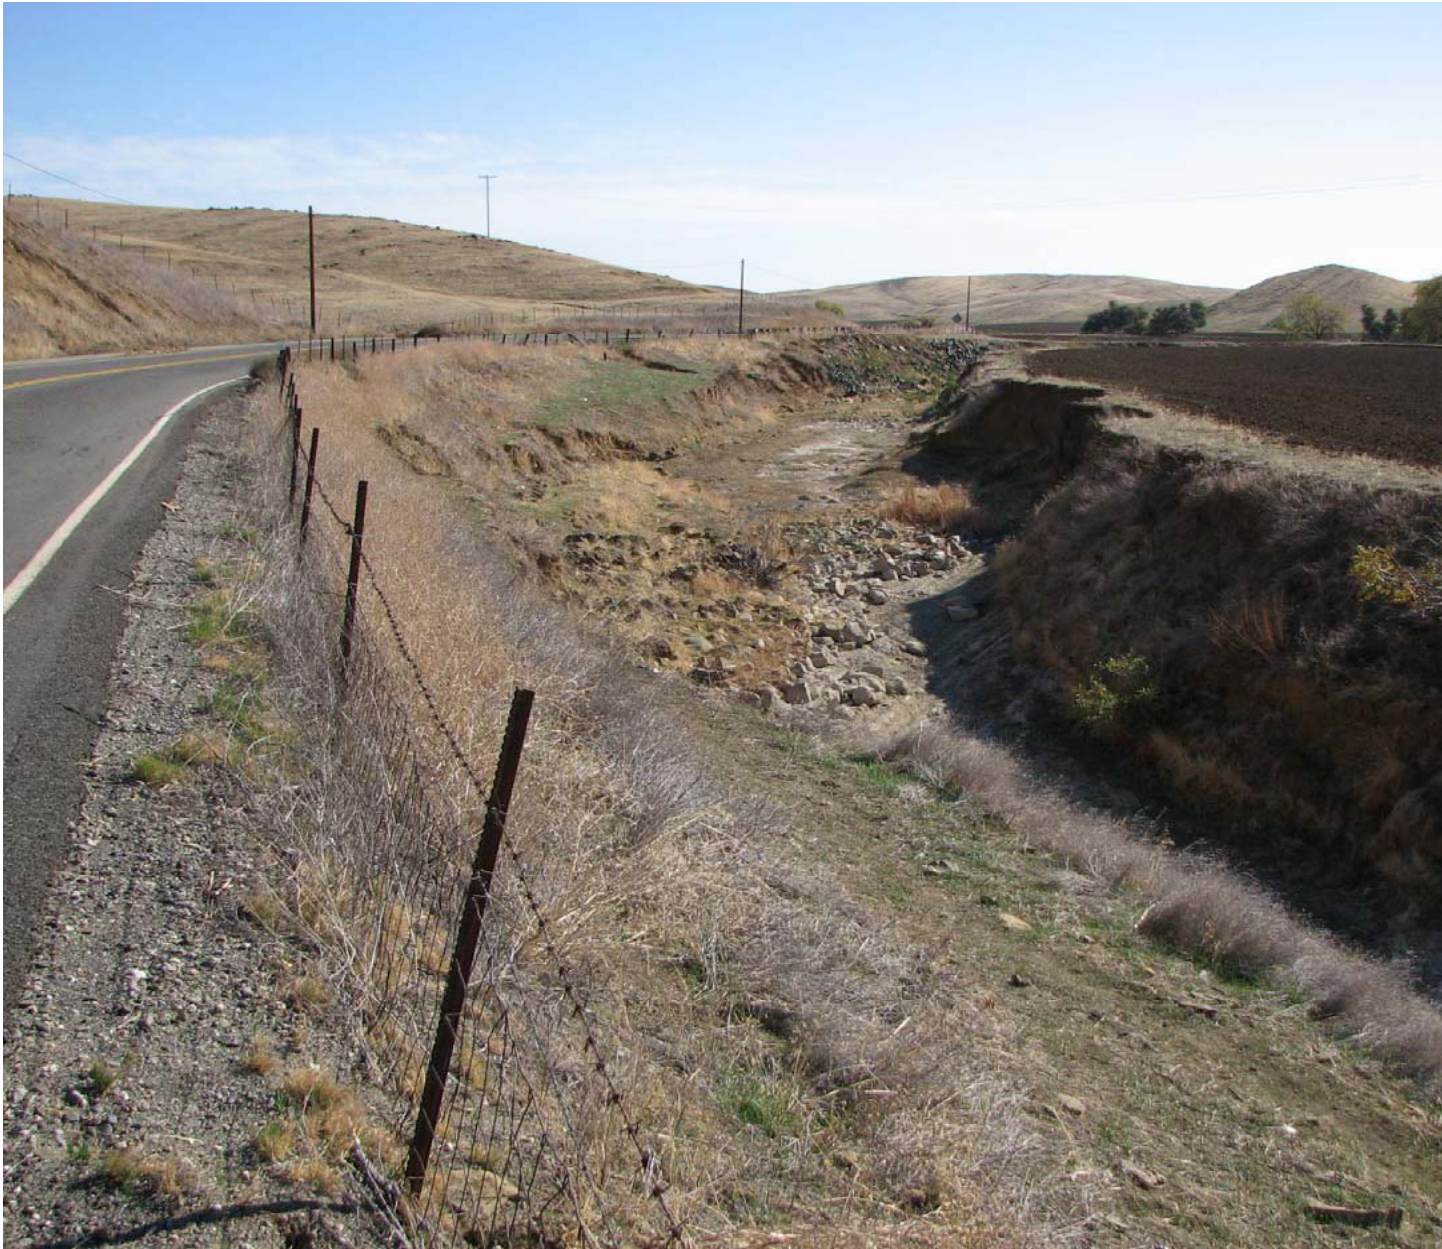
**Figure 6-Geomorphology.** Photo of Stone Corral Creek looking approximately upstream and downstream from edge of Maxwell Sites Road about 3 mi downstream that the channel is deeply incised in the valley fill and rip-rap protecting edge of the road in the background. Soil is Corval clay loam of alluvial fan. November 6, 2007.

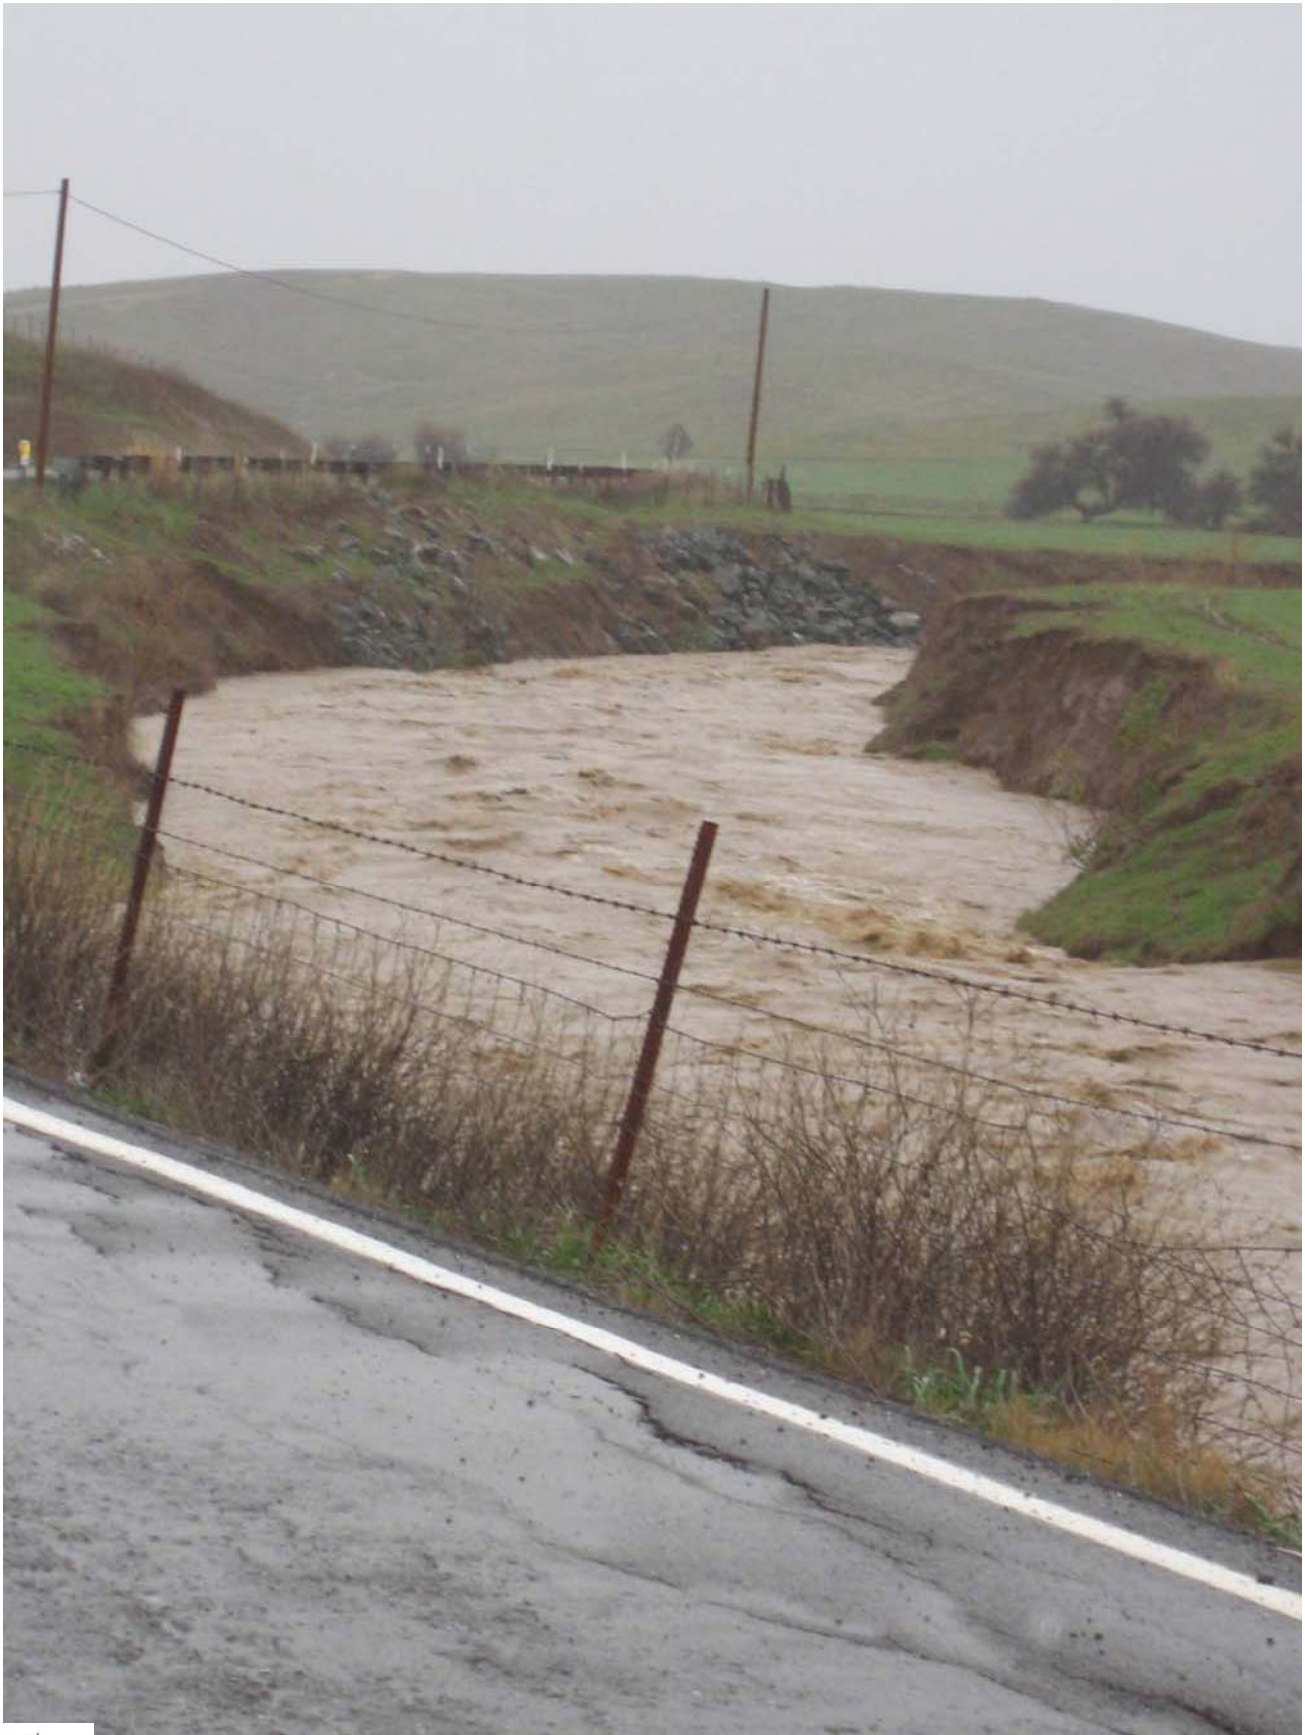
**Figure 7-Geomorphology.** Photo of Stone Corral Creek looking approximately southeasterly and downstream from edge of Maxwell Sites Road about 3 mi downstream from Sites during high runoff conditions. Soil is Corval clay loam of alluvial fans and floodplains. (Photo by Jennifer Masters, January 25, 2008).

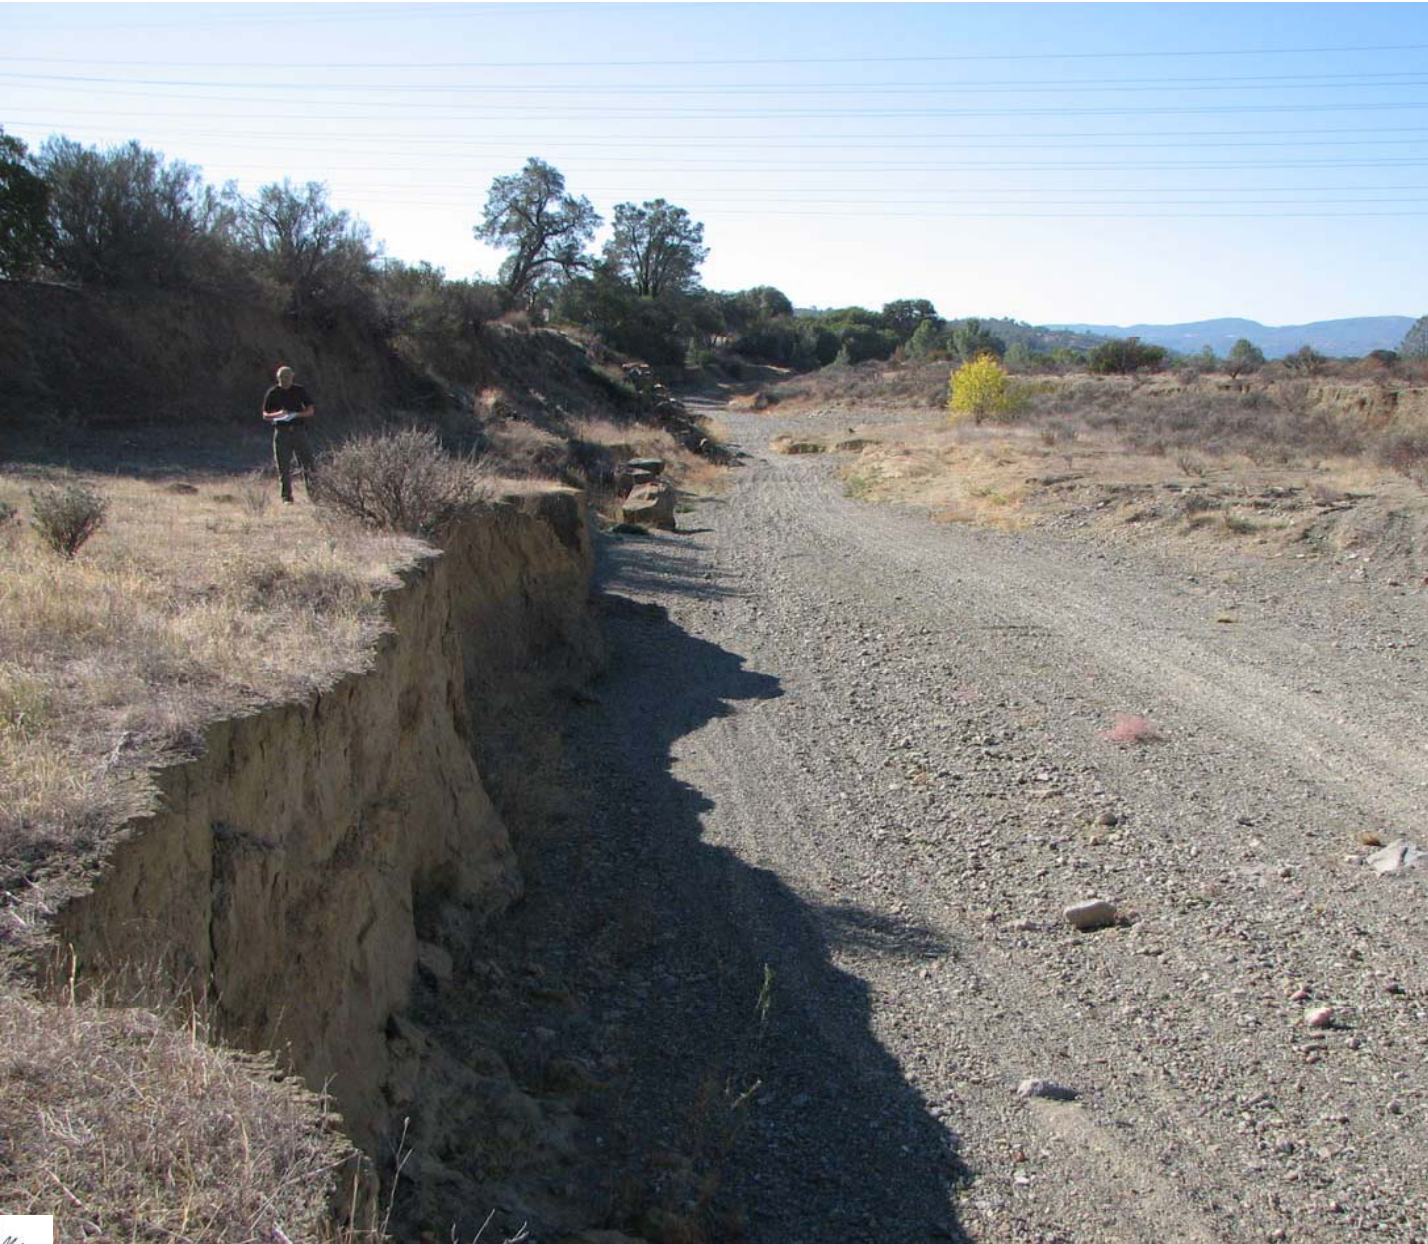
**Figure 8-Geomorphology.** Sand Creek looking approximately westerly and top of right bank about  $\frac{3}{4}$  mi upstream from Cortina School Road. Note clay channel in mid-ground. Elsewhere in vicinity bed is cut in grooved clay with deposits. November 6, 2007.

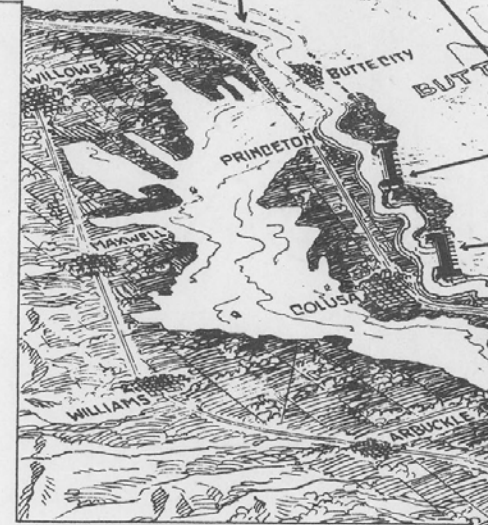
Runoff in the Sacramento River Basin in flood time exceeds capacity of river channel, necessitating weirs.
