**CENTRAL VALLEY PROJECT IMPROVEMENT ACT
FISHERIES INVESTIGATIONS**

**Annual Progress Report
Fiscal Year 2016**

Prepared by staff of
The Anadromous Fish Restoration Program

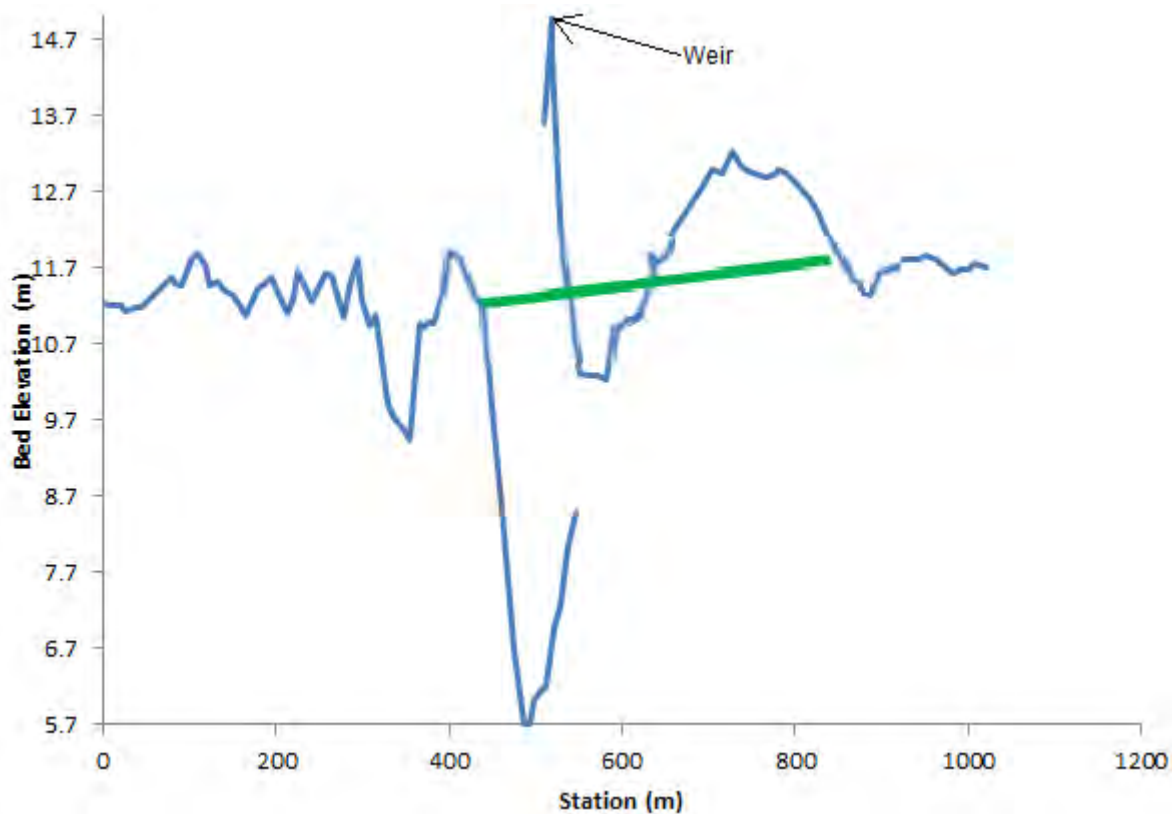
Figure 3

Sunset Pumps Existing Conditions (with weir) Thalweg Profile (blue line). The blue line is broken due to the discontinuity of the thalweg at the weir. Green line is the feature line used to calculate scour volume upstream of the weir.

The estimated volume of the weir is 7,325 cubic yards, while the estimated volume of material that would be expected to be scoured upstream of the weir (Figures 3 and 4) is 13,576 cubic yards, based on a thalweg going from 11.6 to 11.8 meters through the scour area. The volume of the weir will be useful in estimating the cost of weir removal, while the volume of material that will be scoured will be useful in evaluating the effects of weir removal.

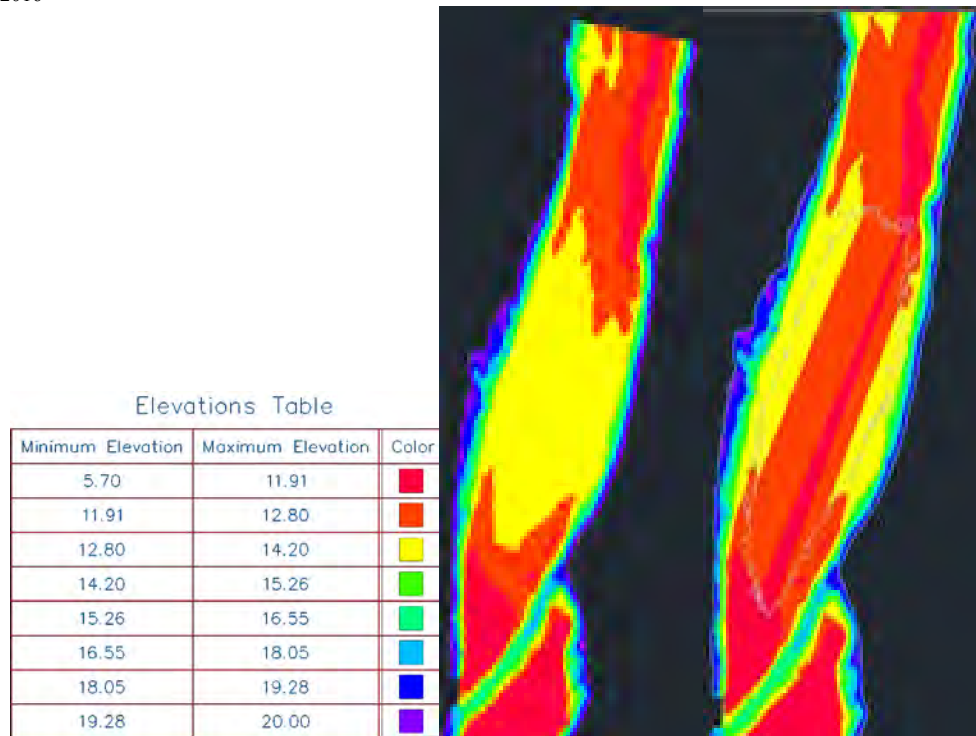
Figure 4

Existing Conditions (with weir, left) and Estimated Post-Scour Conditions (without weir, right) upstream of Sunset Pumps weir. Units of Elevation are meters.

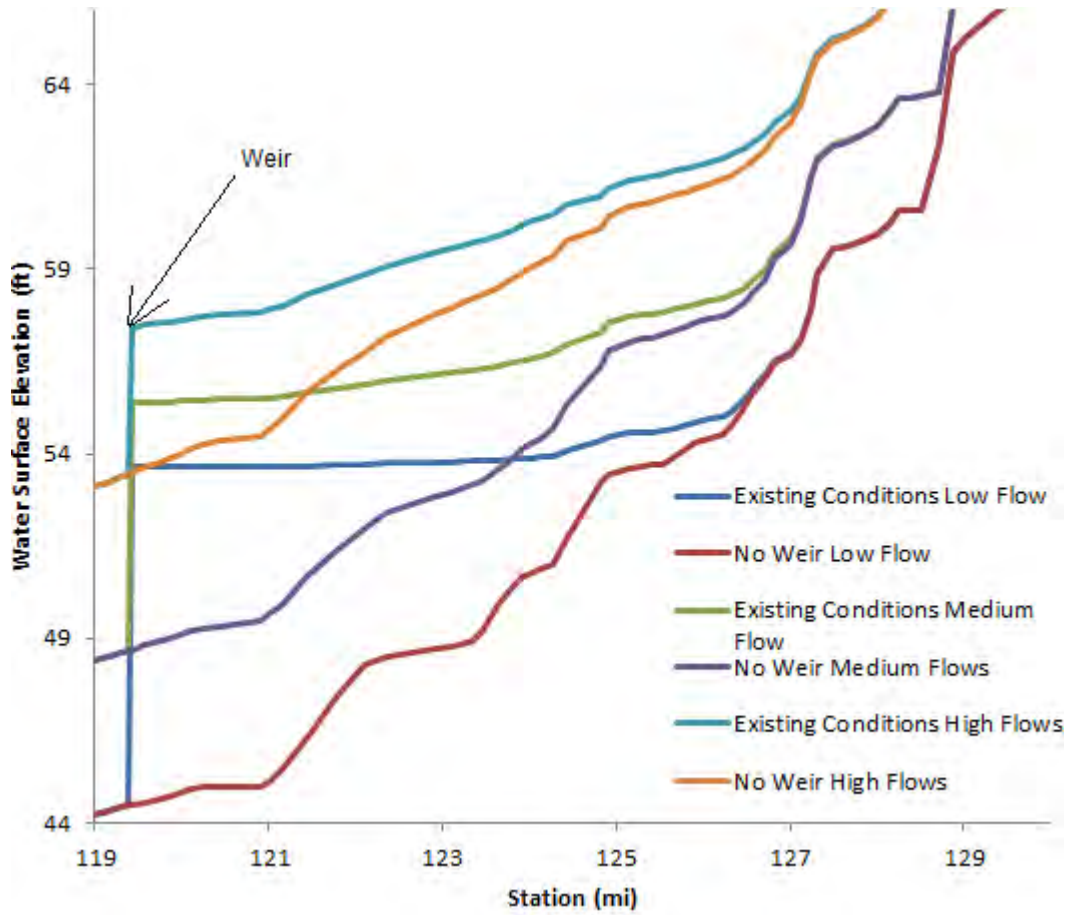
Figure 5

Full HEC-RAS model output showing that the No Weir Low Flow red line option would be a better option than existing conditions

Results of the HEC-RAS models are shown in Figures 5 and 6. Removing the weir reduces water surface elevations, particularly at low flows and near the weir location. Removing the weir reduces flood risk at lower flows and has no effect on flood risk at higher flows. As shown in Table 2, lowered river levels associated with removing the weir should have a minimal effect on upstream diversions, requiring an additional two feet of 6-10 inch flexible pipe at the first two diversions upstream of Sunset Pumps, but may require modification of the Live Oak boat ramp.

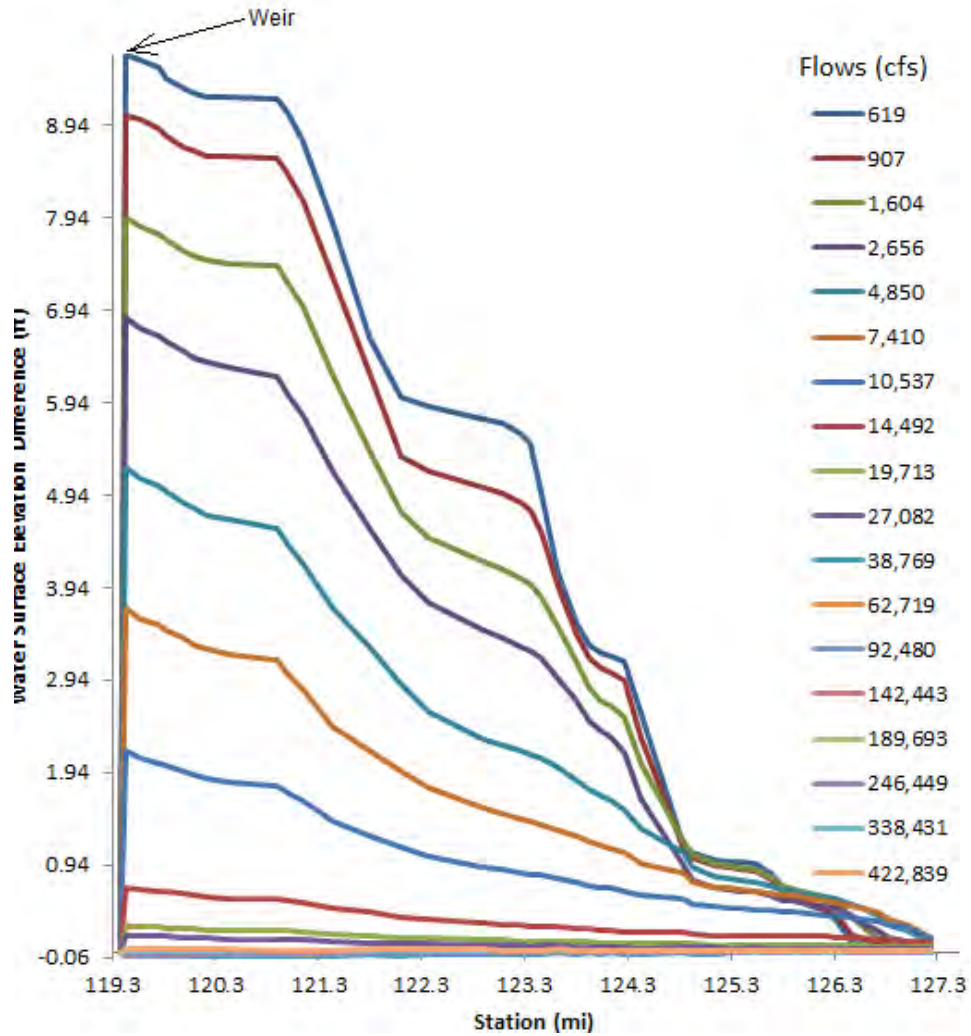
Figure 6
 Simplified HEC-RAS model output. Sunset Pumps is at RM 119.4.

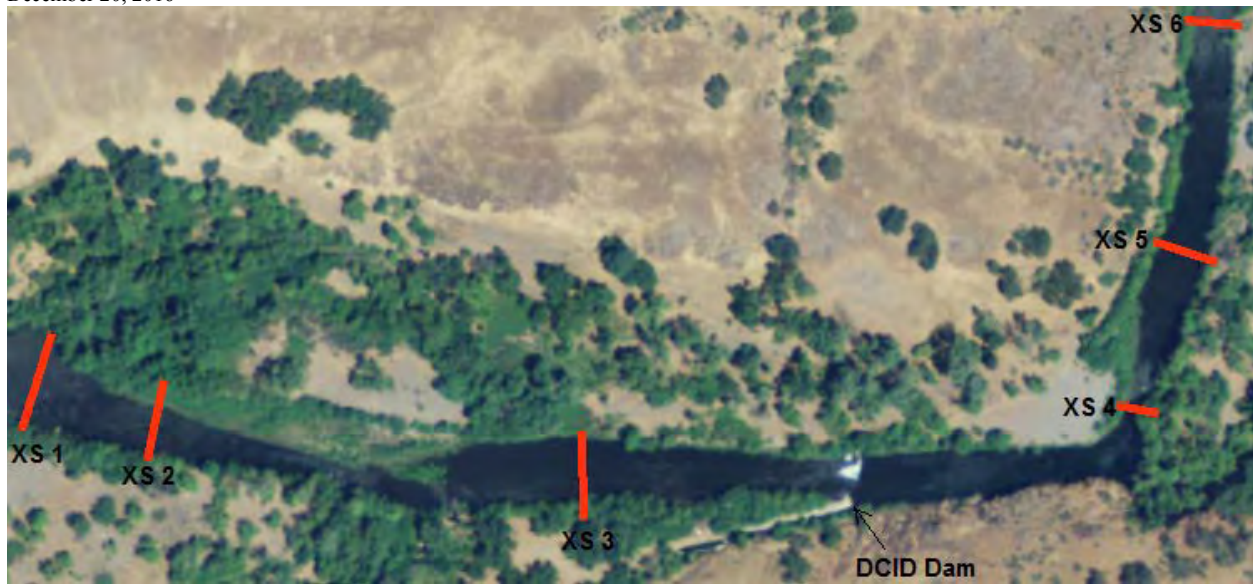
Figure 11
Deer Creek Irrigation District Dam Transects

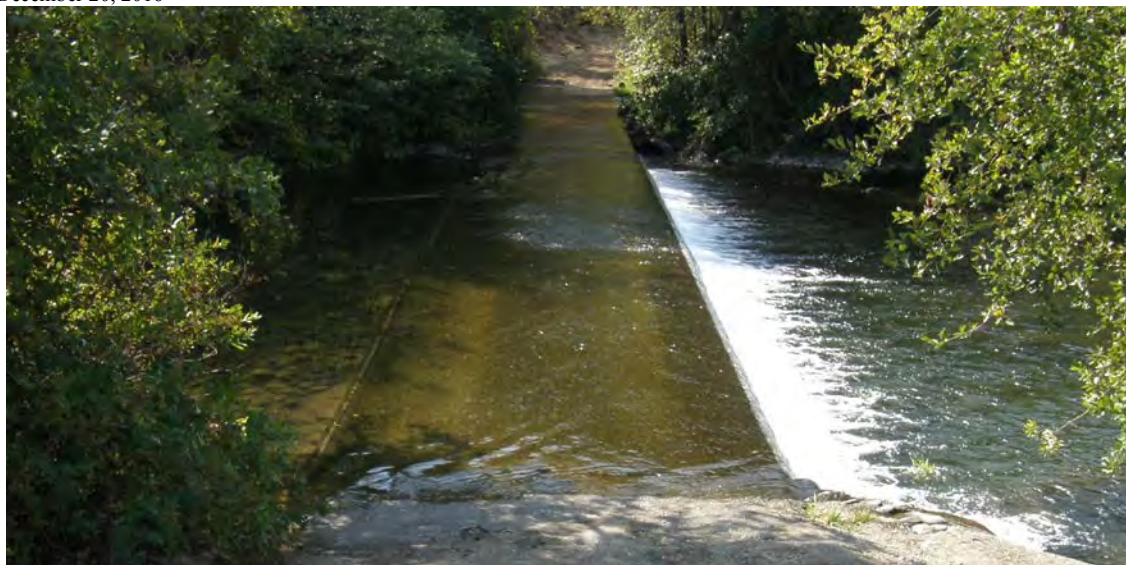
Figure 18
Antelope Creek lower slab pre 2014 high flows

The goal of this task was to develop a solution to the barrier to upstream passage of adult spring-run Chinook salmon caused by the Antelope Creek lower slab (Figure 18), also known as Facht's Place crossing. A River2D model developed for the site with data collected in 2014 indicated that the slab would be an upstream passage barrier for flows of less than 441.5 cfs, which are only exceeded 5% of the time during the migration period for adult spring-run Chinook salmon. A field visit on November 18, 2015 indicated that there had been significant channel changes in the vicinity of the lower slab (Figure 19) so that river left is no longer a barrier, with the dominant flow path being down the length of the slab, rather than across the slab. As a result, we collected additional topography data in the vicinity of the slab on May 25, 2016 to update the hydraulic model to use in developing a solution to the upstream passage barrier. Topographic data were collected using a total station and a survey-grade RTK GPS unit. We also collected substrate and cover data for each topographic point collected with the total station and survey-grade RTK GPS unit.

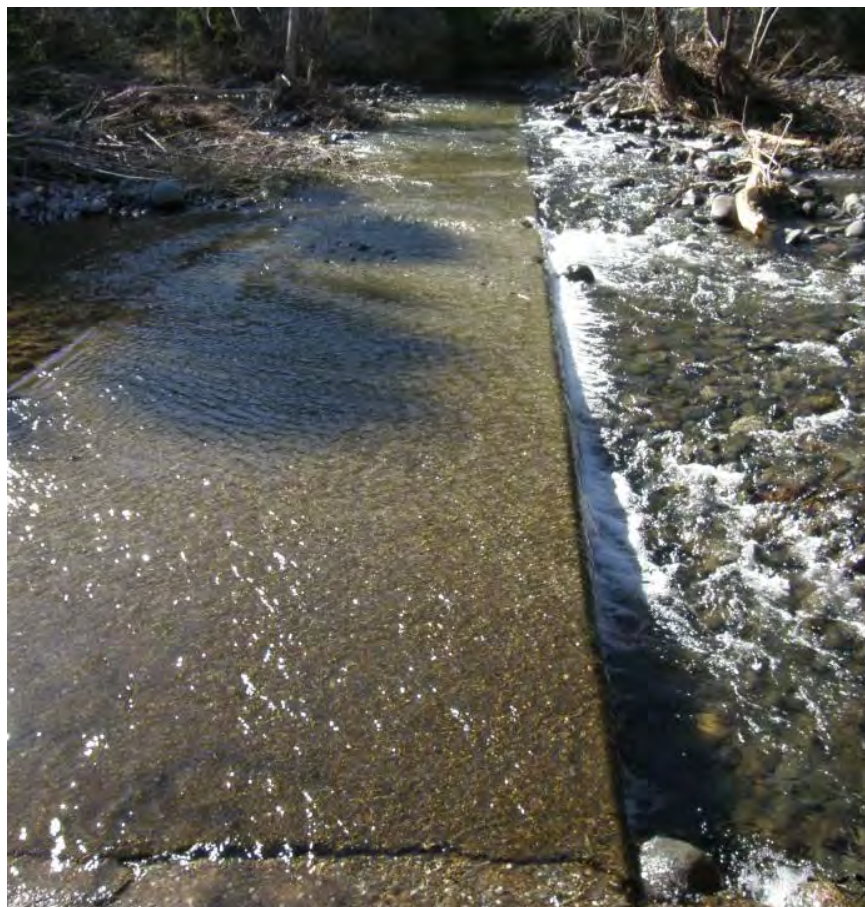
Figure 19
Antelope Creek lower slab post 2014 high flows

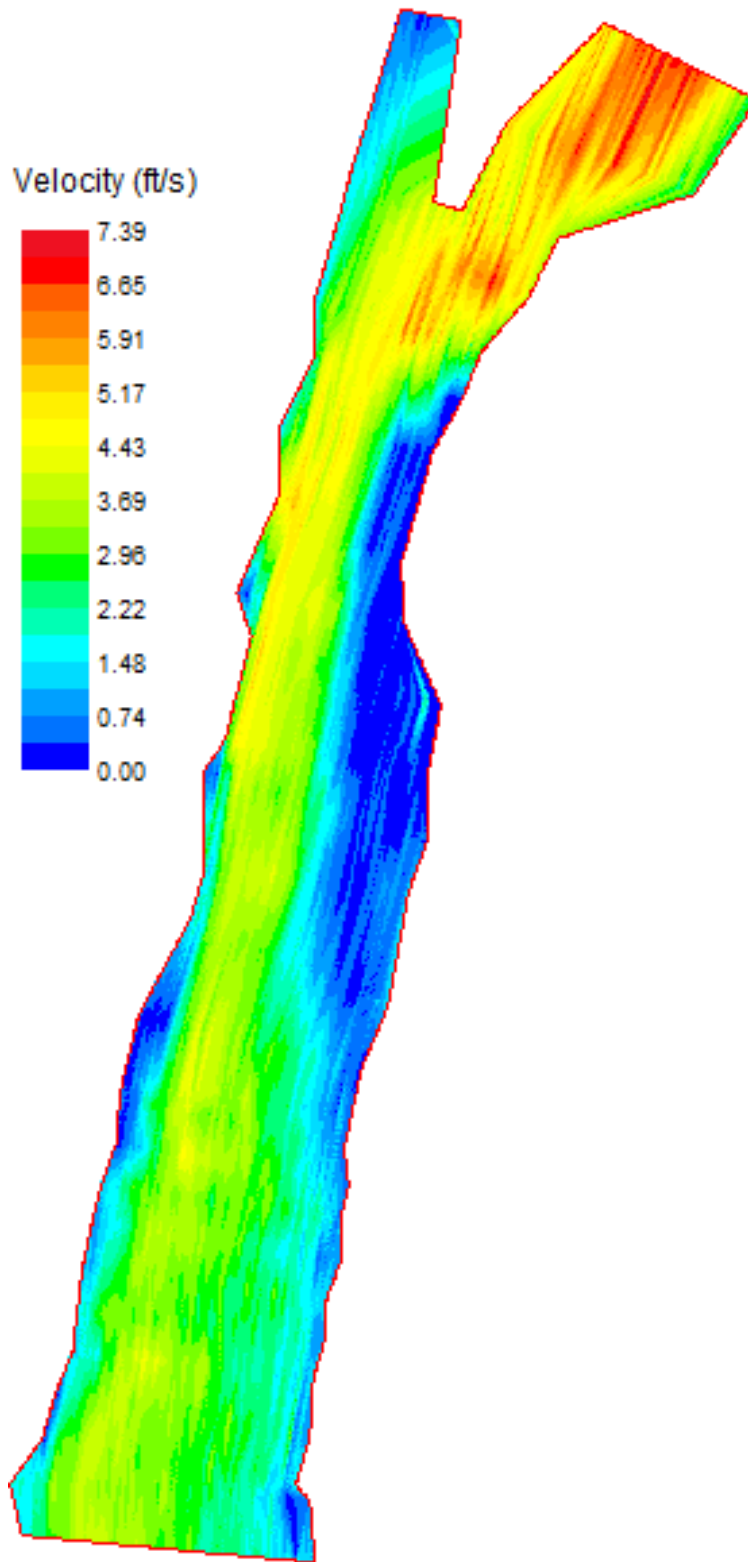
Figure 26
Rkm 370 Velocities

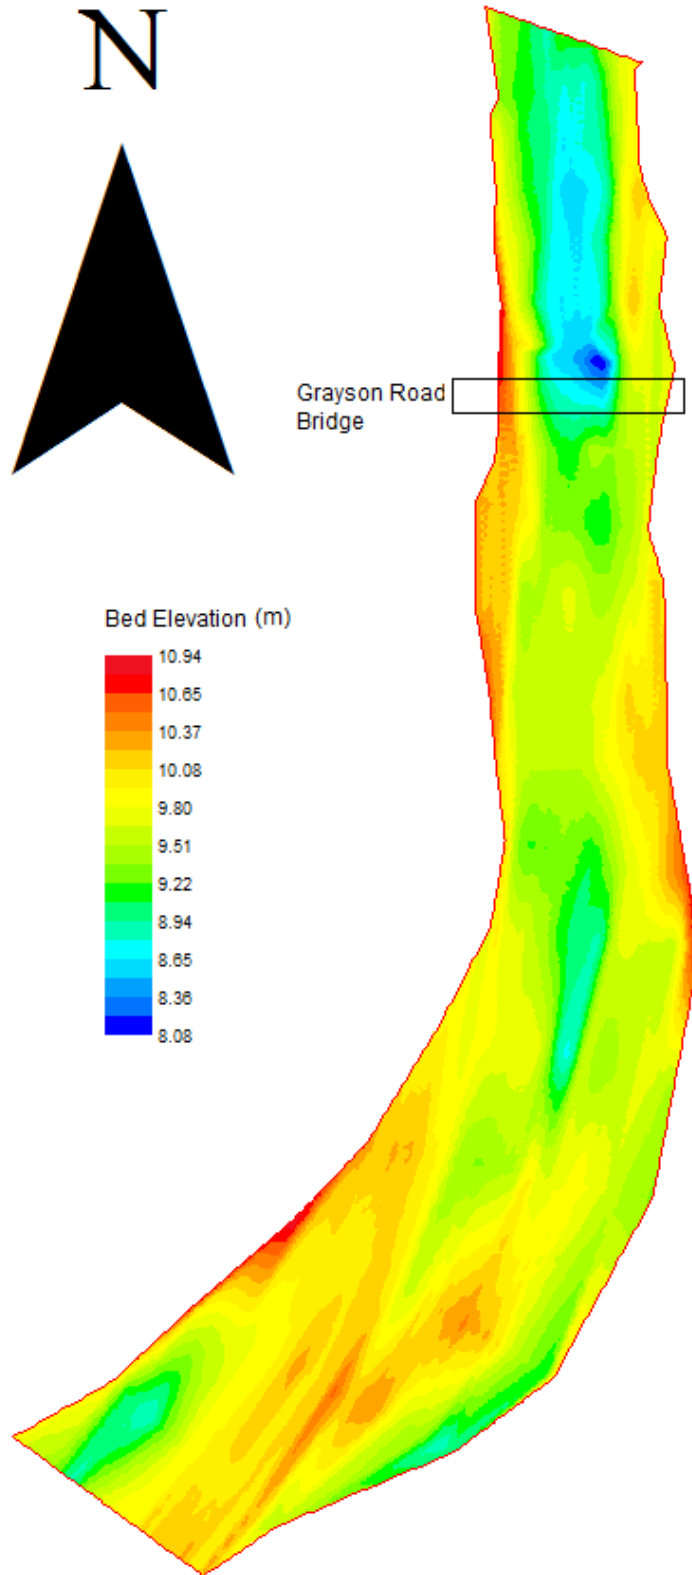
Figure 27
Rkm 142.5 Bed Topography

We were unable to sample the portion of the Rkm 142.5 site under Grayson Bridge due to interference of the bridge with GPS signals. However, by collecting data just upstream and downstream of the bridge, we were able to maintain the same spacing of ADCP traverses that we had for the remainder of the site. Accordingly, the inability to sample under Grayson Bridge did not affect the mapping of depths and velocities at this site.

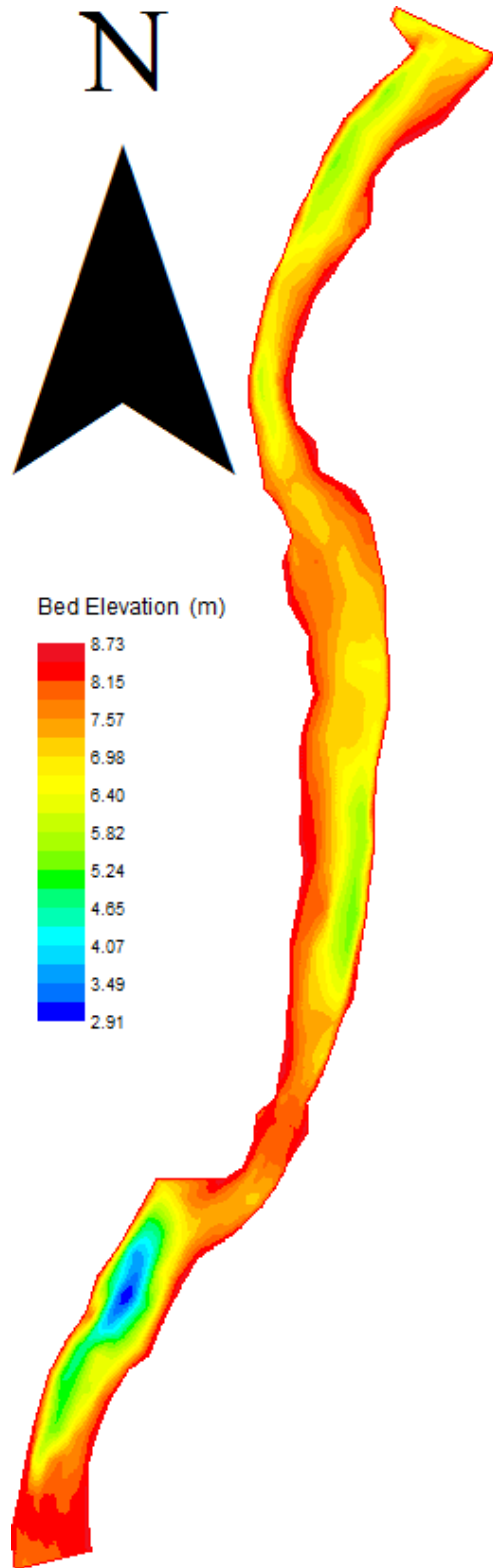
Figure 28
Rkm 140.4 Bed Topography

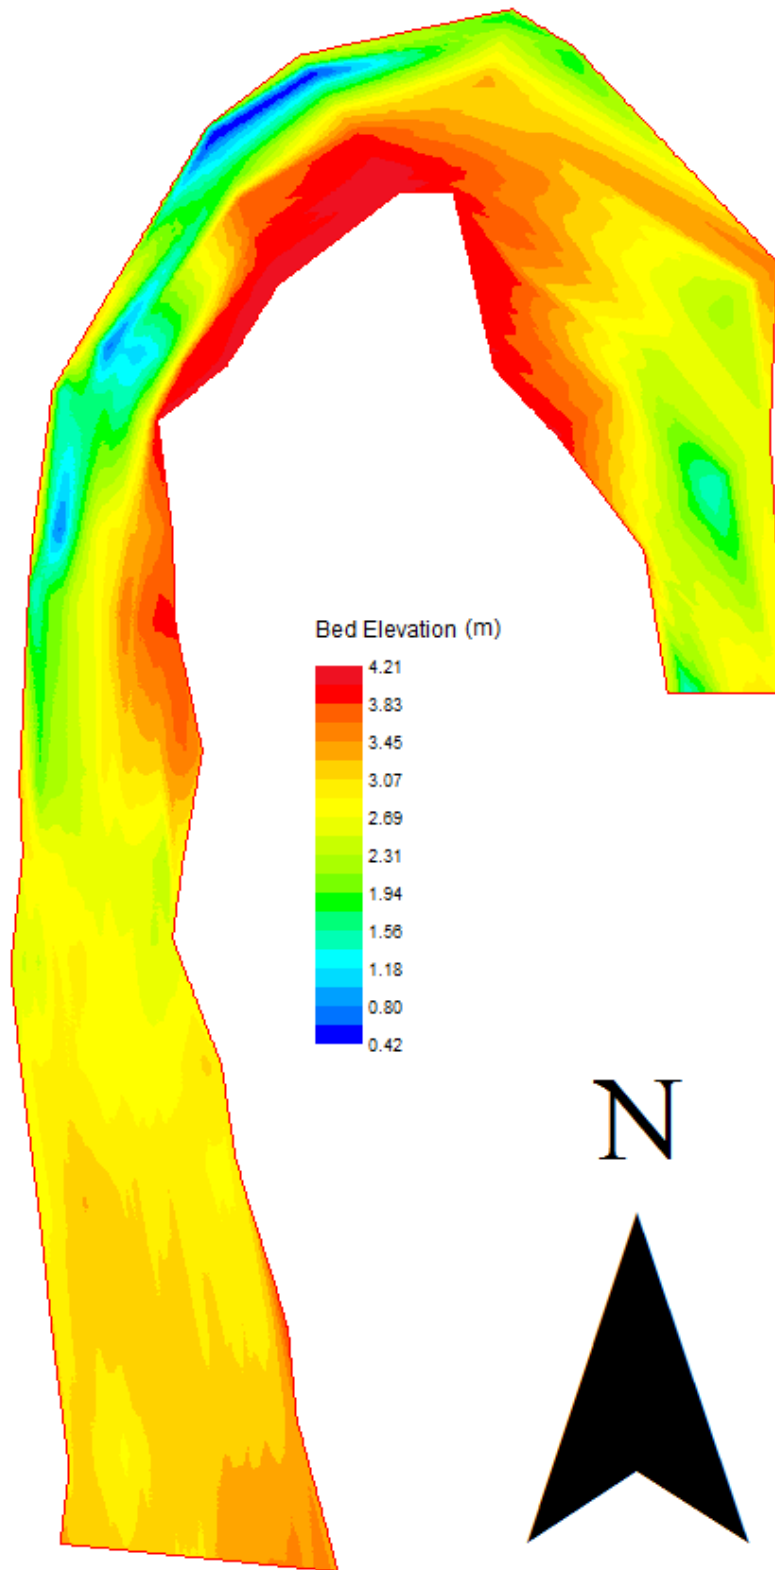
Figure 29
Rkm 118.4 Bed Topography
45

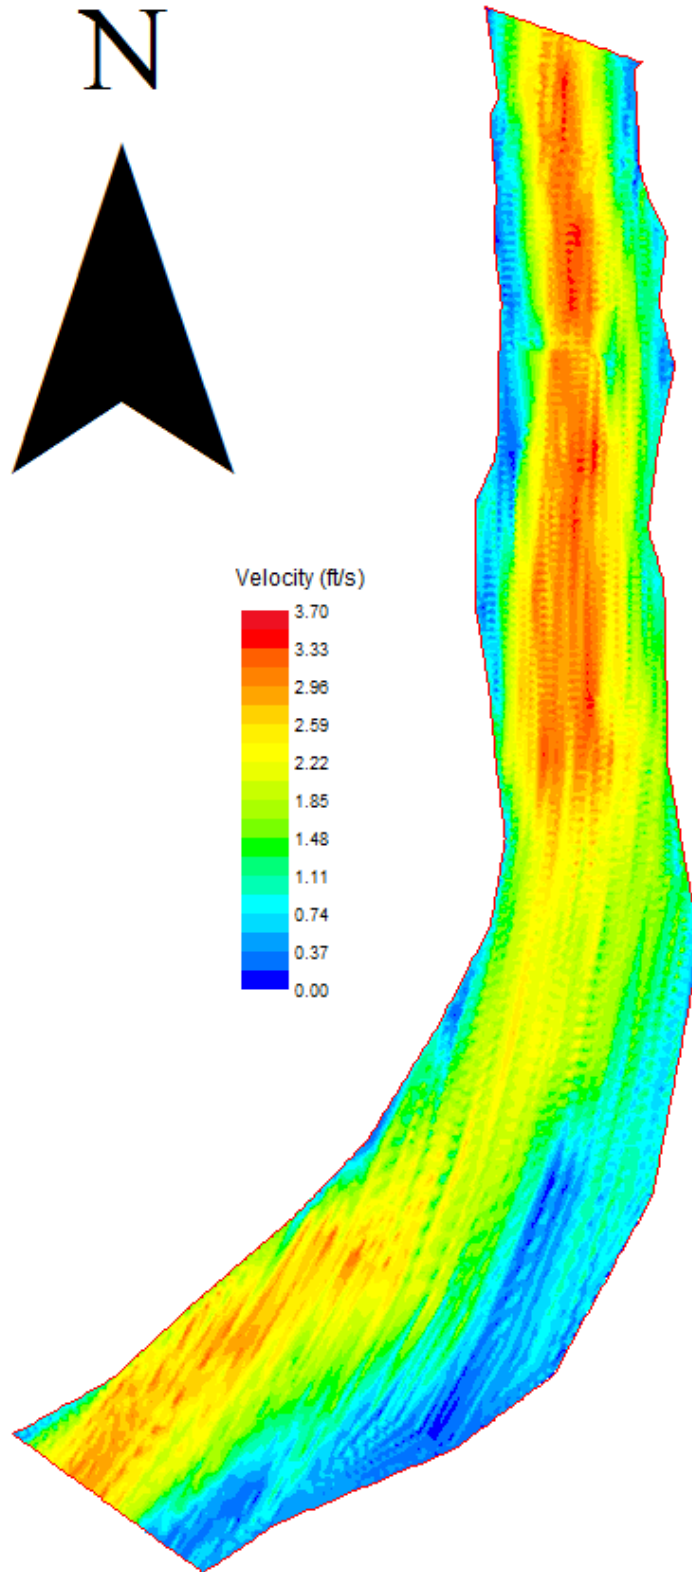
Figure 31
Rkm 142.5 Velocities

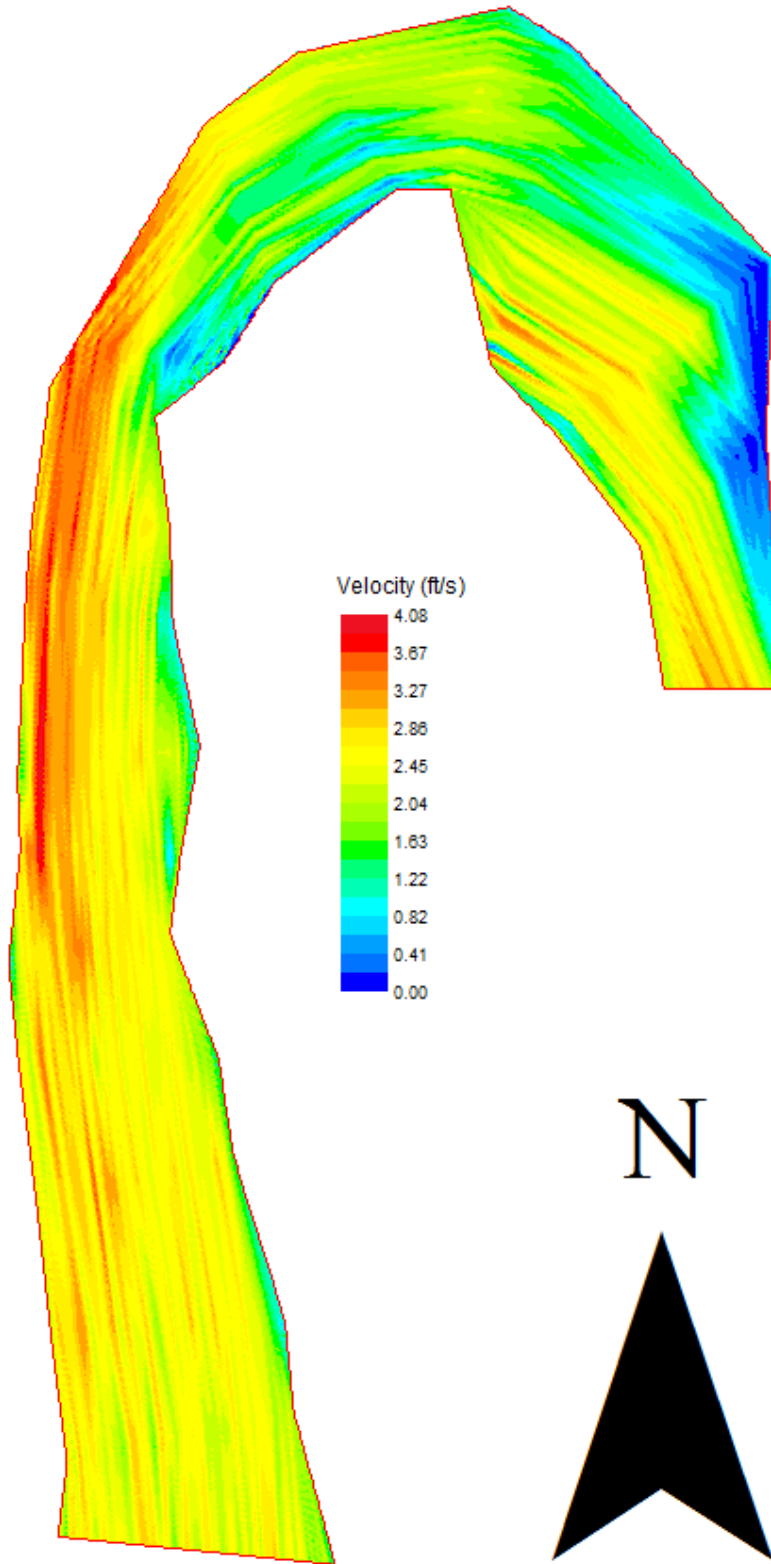
Figure 35
Rkm 118.4 Velocities

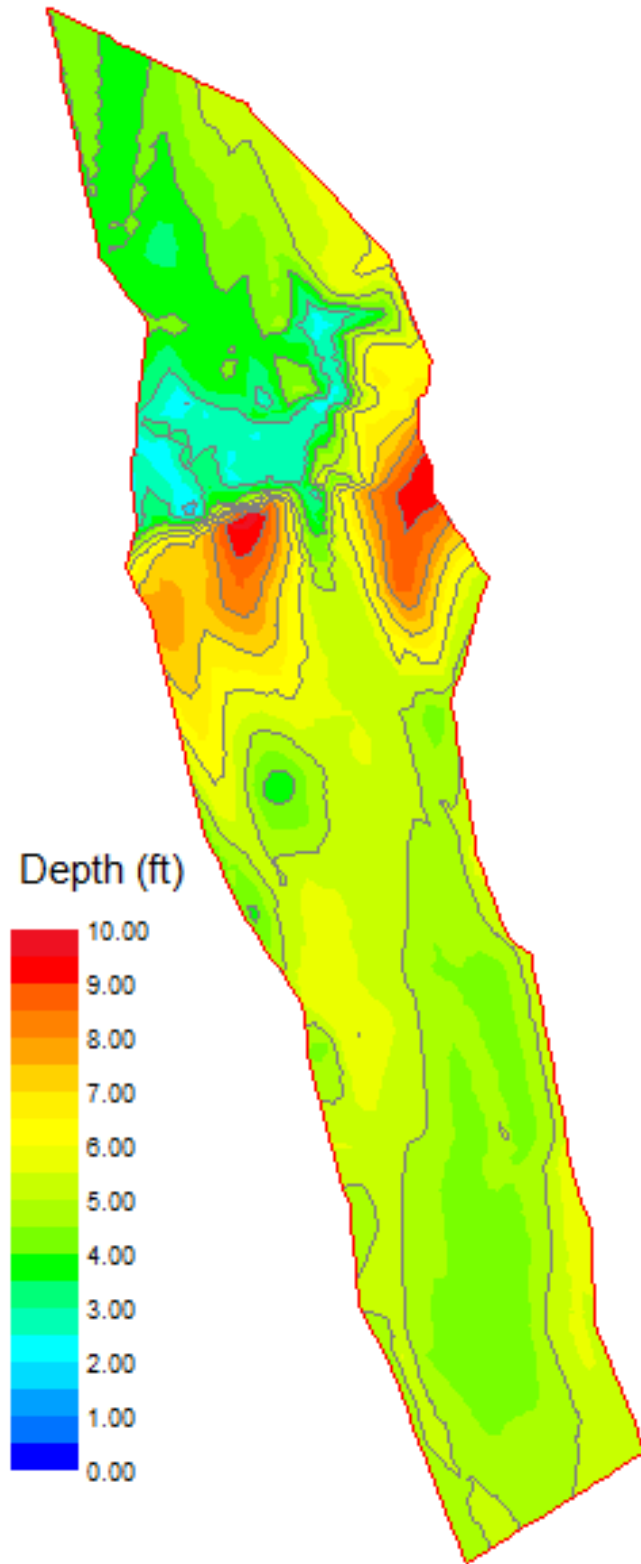
Figure 37
Stanislaus River Potential Upstream Migration Barrier Depths at 973 cfs
