**California Department of Fish and Wildlife**

**Colusa Basin Drain and Wallace Weir  
Fish Trapping and Relocation Efforts  
November 2013 – June 2014**

**August 2016**

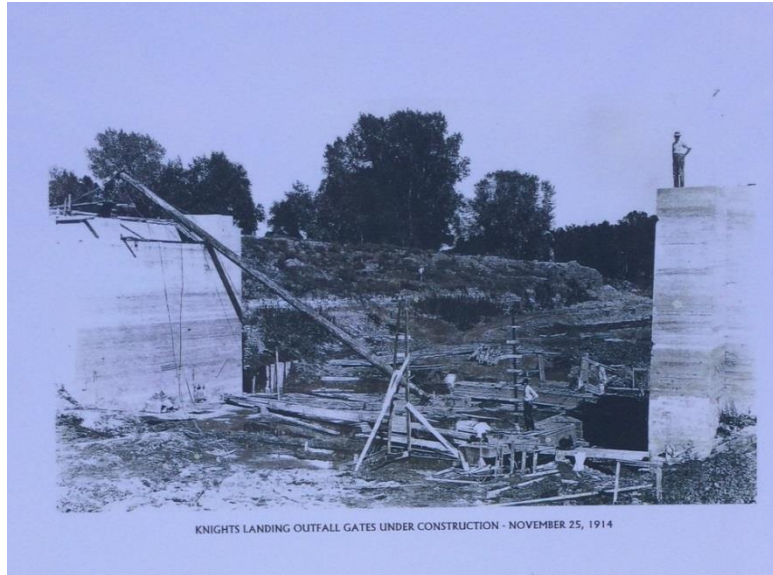
**Figure 3.** Knights Landing outfall gates under construction in 1914.

Originally known as Sycamore Slough Outfall Gates, KLOG was constructed around 1914 (Figure 3). The structure was modified again in 1929, 1930, and 1949. The outfall gates were updated most recently in 2012. However, these updates did not include any measures to reduce the likelihood of fish entrainment.

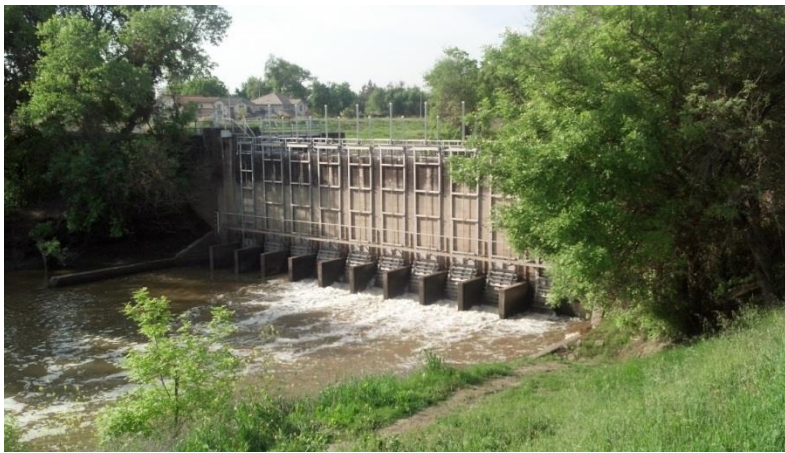
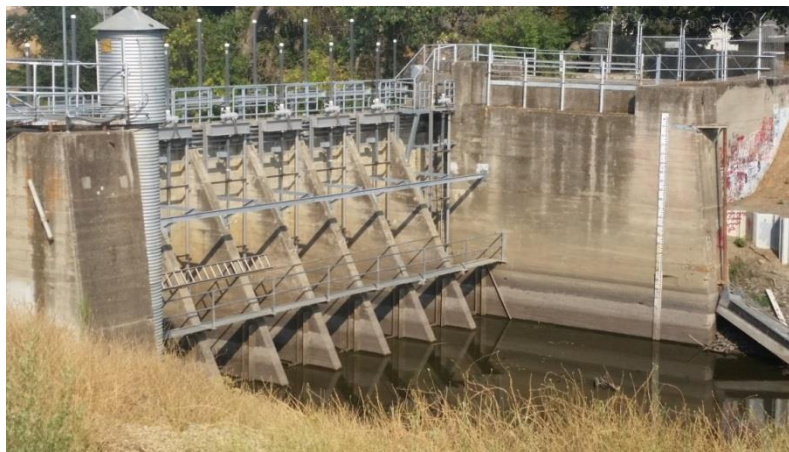
**Figure 4.** Knights Landing outfall gates on April 8, 2014. Downstream (top) and upstream (bottom).

The KLOG structure is operated by the DWR and consists of a concrete barrier wall at the terminus of CBD canal with 10 automated round gated openings. These gates allow water to drain from the CBD to the Sacramento River during river flows up to approximately 27 feet and also prevent water from the Sacramento River from entering the CBD during periods of river flow with stage height greater than 27 feet. During high flows in the Sacramento River (with gates closed), all CBD water is shunted through the KLRC into the Yolo Bypass (Navigant

Consulting, 2004). Eight of the KLOG gate openings are 5.5 feet in diameter and two are 3.5 feet in diameter. All have a centerline elevation of 21 feet and are equipped with automated slide gates on the upstream (canal) side and a flap gate on the downstream (river) side. Automated slide gates allow water level in the canal to be regulated at an elevation above river level and flap gates prevent Sacramento River water from passing into CBD when the river is higher than the water level in the canal. The gate structure has a concrete slab at 17' elevation extending downstream of the gate openings for approximately 40 feet to prevent bed erosion from water discharging through the gates (Heise, 2014). Operations at KLOG also allow for regulation of CBD water elevations for irrigation use in the agricultural lands around the CBD and ridge cut. Stage height is kept at a relatively constant level, approximately 25 feet above the U.S. Army Corps of Engineers geodetic datum upstream in CBD (Yolo Bypass Working Group 2001) (Figure 4).

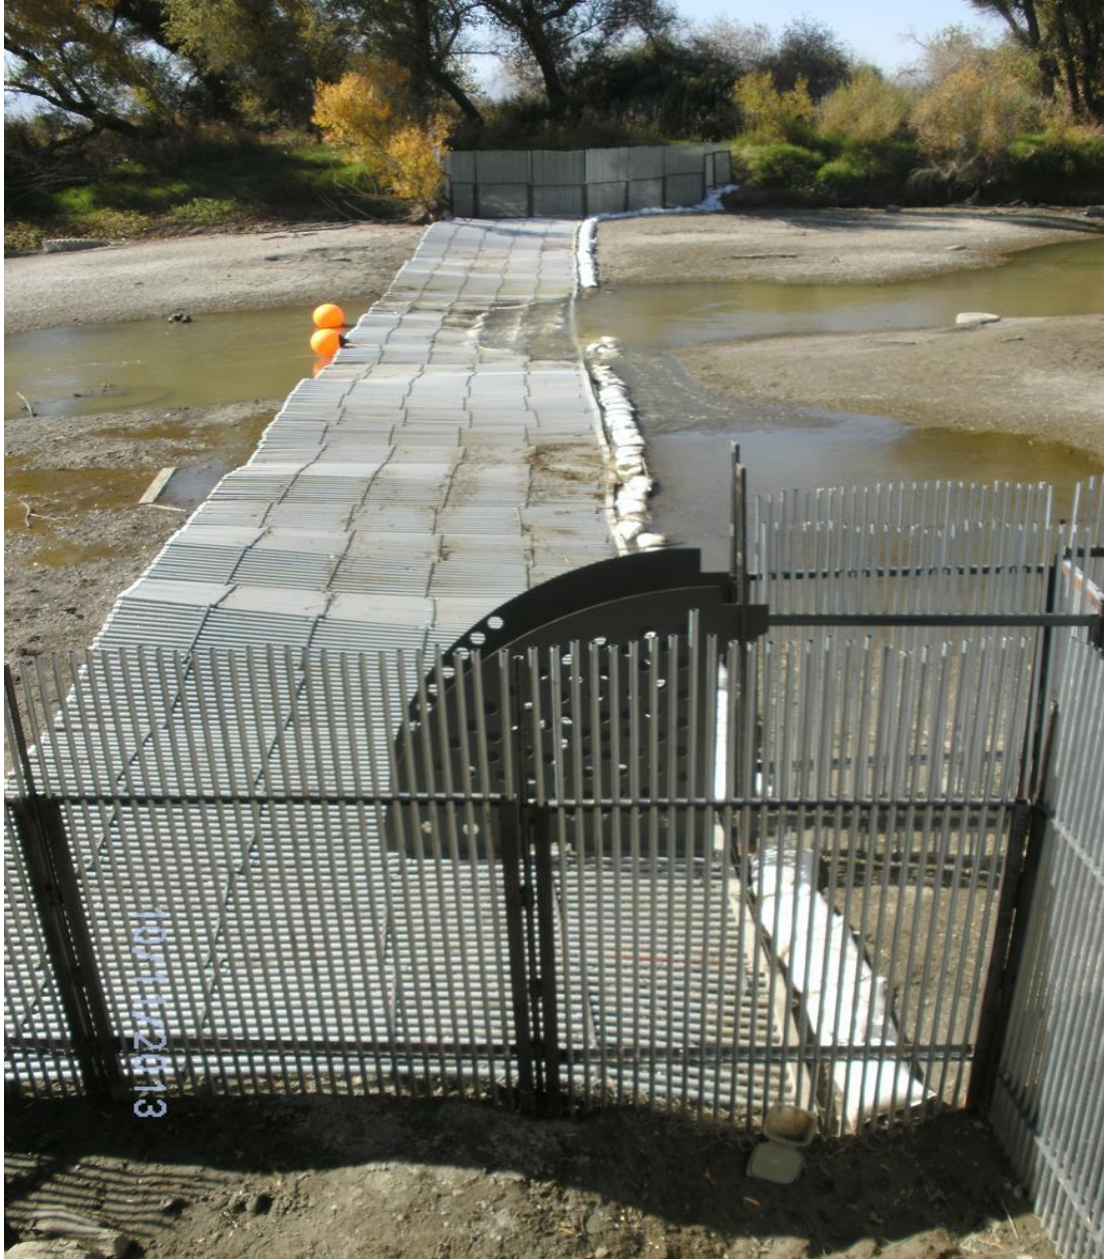
**Figure 6.** Photo of the Colusa Basin Drain weir and trap entrance.

On 2 November 2013, DFW installed a 125-ft wide resistance board-style weir and associated fish trap in CBD (38°54'10.78"N, 121°54'54.71"W) approximately 14 miles upstream from Knights Landing (Figure 5; Figure 6). This trapping site was operated through 22 May 2014. The site was selected based on security, access, stable bank characteristics, and channel uniformity. Design, construction, and installation of the weir were based on methods developed by the Alaska Department of Fish and Game and the United States Fish and Wildlife Service (Stewart 2002, Stewart 2003, and Tobin 1994). The weir had three major components: panels, an anchored substrate platform, and a fixed picket section (Figure 7).

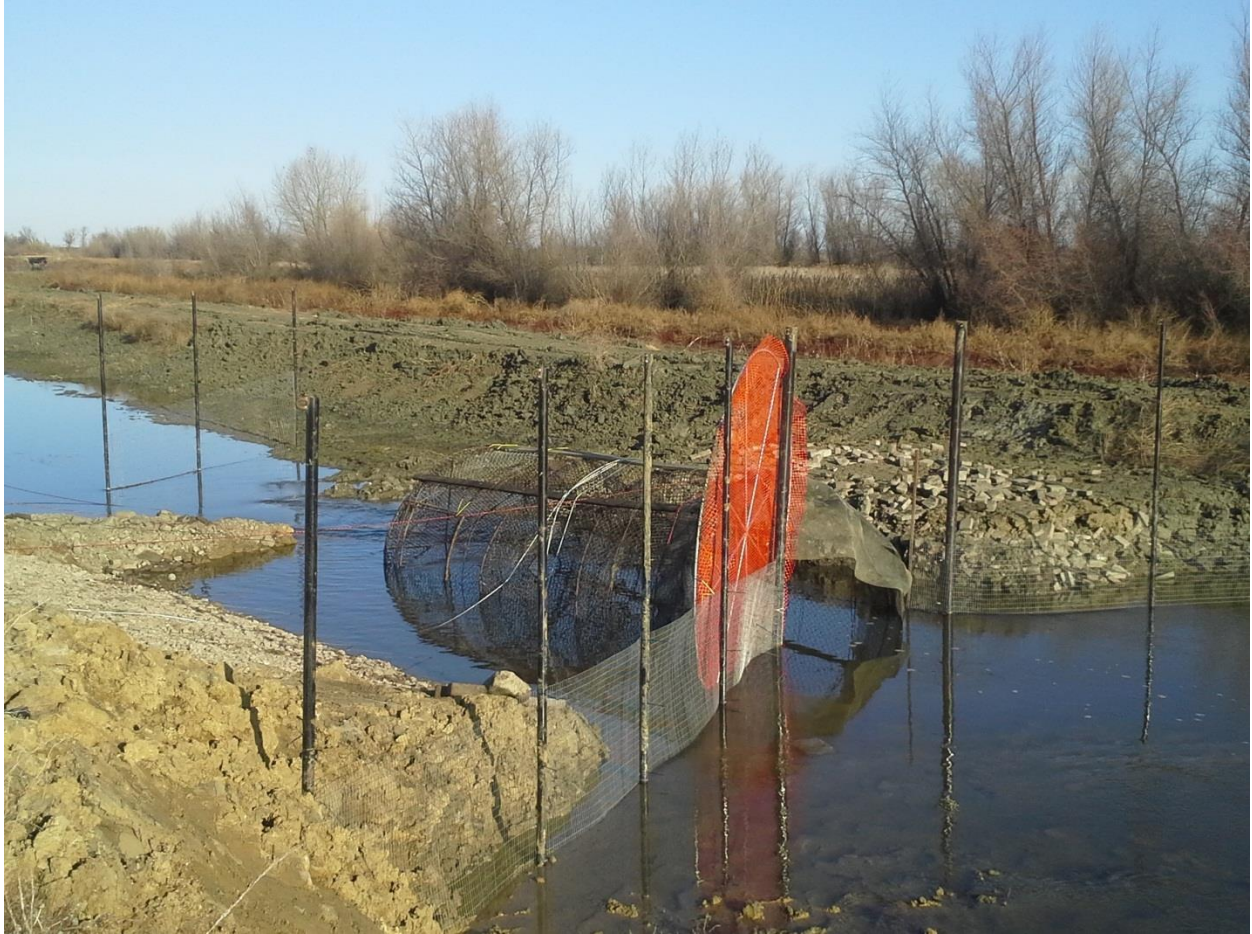
**Figure 8.** Photo of the Wallace Weir fyke trap.

A 10' x 20' fyke trap was installed a few hundred yards downstream from Wallace Weir on 22 January 2014 in the KLRC (38°43'4.353"N, 121°39'35.4672"W) (Figure 5; Figure 8). The fyke trap was constructed of 2" x 4" wood cross beams, circular piping, and 2" diameter plastic and wire mesh. The trap was open at one end and contained two funnels which act as behavioral one-way shoots within the trap. Once past the funnels, fish were held in enclosed spaces between the funnels inside the trap. The trap was constructed with three openings covered with strap-on doors which allowed staff to access the holding area to gather catch. The trap was fished with the back, or open end, facing downstream (Figure 8). To increase capture efficiency, the trap was positioned in the KLRC between two wing wall structures that were 33' x 9' and constructed from  $\frac{1}{4}$ " gauge galvanized steel hog wire paneling with 2" x 4" openings on the downstream end of the trap to prevent fish from bypassing the trap (Figure 9).

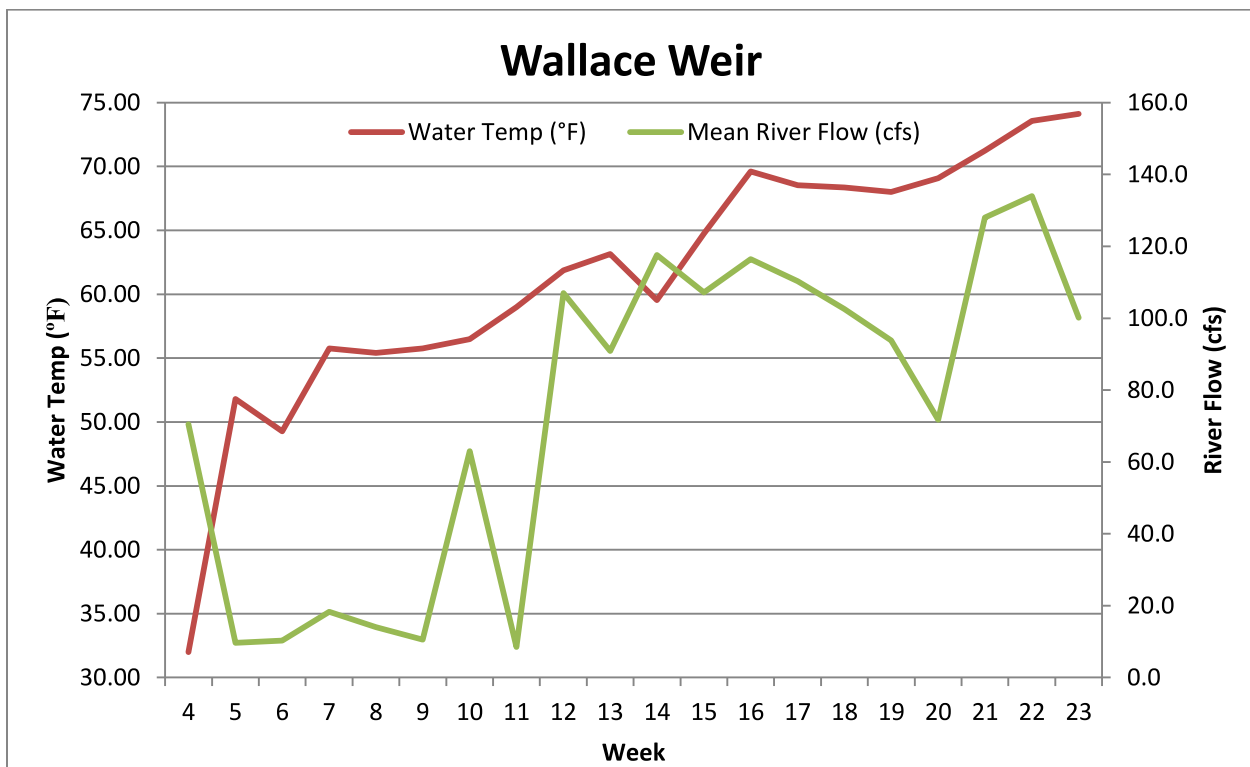
Figure 13. Mean weekly water temperature and mean weekly river flow for the Knights Landing Ridge Cut measured at the Wallace Weir sampling location from 22 January through 6 June 2014 (week 4 through week 23). Water flow was reported by CDEC, Ridge Cut Slough (RCS) gauge and reported in cubic feet per second.

Wallace Weir fyke trap operations were conducted for 136 days from 22 January through 6 June 2014. Mean weekly flow measurements at Wallace Weir ranged from 134.0 cfs (week 22) to 8.5 cfs (week 11) and water temperatures ranged from 48°F on 4 February 2014 to 76°F 5 June 2014 during the trapping period (Figure 13 and Table 2). During weeks 10, 11 and 12 (6 March to 11 March 2014, and 14 March to 17 March 2014) flows at Wallace Weir were high enough to overtop the fyke, upstream debris barrier and wing walls. For crew and equipment safety, trapping operations were stopped during these events. After each event, the fyke, upstream debris barrier and wing walls were re-installed and trapping operations were resumed. During periods when the trap was out, adult Chinook salmon could have passed migrated upstream into the CBD.

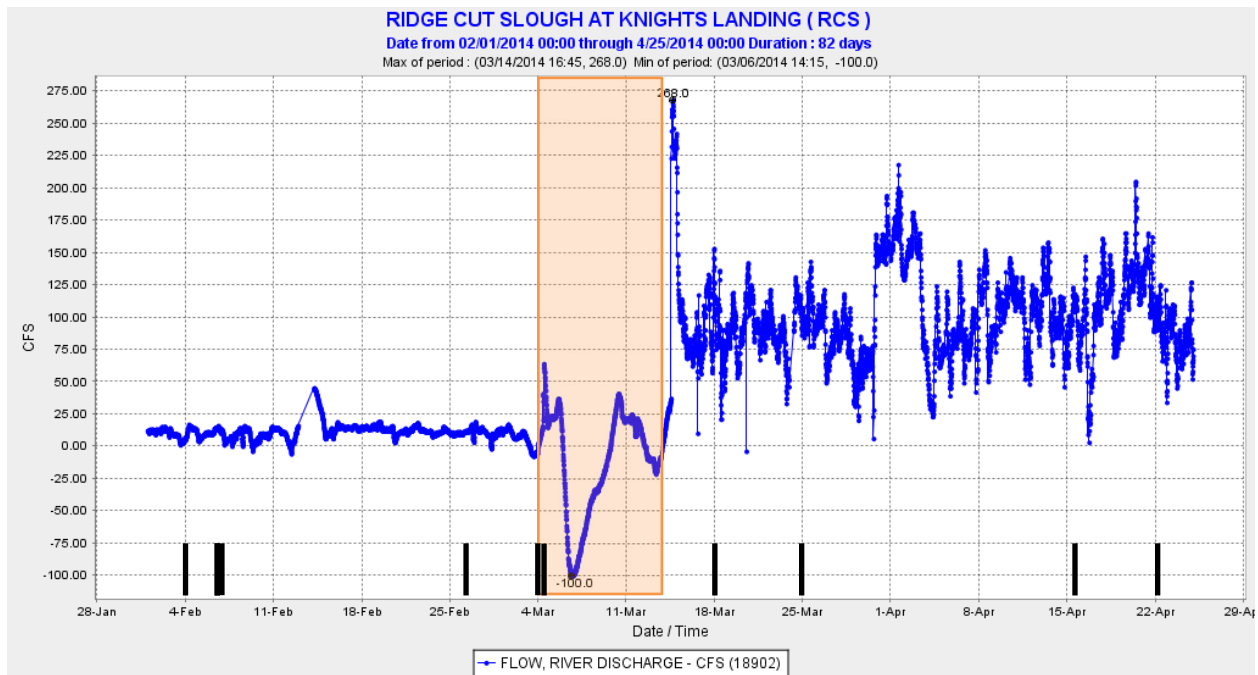
**Figure 18. Ridge Cut Slough flow 28 January 2014 to 29 April 2014. The red box highlights the time period where Knights Landing outfall gate operations likely resulted in reverse flows within the ridge cut. Lines denote periods when Chinook salmon were observed at Wallace Weir. Note, fish recovered on 18 March 2014 was from CBD trapping site and was dead. Migration route for this fish is undetermined. Data source CDEC, accessed 10/24/15.**
