# TULE RED TIDAL RESTORATION

## Annual Monitoring Report – Year 1 2020

Prepared for  
Westervelt Ecological Services  
State and Federal Water Contractors  
Agency

February 2021

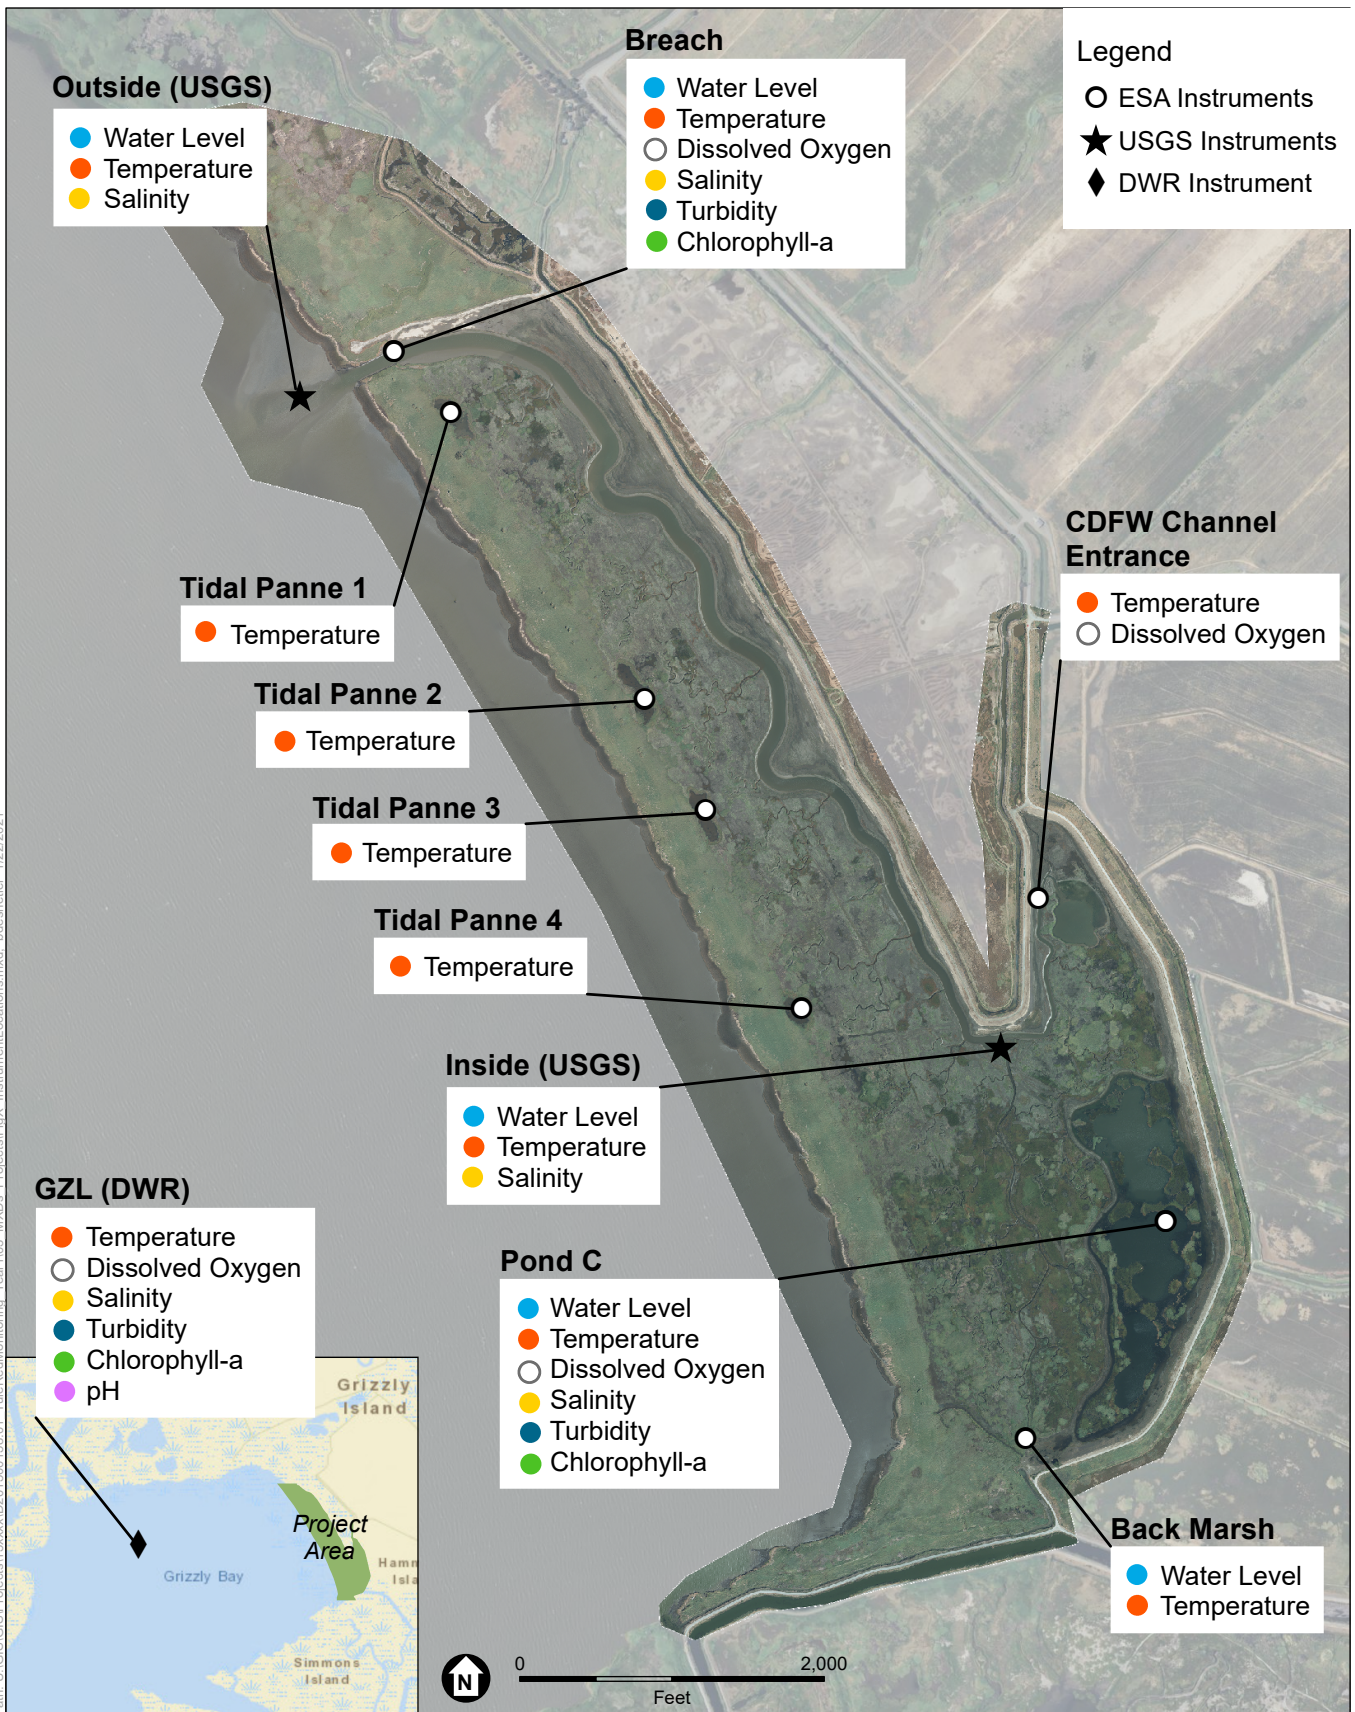
Water level monitoring was performed to document the hydrological processes on the site. Two separate methods of water level data collection were employed: water level data were collected at three locations across the site using non-vented pressure transducers, and water inundation data were collected in the four constructed tidal pannes using paired temperature sensors (**Figure 3-2**).

Continuous water quality sondes were installed and maintained at two locations in order to monitor temperature, conductivity, dissolved oxygen, turbidity, and chlorophyll-a (Figure 3-2). One sonde was installed just inside the breach adjacent to the breach water level gauge. A second sonde was installed in Pond C, the central of the three ponds within the marsh pond complex, adjacent to the Pond C water level gauge. The sondes were programmed to collect measurements at 1-hour sampling intervals and were serviced according to manufacturer recommendations and the USGS “Wagner Method” (USGS, 2006). In-Situ Aqua TROLL 600 multiparameter sondes were used with Tube 300R telemetry systems which push the measured water quality data to an online server via cellular every 3 hours. The telemetry systems minimize potential for data loss, allow for remote access to near-real-time data throughout the monitoring period, and reduces the frequency of service visits needed. Data was collected from June 9, 2020 to December 4, 2020. Data for the breach water quality sonde is not available from June 30, 2020 to July 22, 2020 due to an equipment malfunction which required the sonde to be sent into the manufacturer for service.

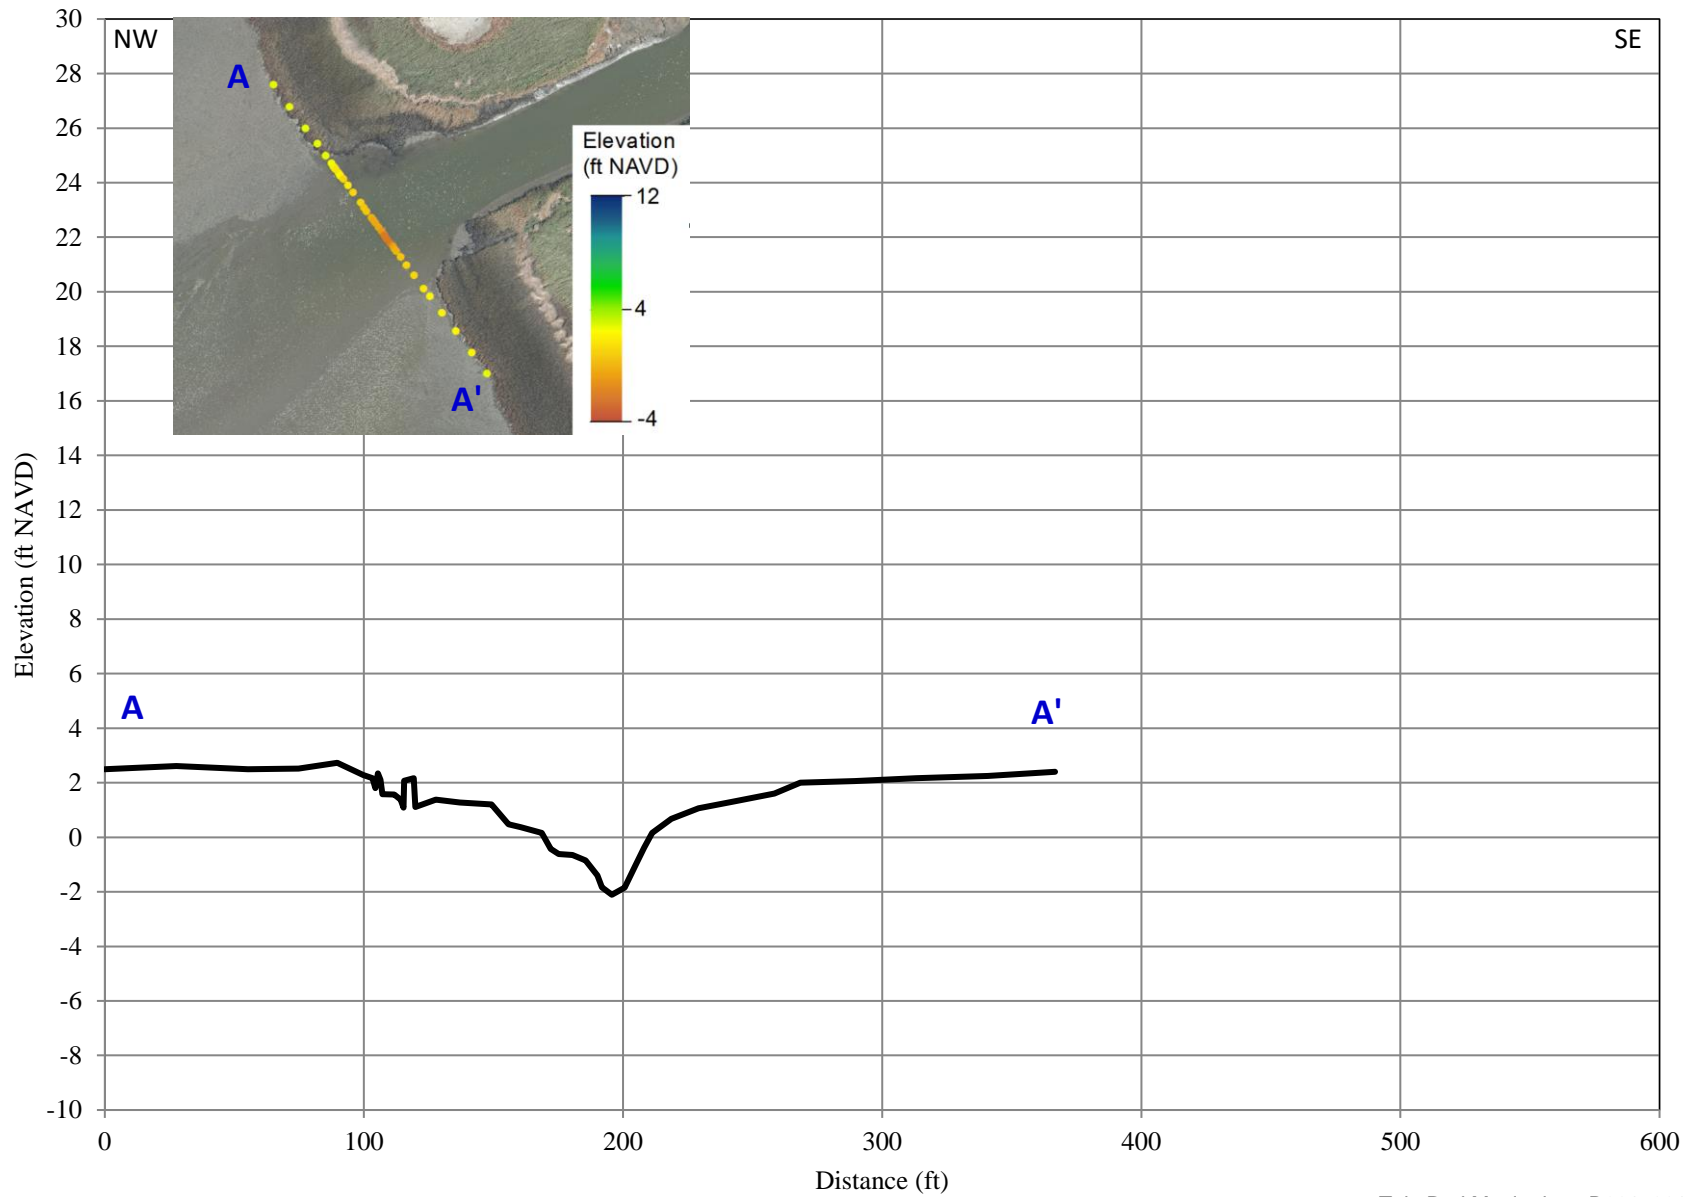
**Figure 4-1**  
Cross-Section BR, Northwest to Southeast  
Breach

Cross-section BR (Figure 4-1), located just bayward of the site breach, shows that the breach channel sits at approximately -2.1 ft NAVD. The breach was approximately 179 feet wide, with a maximum channel depth approximately 4.5 feet deep. Nearby As-Built survey points indicate that nearly 2 feet of channel deepening has occurred at this location since breach. Visual observations of persistent channel bank slumping and widening in the breach corridor throughout Year 1 monitoring efforts indicate that the breach is re-sizing to match the tidal prism of the site interior.

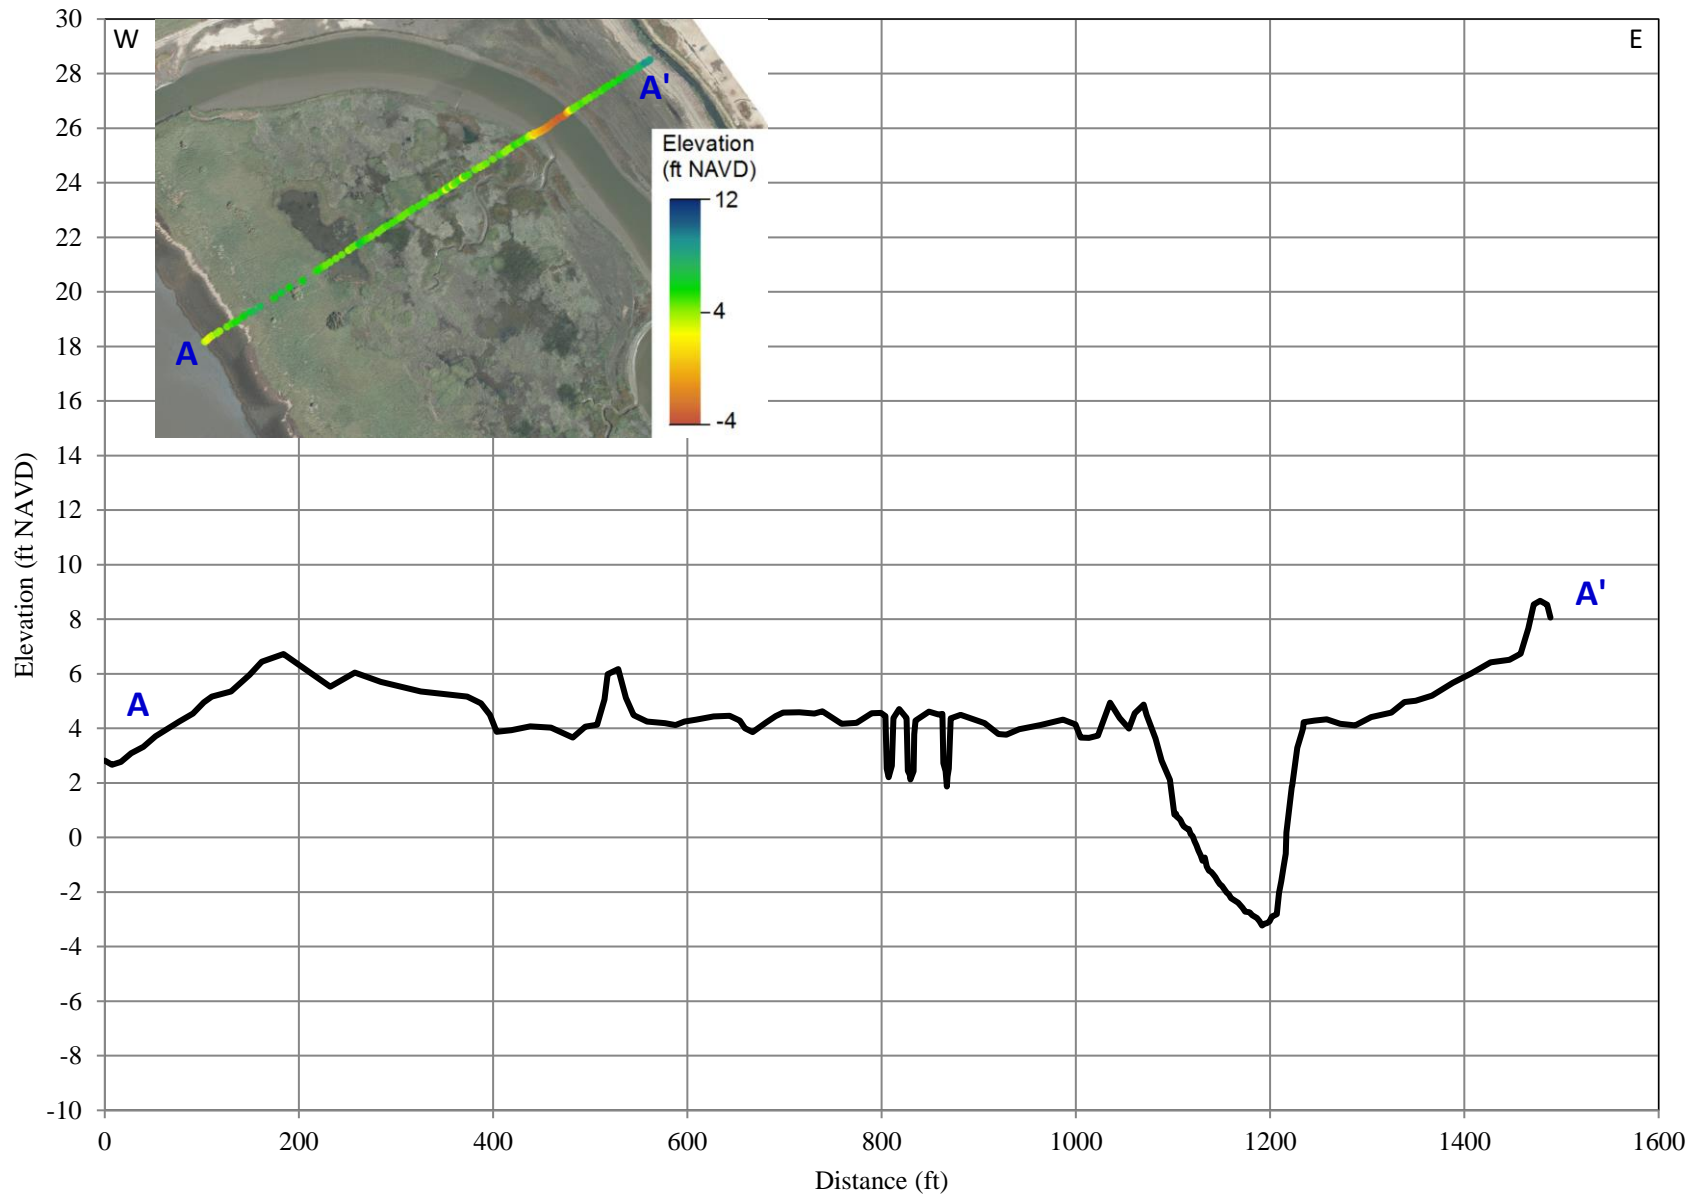
**Figure 4-2**  
Cross-Section 1, West to East

Cross-section 1 (Figure 4-2) is located near a large bend in the primary fourth-order channel, which compared to design shape appears to be aggrading along its inside (west) bend. It also passes through the northernmost constructed tidal panne, which has a depth of approximately 1 foot as compared to nearby marshplain elevations to the west and has a panne bottom at approximately 4 ft NAVD. Cross-sections 3, 4, and 5 pass through the other three constructed tidal pannes, which vary in depth along the profiles from 1.0-1.5 feet and all have a bottom that sits at approximately 4 ft NAVD (Figures 4-4 through 4-6). Cross-sections 2 through 5 show mounds in the profile along the bottom of the primary fourth-order channel (Figures 4-3 through 4-6), which could be slump blocks indicating erosive widening activity in nearby lower order channels. Cross-section 6 (Figure 4-7) shows that the third-order channel which drains the back marsh (the deepest channel in the profile) has deepened to -2.4 ft NAVD from an as-built bed elevation of approximately 0 ft NAVD. This channel was visually observed to be slumping substantially during survey efforts (**Figure 4-10**), indicating active channel expansion. Cross-sections 7 and 8 cross through the constructed marsh ridge surrounding tidal ponds B, C, and D.

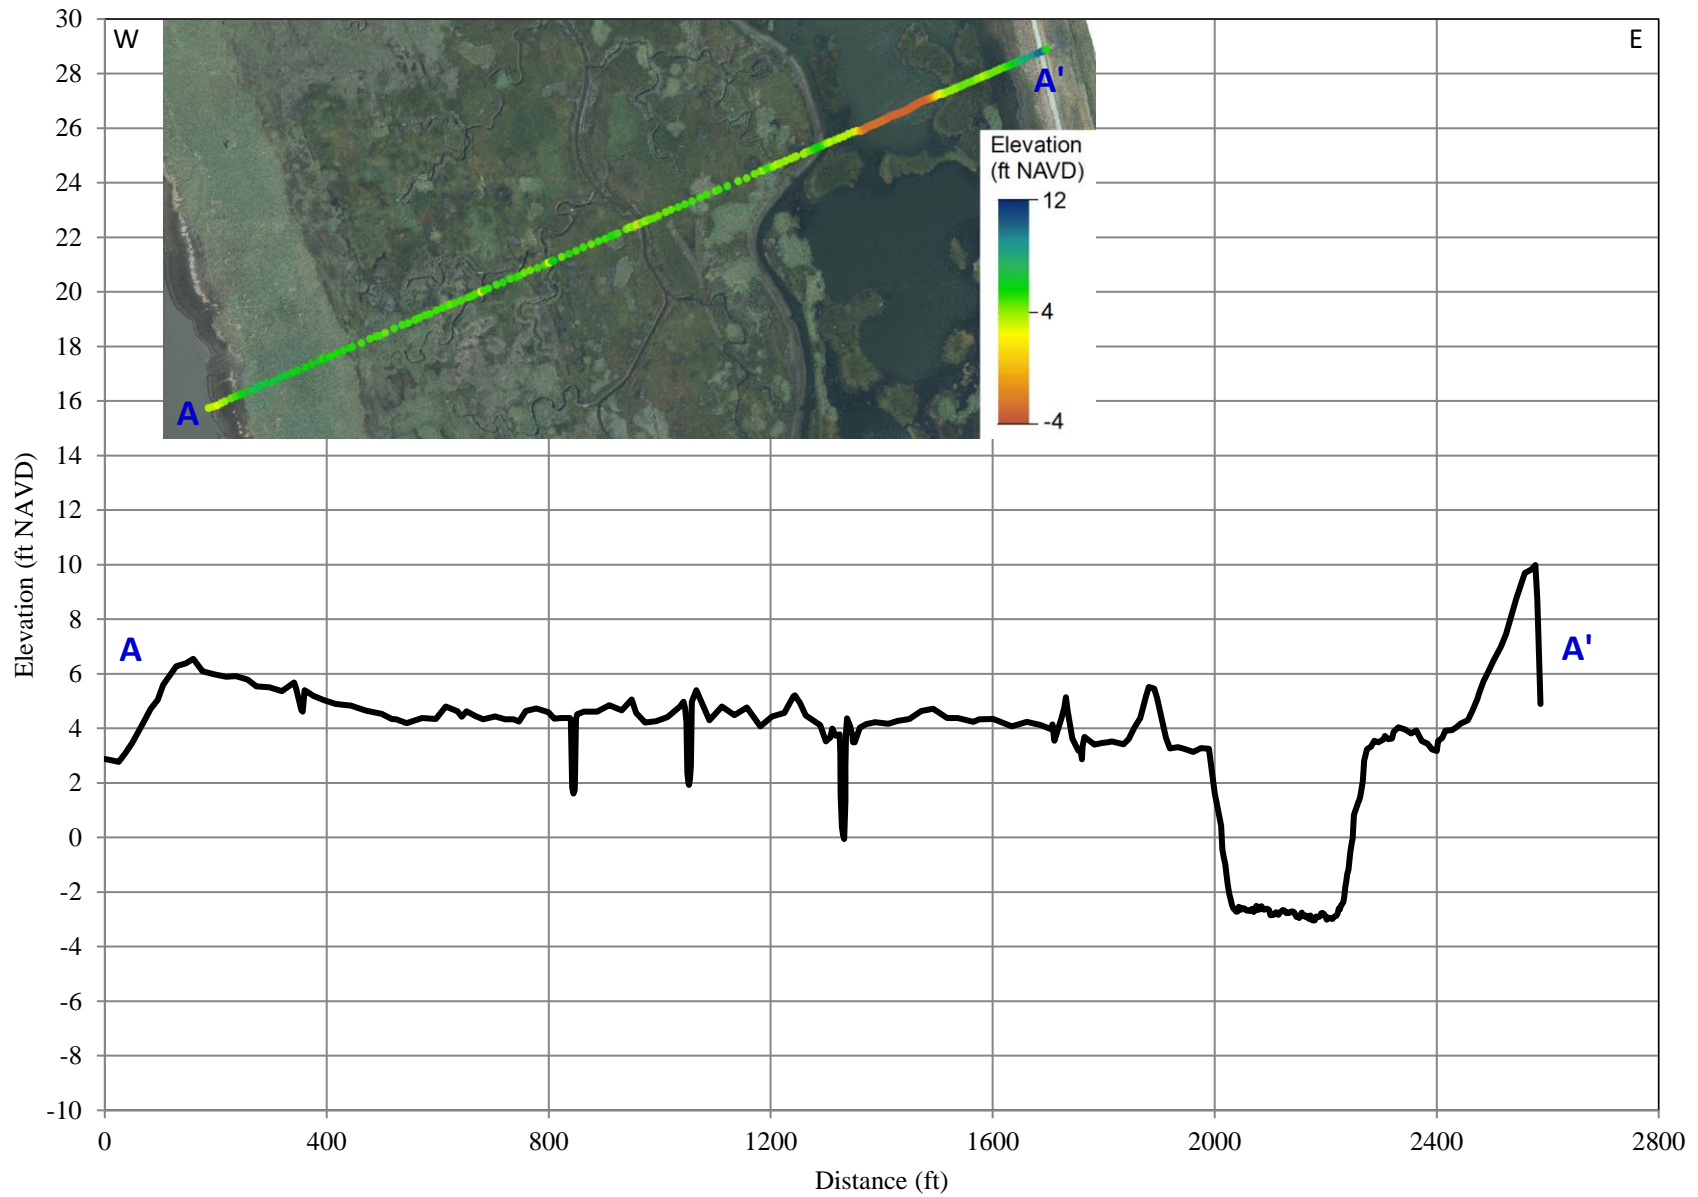
In the back marsh, a tidal flood stage attenuation threshold was observed at approximately 4.6 ft NAVD (Figure 4-13). Based on nearby survey data from cross-sections 6, 7, and 8 (Figures 4-7 through 4-9), this elevation corresponds to the height of surrounding marshplain. On flood tides, the rate of rising water levels slows when the tide reaches marshplain elevation (4.6 ft NAVD), where the cross-sectional area being filled increases substantially. The reverse happens on ebb tides: around marshplain elevation, the rate of drainage rapidly increases when the area being drained is limited to channels.

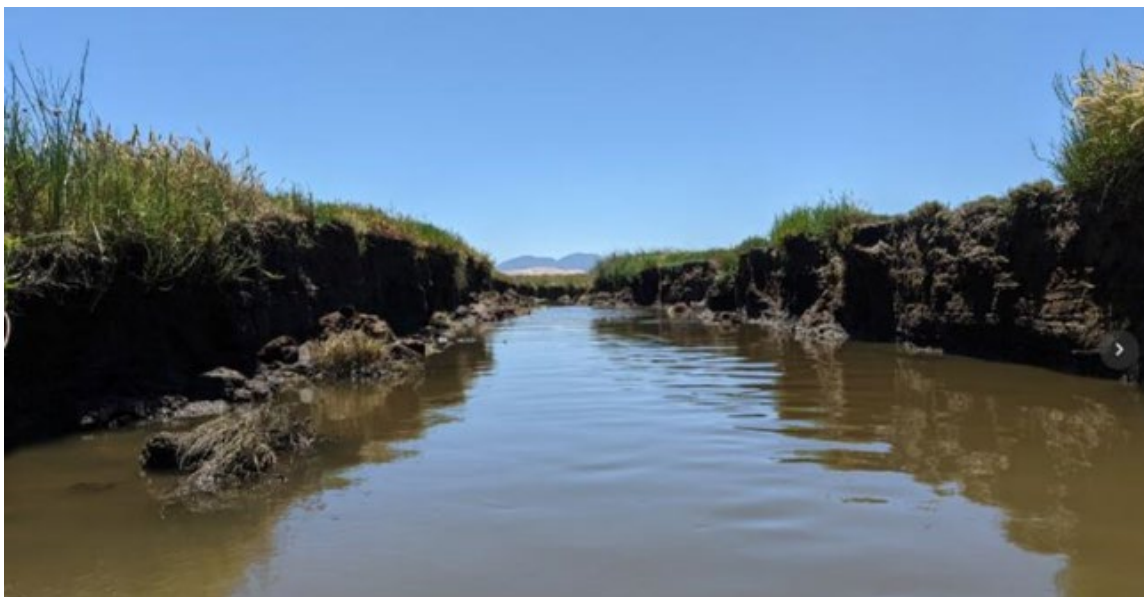
**Figure 4-10**  
Slumping erosion in 3<sup>rd</sup> order channel near Cross-section 6

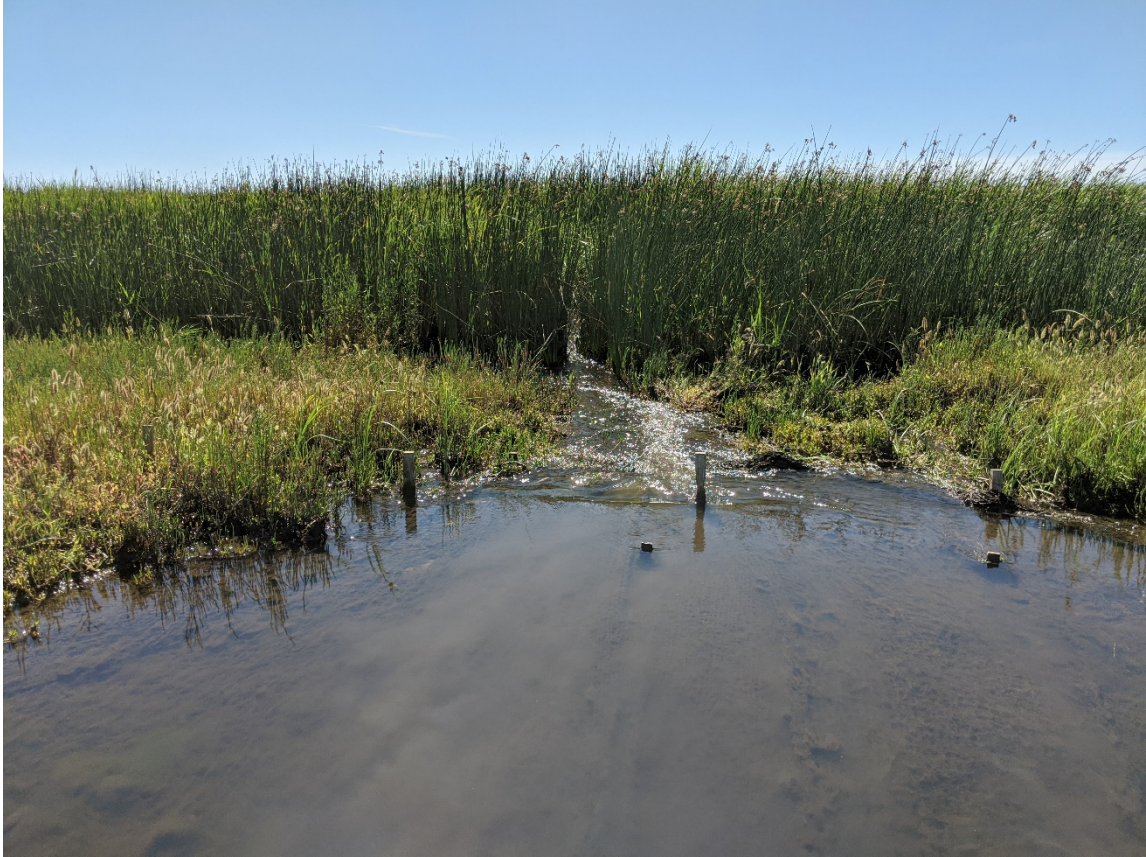
**Figure 4-14**  
Ebb tide drainage being “funneled” through a marsh ridge swale, a low point in the berm surrounding Ponds B, C and D

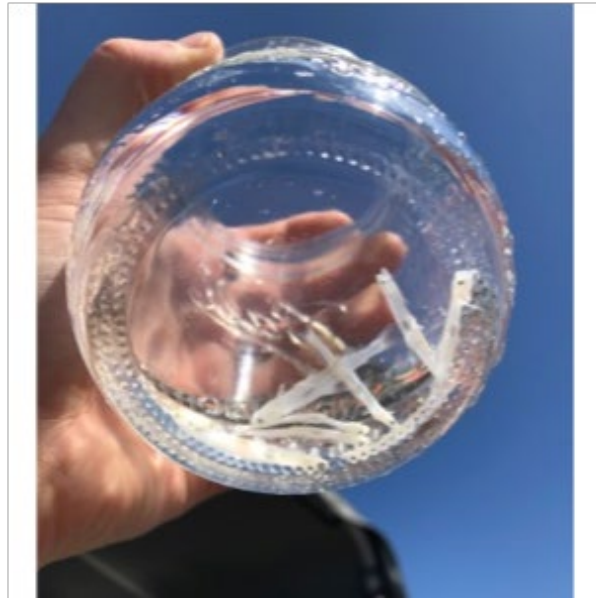
**Figure 4-28**  
Larval longfin smelt sampled in Tule Red Main Channel

Following the Tule Red coordination call on May 1, 2020, ICF, as part of their fish studies in Suisun Marsh with DWR, conducted brief trawling on May 7, 2020 in the main channel and successfully documented larval longfin smelt (L. Grimaldo, ICF, pers. comm.) (**Figure 4-28**). ICF also seined the marsh ponds March 3 and June 8 as part of a food web study by UC Berkeley. Fish species included threespine stickleback (most common), prickly sculpin, staghorn sculpin, and an unidentified goby (*Tridentiger* species) (I. Woo, USGS, pers. comm.). IEP's regional fish surveys in Grizzly Bay documented longfin smelt but no delta smelt or Chinook salmon in 2020 (**Table 4-2**).

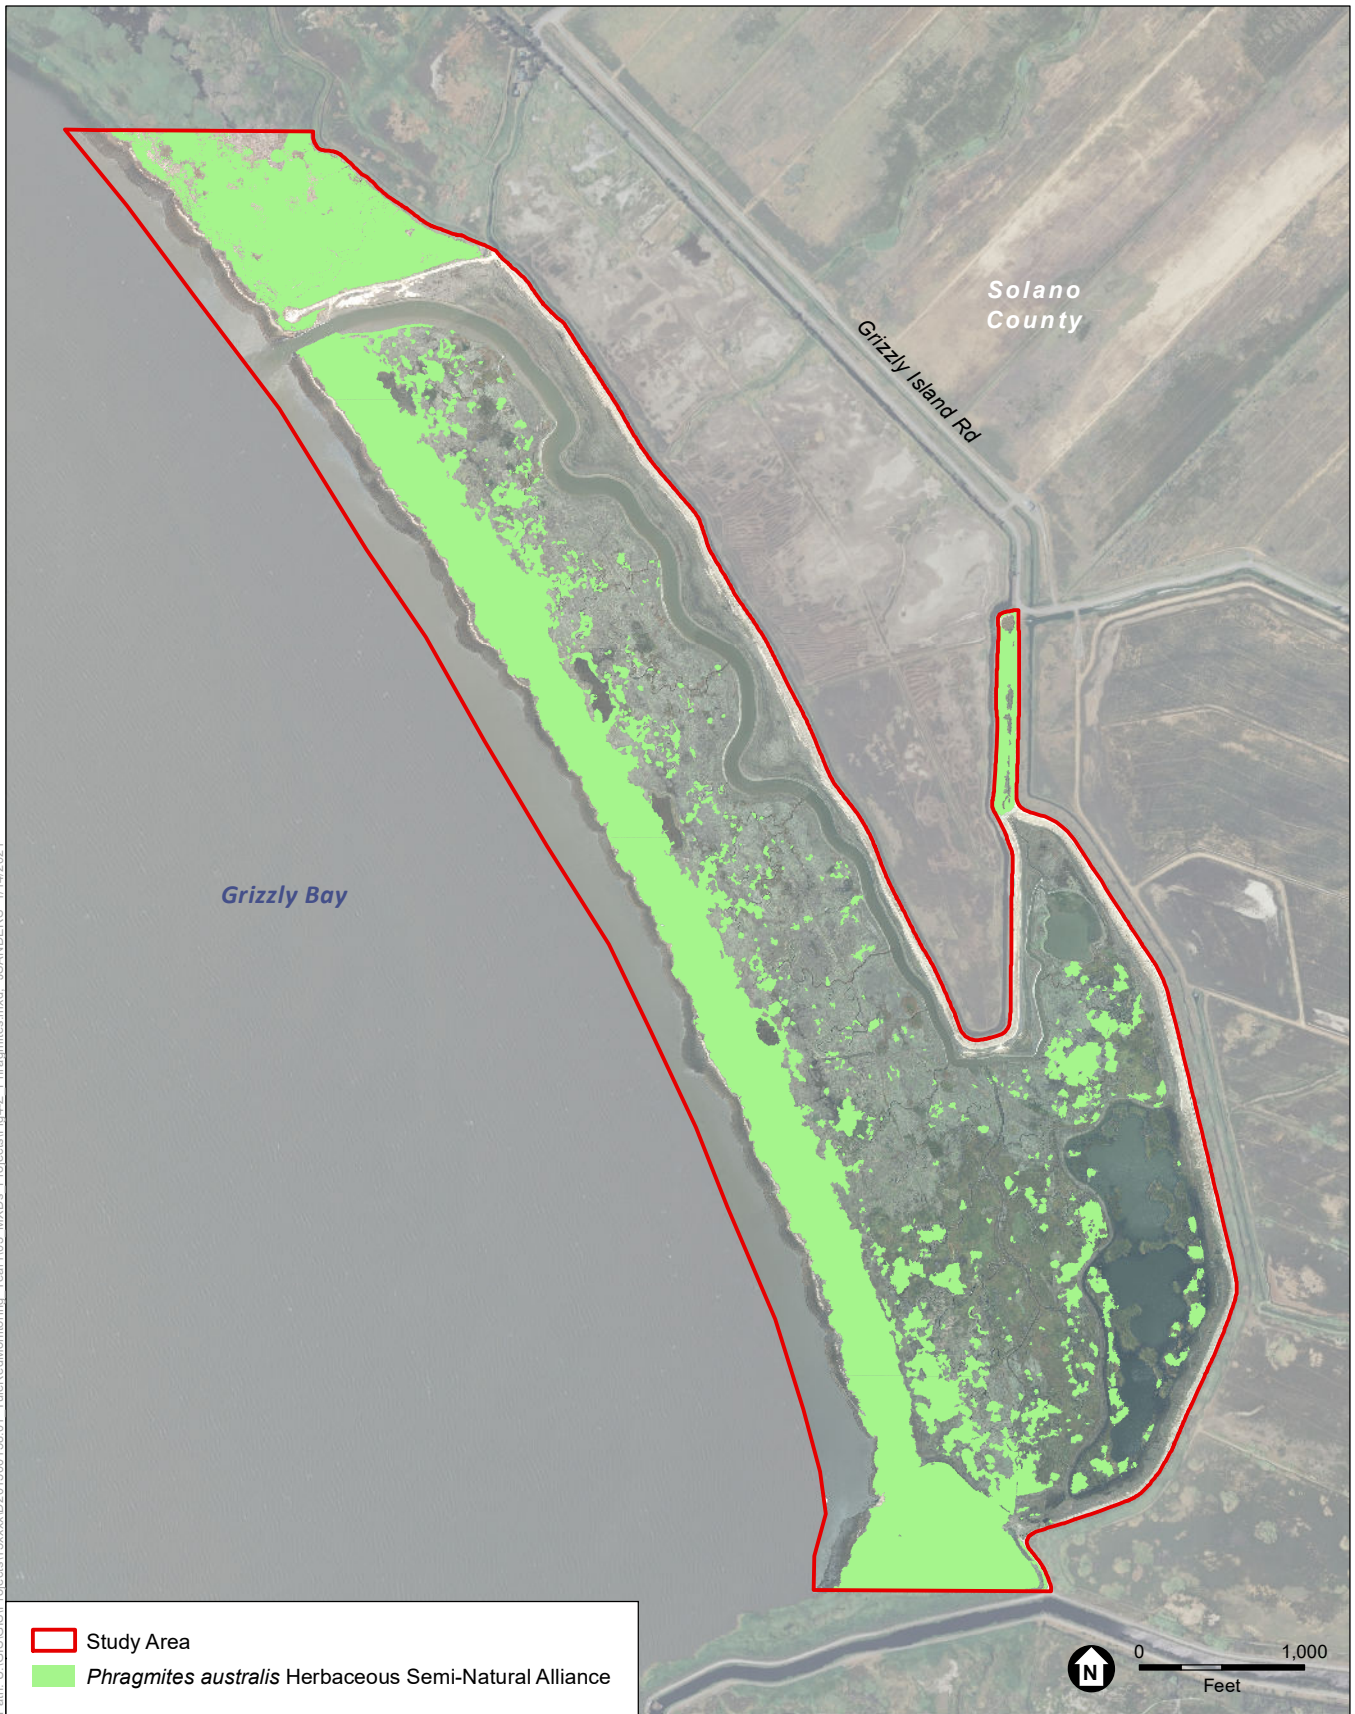
**Figure 4-30**  
Year 1 (2020) Location and Extent of *Phragmites australis*

The distribution and extent of the invasive *Phragmites* appears to be affected by a combination of changes in hydrology and management practices, as well as recent ground disturbance associated with construction. It is important to note that there is a portion of the area to the north of the newly constructed main channel that has not experienced changes in hydrology associated with this project (see top frame in **Figure 4-31**). In reviewing the *Phragmites* mapping performed in 2017 and 2020, it appears that expansions of existing *Phragmites* patches are still occurring in the

on controlling Phragmites are recommended over the upcoming years to adequately manage this invasive plant species. When possible in areas where Phragmites is just beginning to expand clonally, hand pulling or other mechanical methods should occur .

Certain herbicides can be used to treat Phragmites patches, where mechanical methods are infeasible or ineffective, for experimental plots or as part of a large-scale treatment proposal. Depending upon the location, size, and other characteristics of the planned treatment, additional permits or authorizations may be necessary. Such management efforts can act as a disturbance, resulting in potentially suitable sites for reinvasion events, and so sometimes revegetation is recommended post-weed treatment. However, there is research suggesting that above-ground dominance of Phragmites does not affect the seed bank underneath as much as site topography and physical structure of wetlands (Hazelton et al, 2017). Tule Red appears to have some combination of a persistent seed bank of native and non-native plants and areas that experience high levels of seed deposition, indicated by the establishment of several native vegetation types into new areas within only one year of the breach event. Additionally, it has been documented that some common aquatic herbicides applied to vegetative plant material, such as glyphosate, do not deleteriously affect existing seed banks (Hazelton et al, 2017). Areas that are effectively disturbed during future Phragmites weed control efforts should also then support the natural recruitment of native vegetation.
