**COLUSA BASIN DRAIN
INVESTIGATION**

**LANDON
ENGINEERING & SURVEYING, INC.**

**LAUGENOUR AND MEIKLE
CIVIL ENGINEERS**

June 1981

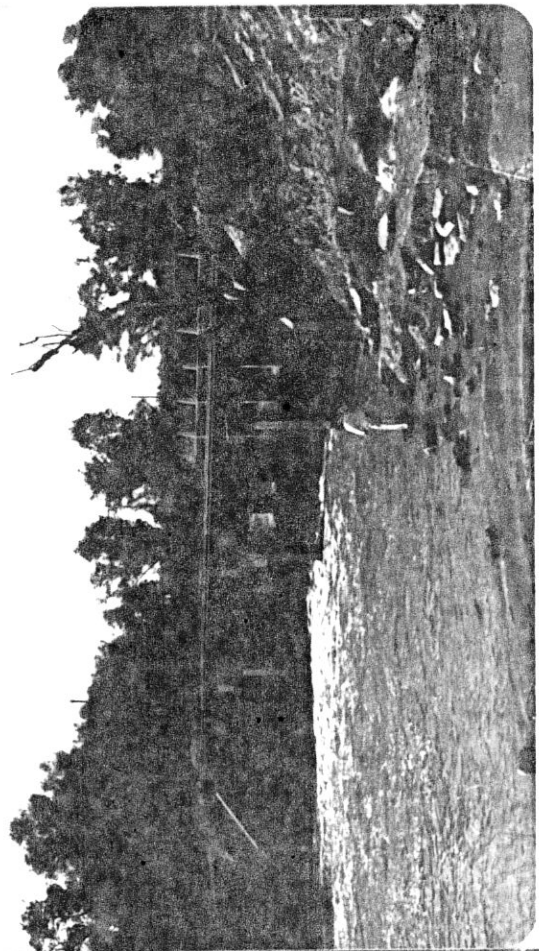
Figure 7A

LOOKING UPSTREAM

ABANDONED SIPHON STRUCTURE - 5 Miles North of Maxwell Road

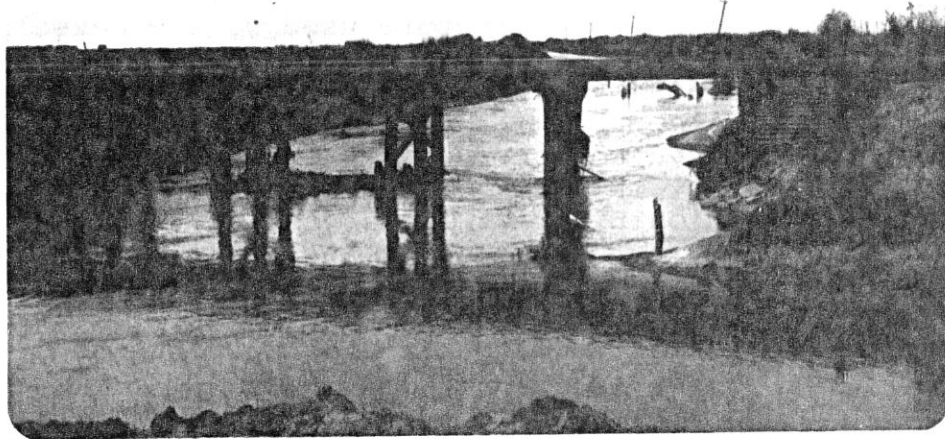
HARBISON ROAD BRIDGE DEBRIS

Numerous other minor encroachments which could restrict flows exist between the location just discussed and the State Highway 20 crossing. A bridge crossing the drain at Harbison Road collects

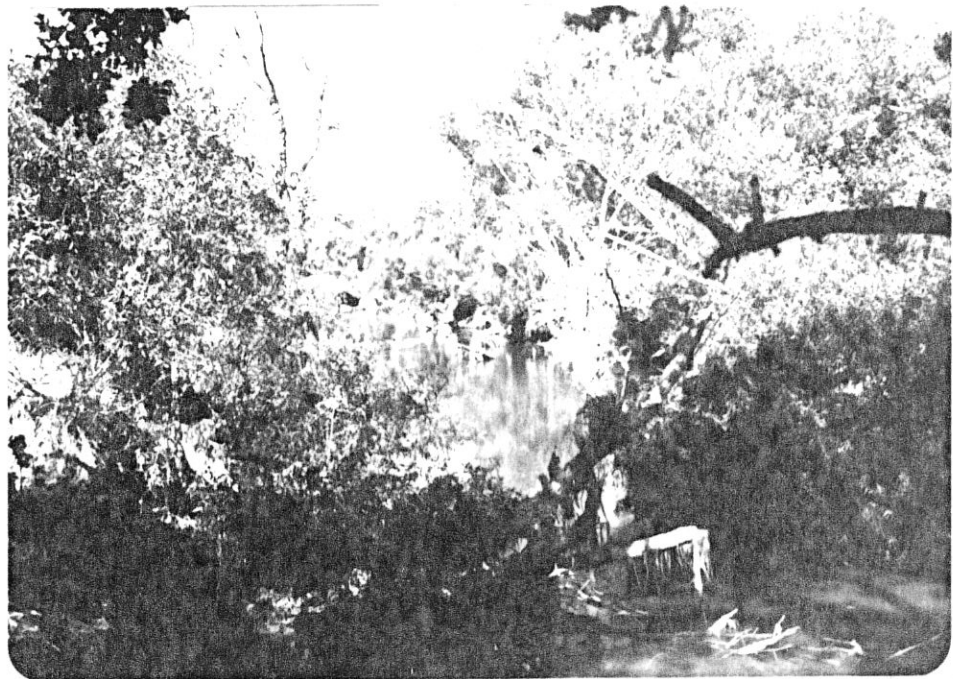
Figure 9.

DENSE VEGETATION
COLUSA GAME REFUGE
COLUSA BASIN DRAIN

Below the State Highway 20 crossing few encroachments appear to impede flow, other than trees and vegetation growing within the existing channel area. Since this area lies adjacent to the Colusa Game Refuge, any removal of natural habitat (i.e., trees and vegetation) would come under the close scrutiny of the U. S. Fish and

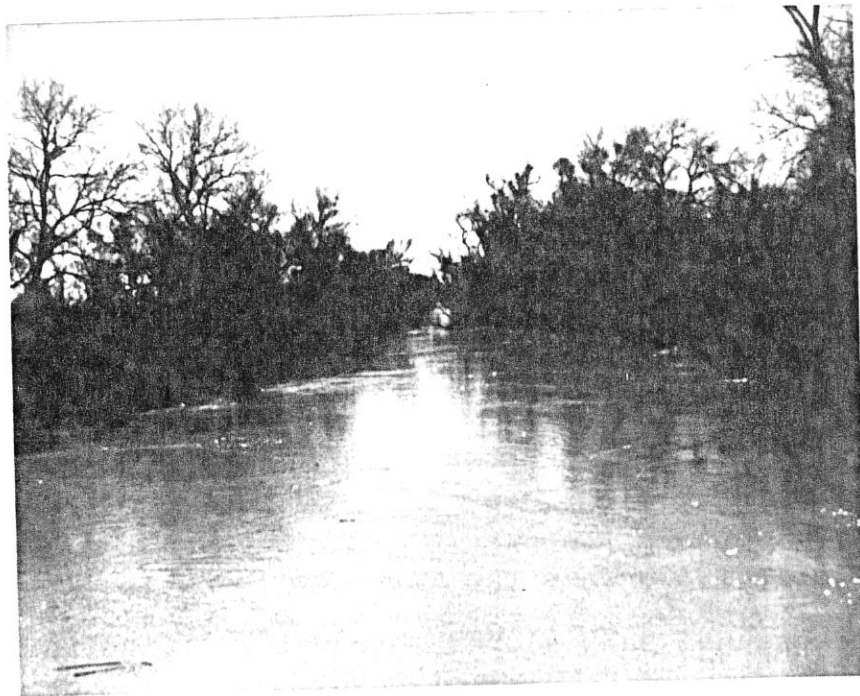
Figure 10.

VEGATATION OVERGROWTH IN DRAIN
LOOKING SOUTH FROM TULE ROAD BRIDGE

At some locations along the west channel-bank tree growth is extensive. Most of the trees do not interfere with "in-channel" flow except between White Road and Tule Road. The overgrowth is such that trees have fallen in the channel or are projecting into it, and old snags and other trash are in the channel. When these conditions are present, some removal of the fallen trees and snags would be desirable and would improve summer localized flow.
