North of the Delta
Offstream Storage Investigation

Appendix O: Phase 1 Fault and Seismic Hazards Investigation

Northern District
California Department of Water Resources

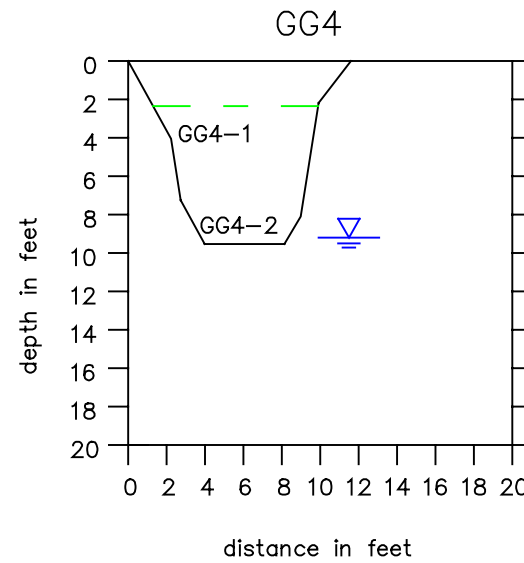
| GG4-1 | CL | CLAY, silty, moist, Munsell color 10YR4/2, dark grayish brown. |
| GG4-2 | CL | CLAY, silty, very moist to wet, Munsell color 10YR3/4, dark yellowish brown. |

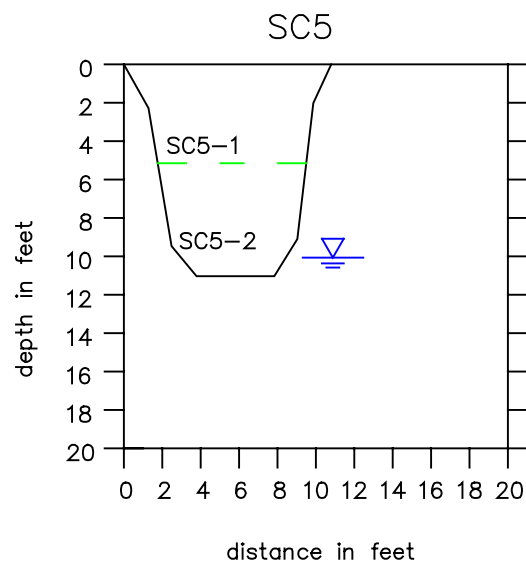
| SC5-1 | CL | CLAY, minor silt, Munsell color 10YR3/1, very dark gray. |
| SC5-2 | CL | CLAY, very minor silt, medium plastic, wet below ten feet, Munsell color 10YR3/3, dark brown. |

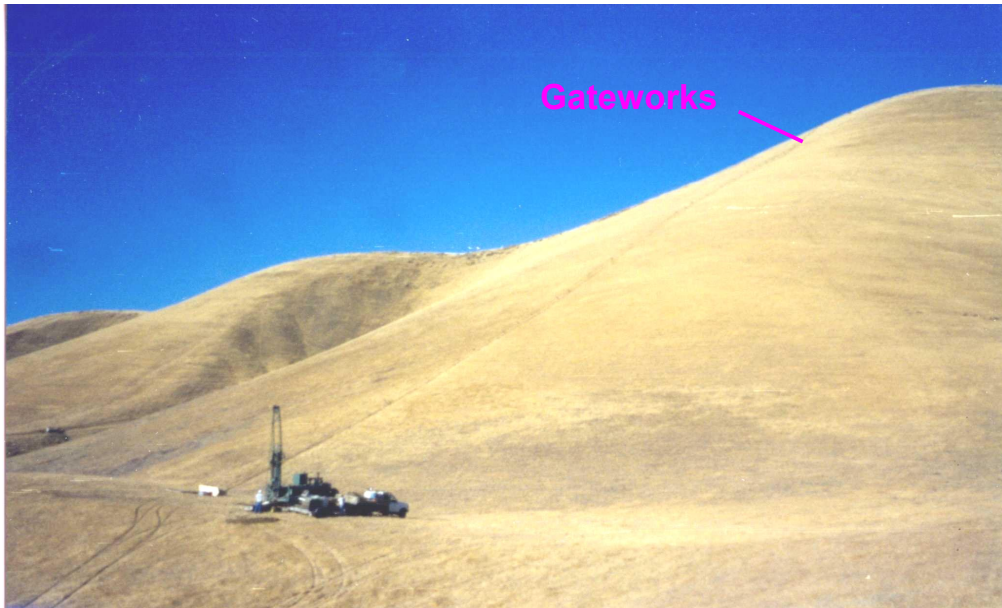
**Photo 21. CME-850 drill rig at western tunnel portal drill hole DHT-1
(note location of gate works still to be drilled)**

Vertical drill hole DHT-1 was drilled to evaluate the rock conditions at the western tunnel portal (Photo 21). It was drilled to a total depth of 224.5 feet. No sample was taken in the upper 2.0 feet of overburden. From 2.0 to 224.5 feet the hole drilled through 60 percent mudstone with 40 percent sandstone interbeds. The permeability in the top 20.3 feet of the tested interval for DHT-1 is 0.24 feet per day and the Lugeon value is 8. From 19.4 to 219.3 feet permeabilities range from 0.00 to 0.26 feet per day, averaging 0.027 feet per day with Lugeon values ranging from 0 to 11, averaging 1.

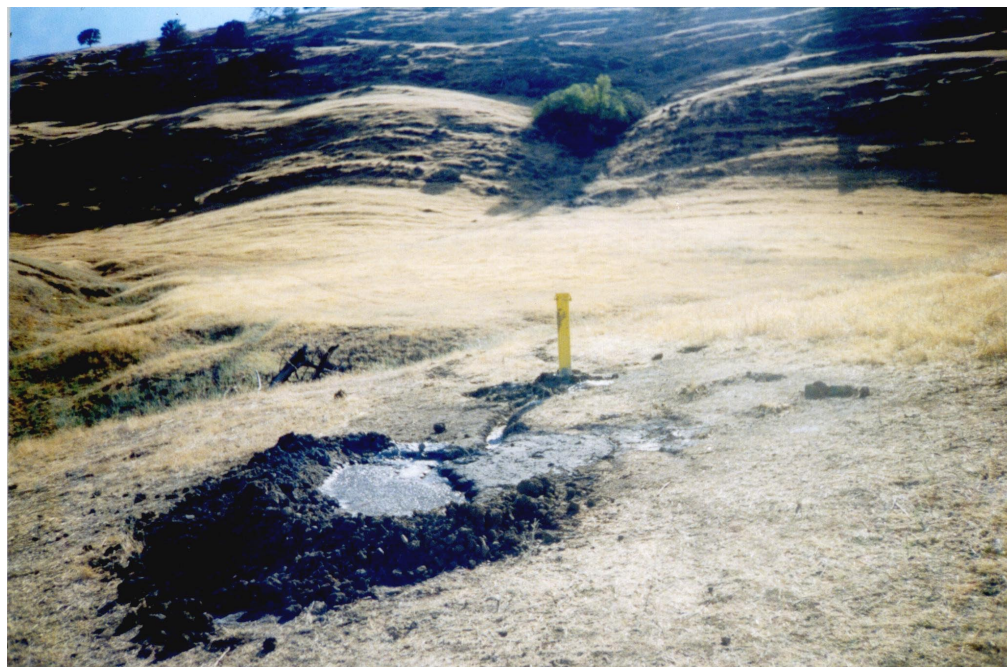
Photo 22. Eastern tunnel portal drill hole DHT-4

Vertical drill hole DHT-4 was drilled to evaluate the suitability of the foundation rock at the eastern tunnel portal (Photo 22). It was drilled to a depth of 199.5 feet. It was drilled to 199.5 feet from July 6 to July 8, 1999. It drilled through 85 percent sandstone interbeds. Numerous shears were logged throughout the hole account for some of the high permeabilities and grouting requirements seen. Extremely pervious conditions are encountered from 17.1 to 70.0 feet, with an average permeability of 19.34 feet per day. A high grouting requirement (Lugeon value >100) is also necessary in this zone.

In general, calculation of RQD indicates that drill hole DHT-1 for the western tunnel portal drilled through rock of fair quality from 25 to 50 feet in depth, then excellent quality to 225 feet, except for a fair zone from 140 to 159 feet near the tunnel invert (Table 14).

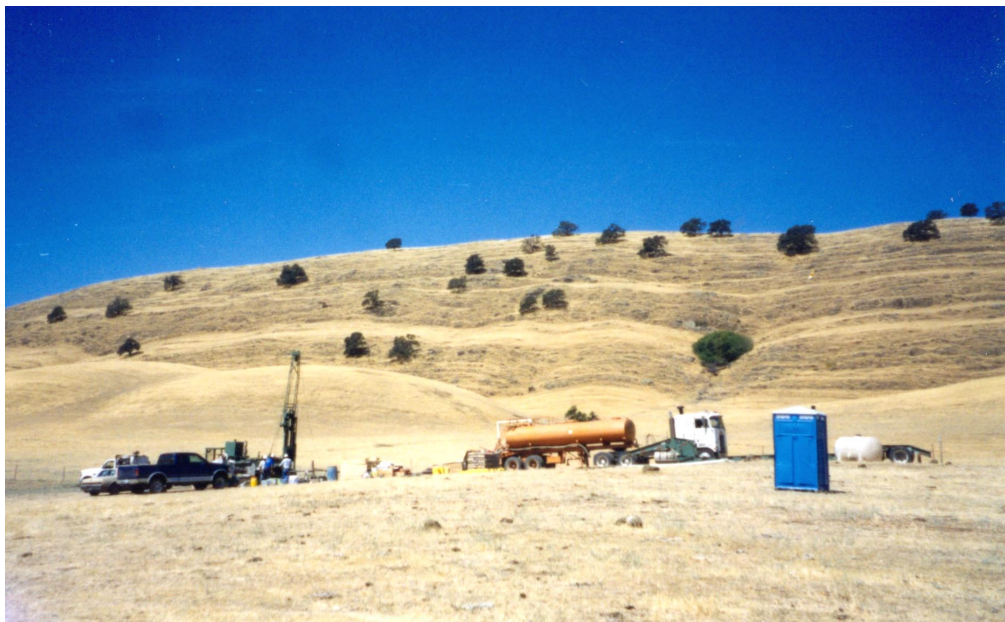
Photo 23. CME-850 drill rig at pumping plant drill hole DHPP-1

Vertical drill core hole DHPP-1 was drilled to help evaluate the suitability of the foundation for the proposed pumping plant (Photo 23). It was drilled to a total depth of 199.6 feet. No sample was taken of the top 5.3 feet of overburden. The rest of the hole consisted of 85 percent sandstone with 15 percent mudstone interbeds. Water testing of this hole showed high permeability in various zones, most likely due to fractured rock. The average Lugeon value from 38.3 feet to the top of the tested interval is 54; average permeability is 0.69 feet per day, indicating pervious conditions. Permeabilities throughout the remainder of the hole range from 0.0 feet per day to 2.48 feet per day, (average of 0.73 feet per day), with corresponding Lugeon values ranging from 0 to greater than 100, averaging 25.6.

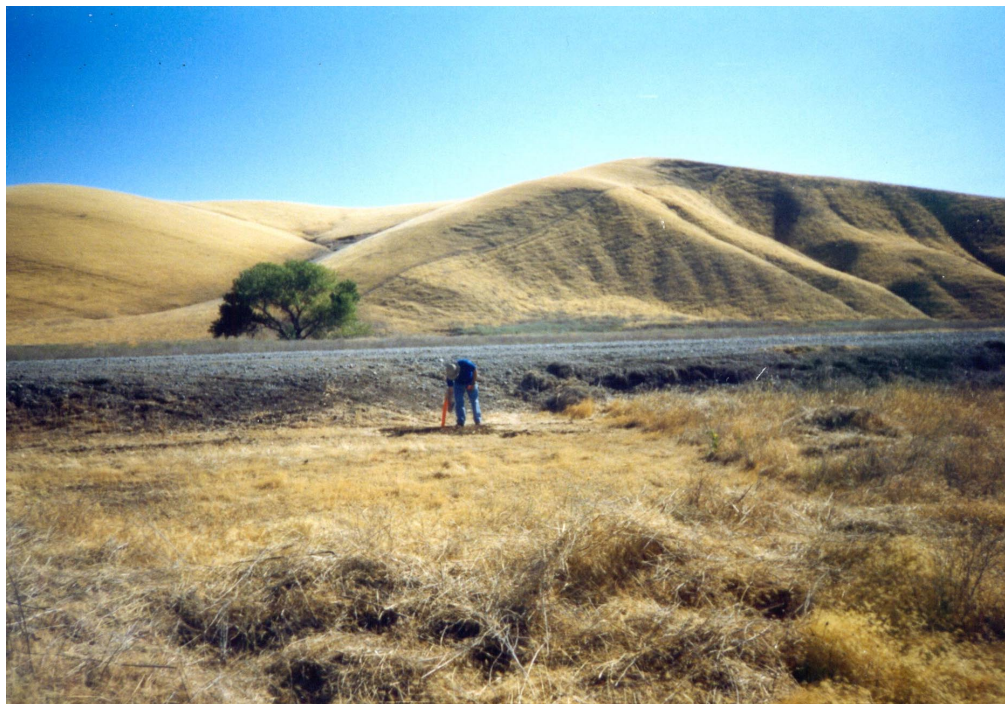
Photo 24. Site preparation at approach channel auger hole AUG-2

Auger holes AUG-1 through AUG-3 were augered to evaluate the depth of soil and foundation suitability for the proposed approach channel (see Technical Memorandum A). AUG-1 was augered 11.0 feet to refusal on July 22. AUG-2 was augered 13.5 feet to refusal on July 1 (Photo 24). AUG-3 was augered 36.3 feet to refusal on June 26 (Photo 25). These all intersected terrace deposits bordering Funks Creek that consist of clay, silt, sand, and gravels.

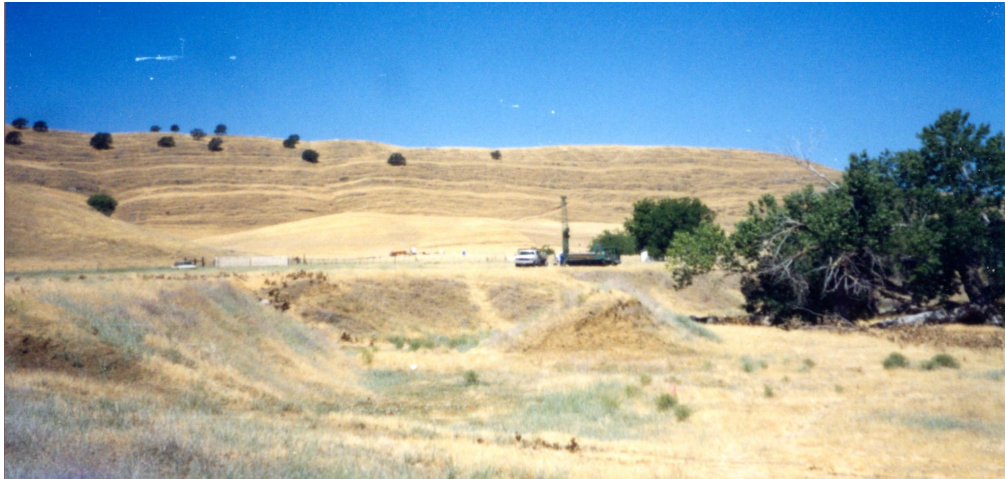
Photo 25. CME-850 drill rig at approach channel auger hole AUG-3

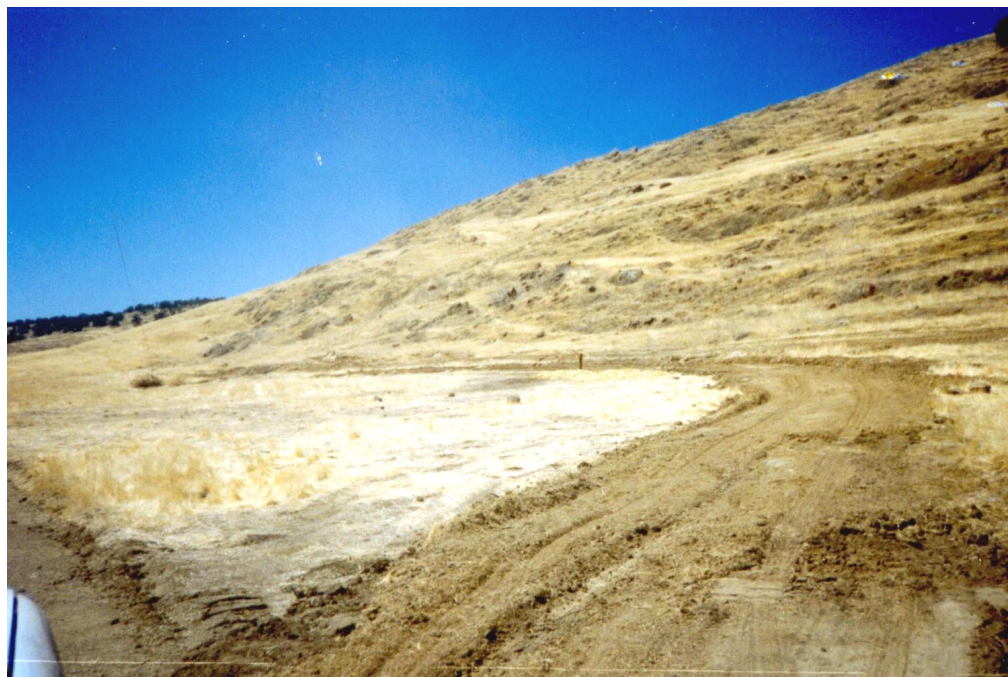
Photo 26. Site of proposed northernmost spillway at Golden Gate Inlet-Outlet Works

Vertical drill hole DHS-1 was drilled to evaluate the suitability of the foundation rock for the northernmost of the two possible locations for the spillway (Photo 26). It was drilled to 199.0 feet at the base of the main sandstone ridge, at about the center of the proposed structure. It drilled through a reddish brown clay to 4.5 feet. From 4.5 to 130.9 feet, the hole drilled through 100 percent sandstone. From 130.9 to 163.0 feet, it drilled through 70 percent mudstone with 30 percent sandstone interbeds. It then went through 100 percent sandstone from 163.0 to 173.5 feet. From 173.5 to 194.8 feet, it drilled through 60 percent sandstone with 40 percent mudstone interbeds. From 194.8 feet to 199.0 feet, there is 100 percent sandstone. Water pressure tests in the northernmost spillway drill hole DHS-1 indicate that there will be low to no grout take to 200 feet, except for high grout takes from 17 to 70 feet in heavily weathered and fractured mudstone and sandstone. Average permeability from 16.0 to 58.9 feet is 1.01 feet per day, with an average Lugeon value 66. From 58.0 to 194.9 feet, Lugeon values and permeabilities both average zero.

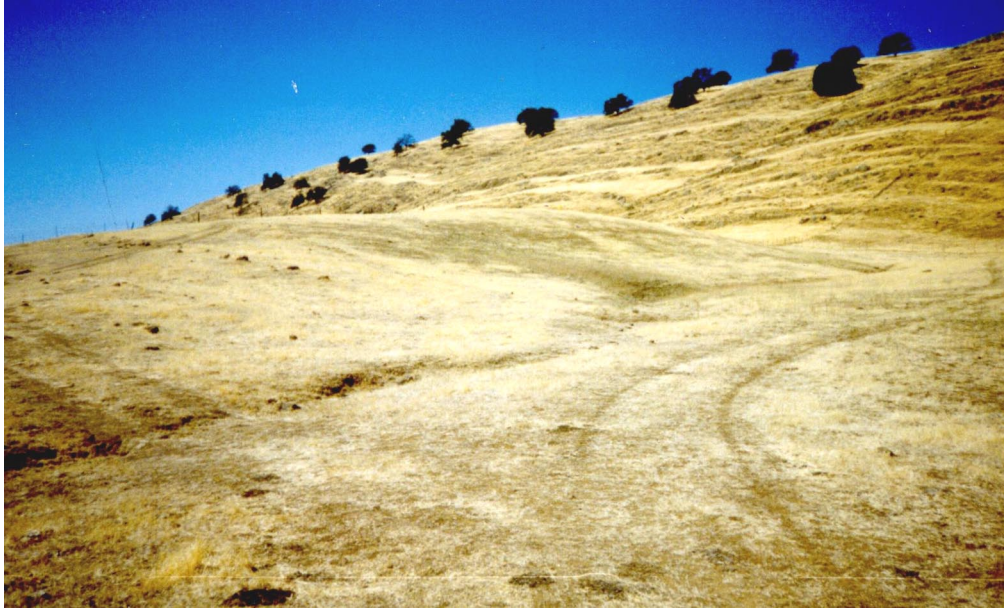
Photo 27. Site of proposed southernmost spillway at Golden Gate Inlet-Outlet Works

Vertical drill hole DHS-4 was drilled to evaluate the suitability of the foundation rock for the southernmost of the two possible locations for the spillway (Photo 27). It was drilled at the eastern base of the main sandstone ridge, at about the center of the proposed structure. It was drilled from July 10 through 12, 1999, for a total depth of 199.5 feet. The upper 0.0 to 2.2 feet of the section is composed of colluvial soil overburden and weathered sandstone and mudstone. From 2.2 to 167.5 feet, the section is composed of 80 percent mudstone and 20 percent sandstone interbeds. From 167.5 to 199.5 feet, the section is composed of 80 percent sandstone and 20 percent mudstone interbeds. Water pressure tests indicate that there will be low to no grout take to 225 feet except for high grout takes from 9 to 20 feet and from 103 to 114 feet in heavily fractured mudstone and

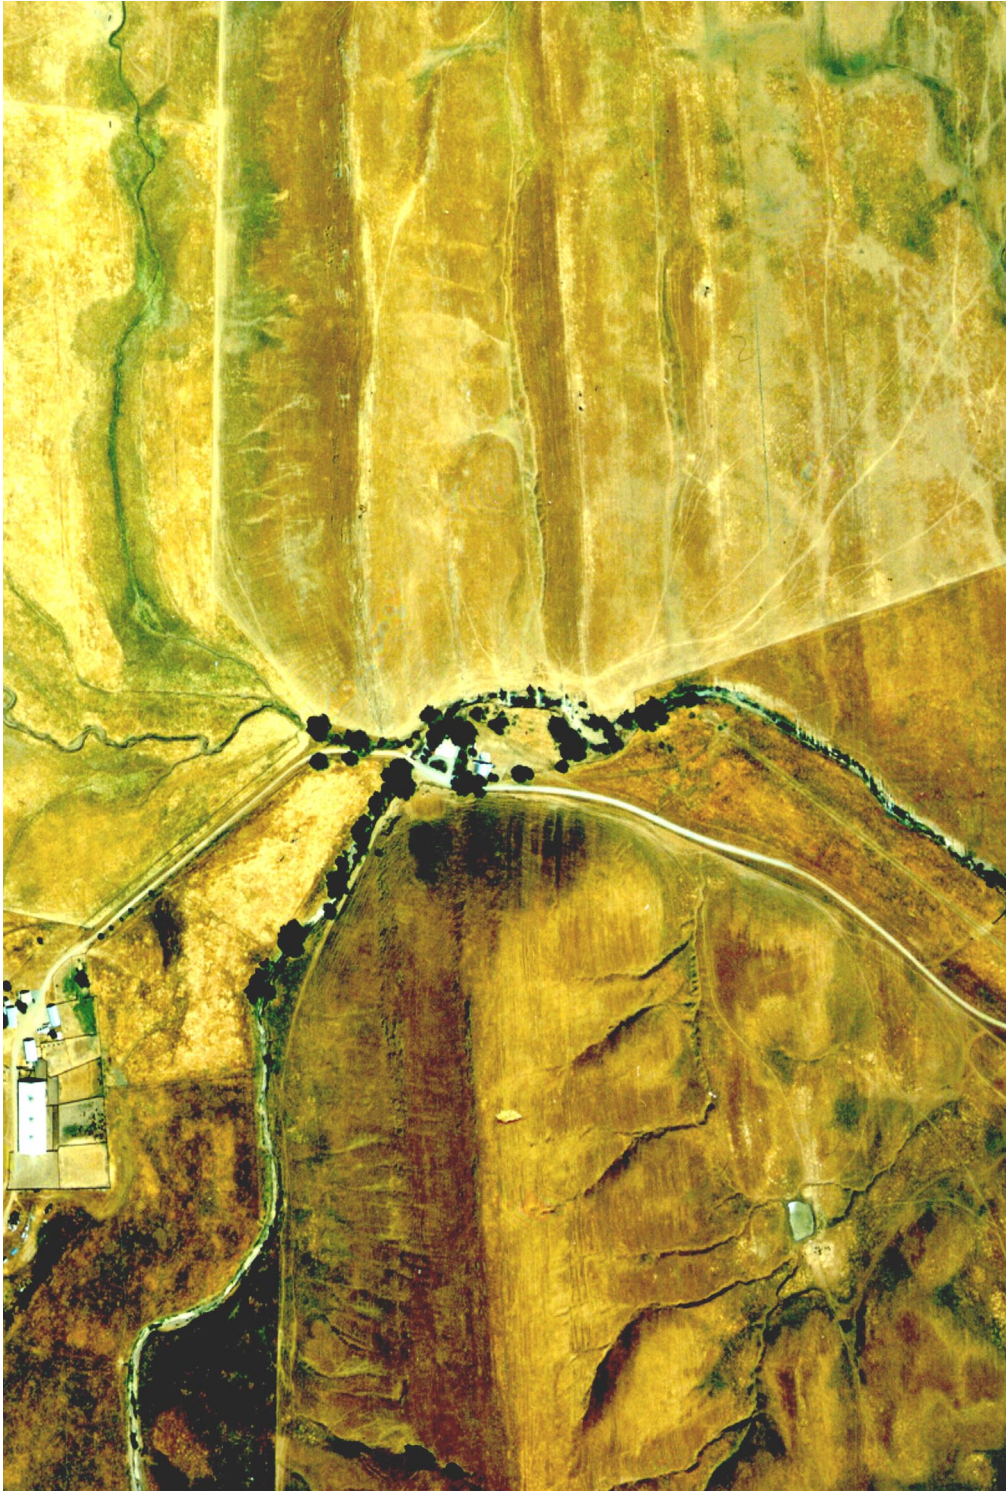
Photo 38. Aerial view of Logan water gap at Logan Dam site

Logan Dam site is located on Logan Creek, about 7 miles west to southwest of the town of Willows in Glenn County (Photo 38). The dam site extends from Section 20 to Section 29, R4W, T19N on the Logan Ridge 7.5-minute USGS topographic quadrangle map. Access is via private roads; the entire dam site is on the Elworthy cattle ranch. The proposed dam, in conjunction with the Sites Dam, Golden Gate Dam, Hunters Dam, and the northern Colusa saddle dams, would impound 3.0 million acre-feet of water in Colusa Reservoir. The dam would be a 270 foot-high earthfill embankment structure with a 7,200-foot crest length at an elevation of 540 feet. The embankment would completely cover the north-south trending main ridge and drape over into the lower areas east and west of the crestline.

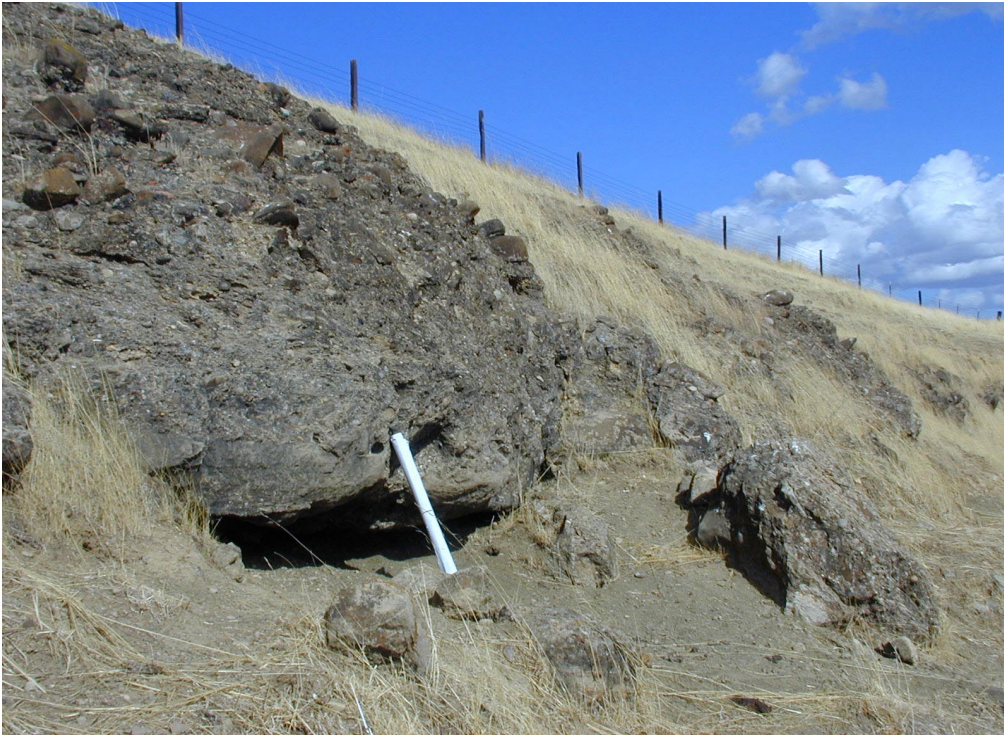
Photo 40. Tertiary Red Bluff Formation overlying Cretaceous Boxer Formation

Five small landslides have been mapped at or near the proposed dam axis. Three of them occur on the north-facing slope of the right abutment, and the other two occur on the moderately steep west-facing slope of the left abutment in the Boxer Formation. All five landslides are small earth flows or debris slides with thicknesses of 2 to 5 feet and should not affect the proposed dam foundation. The Red Bluff Formation occurs at the northern edge of the map outside of the dam footprint (Photos 40 and 41). The formation consists of medium to coarse gravels with abundant sand, silt and clay.

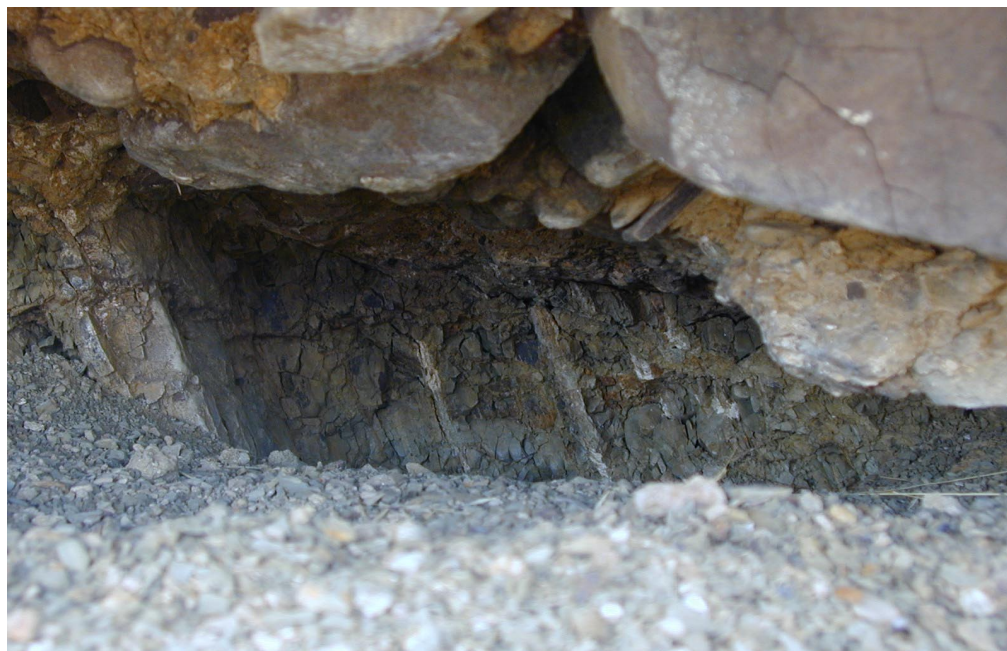
Photo 41. Contact between the Red Bluff and Boxer Formations (close-up)

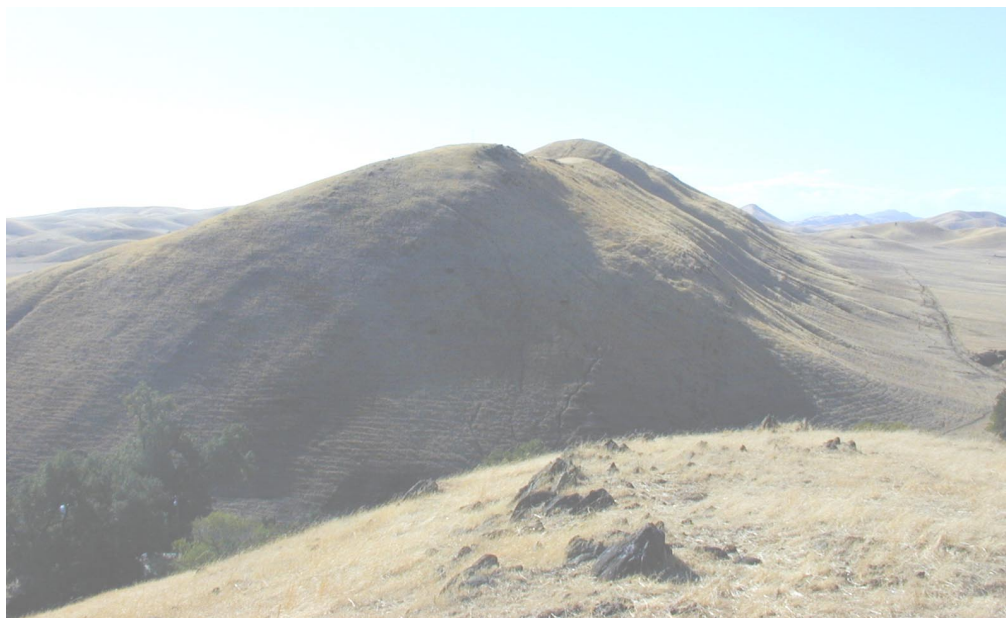
Photo 44. Southern view of right abutment of Logan Dam site

This abutment has a slope angle averaging 50 degrees on the western face of the ridge and a slightly gentler slope of 35 degrees on the eastern face (Photo 44). In addition, the western portion of the abutment extends about 600 feet out into the very gentle slopes of the Boxer Formation. Stripping requirements may vary from a few feet in the more competent ridge-forming sandstones to 15 feet in the mudstones. Stripping estimates are based only on visual surface observation since no subsurface exploration has been completed at this time. Vegetation on the right abutment consists exclusively of scattered grasses.

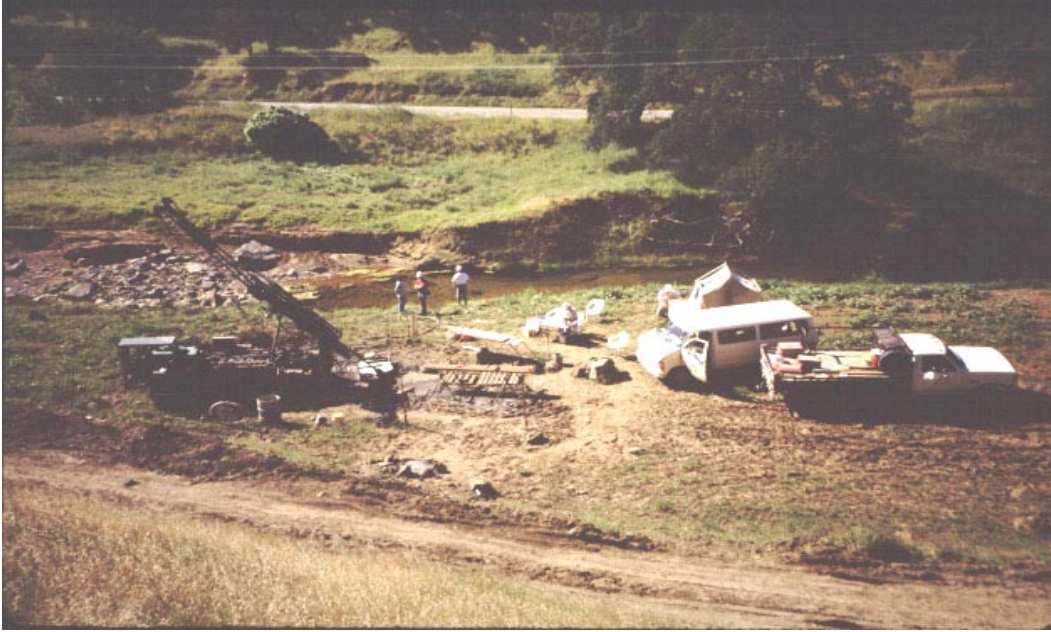
Photo 4. CME - 850 drill rig at Sites Dam site drill hole LC-2

Angle drill hole LC-2 was drilled to evaluate the possible existence of the Salt Lake fault or associated deformation in the upstream footprint of the proposed dam axis (Photo 4). It was oriented cross-channel at S62°W to also explore the possibility of a "blind" or hidden fault under the alluvium that trends nearly parallel with Stone Corral Creek. It was drilled to a total depth of 202.2 feet. The upper 0.0 to 20.5 feet are composed of terrace deposits consisting of a mostly lean clay. From 20.5 to 39.0 feet, the hole drilled through 80 percent mudstone with 20 percent siltstone interbeds. From 39.0 to 50.7 feet, the hole drilled through 50 percent mudstone and 50 percent siltstone interbeds. From 50.7 to 72.0 feet, it intersected 80 percent sandstone with 20 percent mudstone interbeds. From 72.0 to 202.2 feet, the hole drilled through 80 percent mudstone with 20 percent sandy siltstone interbeds. It also intersected minor shears from 39.7 to 39.9 feet, 194.2 to 194.7 feet, and a shear zone from 111.7 to 121.0 feet. These zones contained slickensides and fracturing that may be related to the S-2 fault (Photo 5).

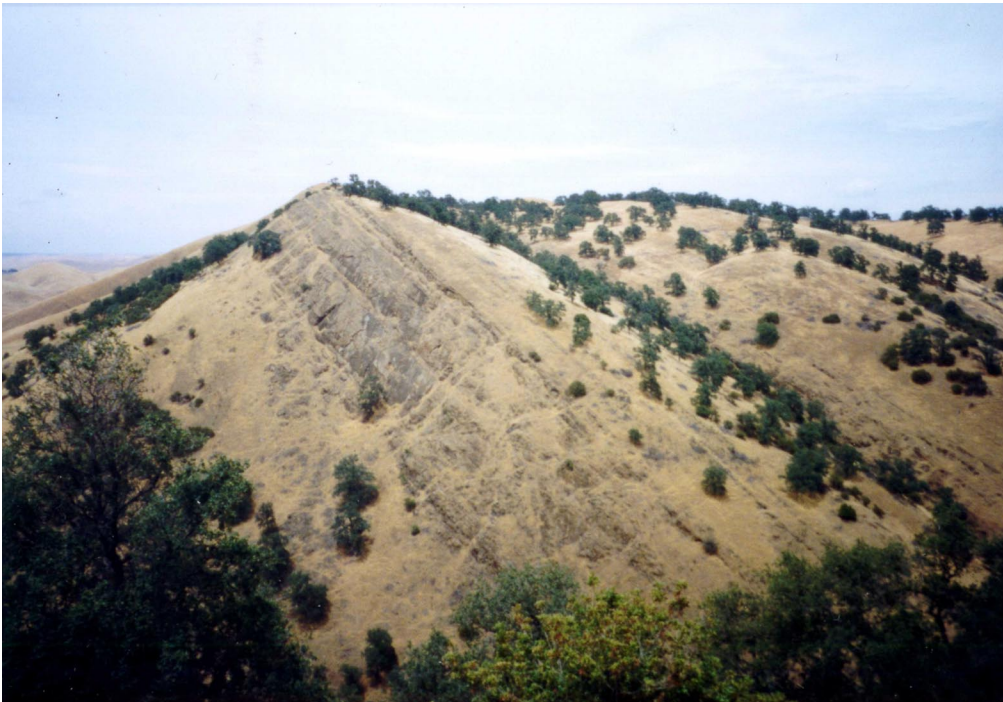
Photo 6. Sites Dam site left abutment

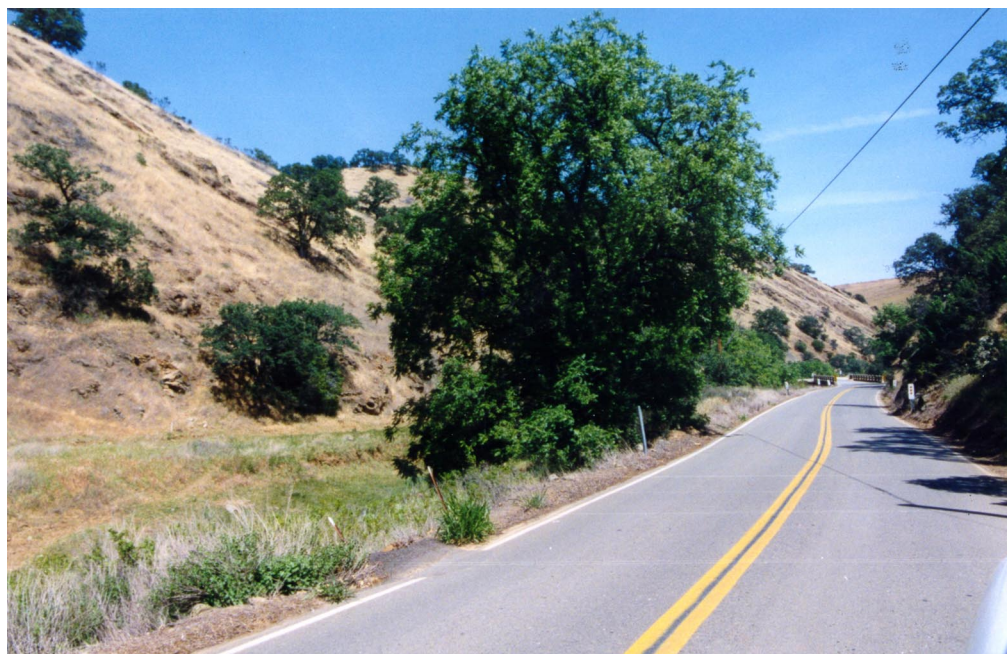
Photo 7. Downstream view of the channel at Sites Dam site

The channel varies in width from about 75 to 450 feet in the footprint, and averages about 150 feet at the dam axis (Photo 7).

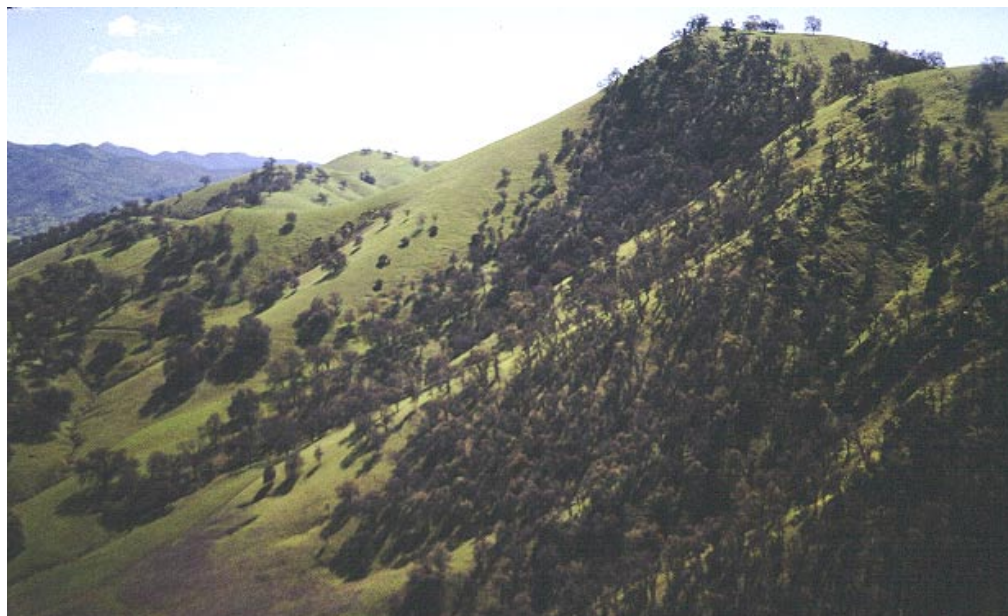
Photo 8. Sites Dam site right abutment

The right abutment is moderately steep with a natural slope of about 0.75 to 1 (Photo 8). The mudstone units mostly upstream of the dam axis are mostly covered by soil creep and/or colluvium and are generally only seen exposed in creek beds, roadcuts, and drill core. The sandstone can generally be observed as outcrops exposed as topographic highs with little or no soil cover. Minimal amount of colluvium and slope wash covers the mid to lower right abutment

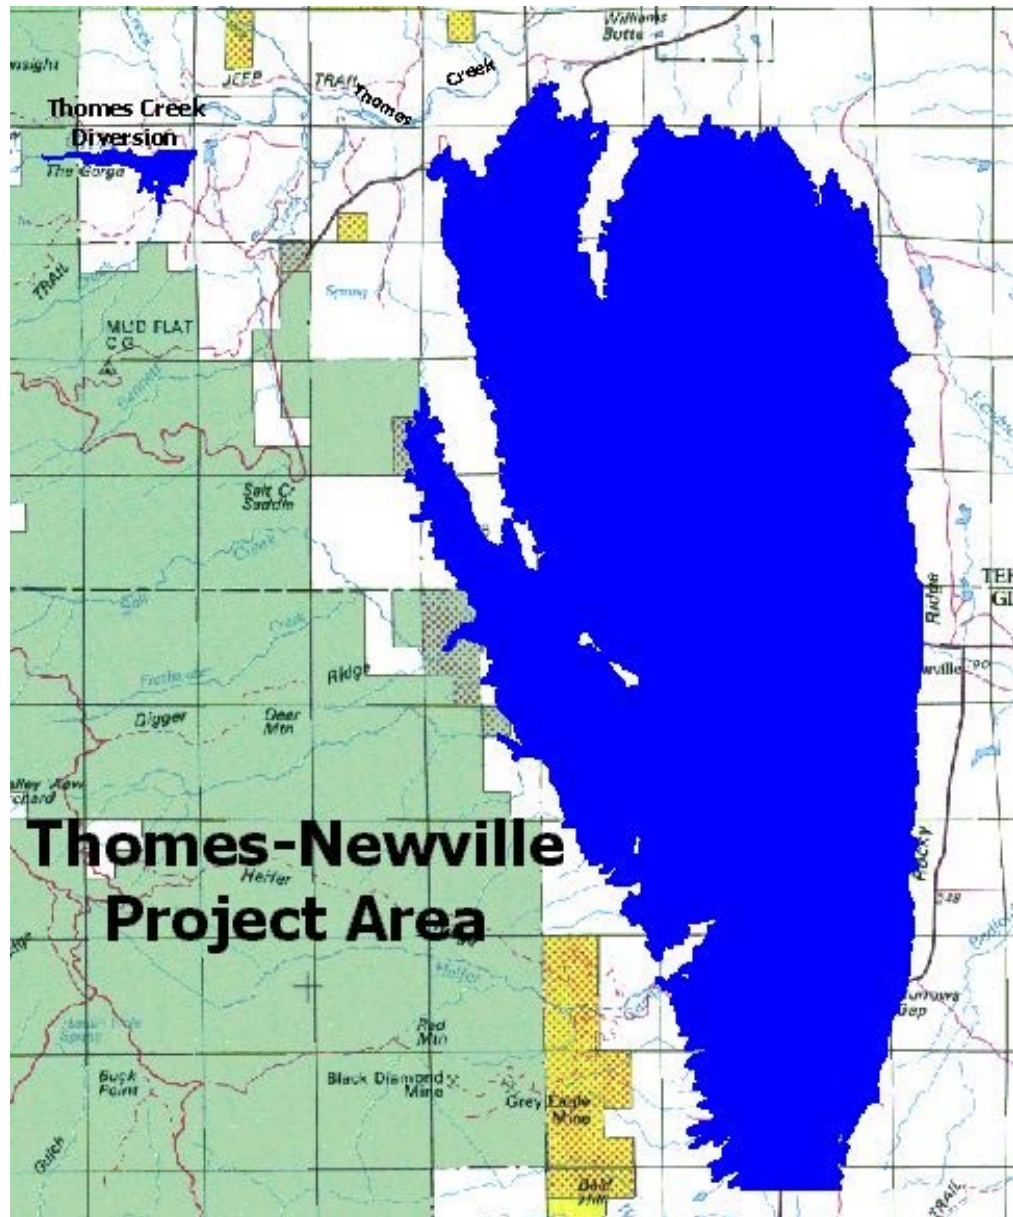
Figure 3. Location of the proposed Thomes-Newville Reservoir Project area in western Glenn and Tehama Counties.
