Mercury Contamination from Historic Gold Mining in California

By Charles N. Alpers and Michael P. Hunerlach

USGS Fact Sheet FS-061-00 May 2000

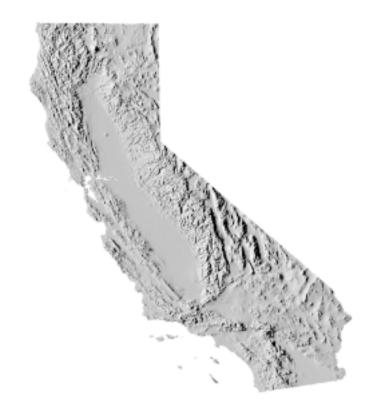
Figure 5. Mercury production from mines in the Coast Ranges of California, 1850-1917 (Bradley, 1918).

Most of the mercury used in gold recovery in California was obtained from the Coast Ranges mercury belt on the west side of California's Central Valley (fig. 4). Historic mercury production peaked in the late 1870s (fig. 5). Total mercury production in California between 1850 and 1981 was more than 220,000,000 lb (pounds) (Churchill, 1999). Although most of this mercury was exported around the Pacific Rim or transported to Nevada and other western states, a significant portion (about 12 percent, or 26,000,000 lb) was used for gold recovery in California, mostly in the Sierra Nevada and Klamath– Trinity Mountains.

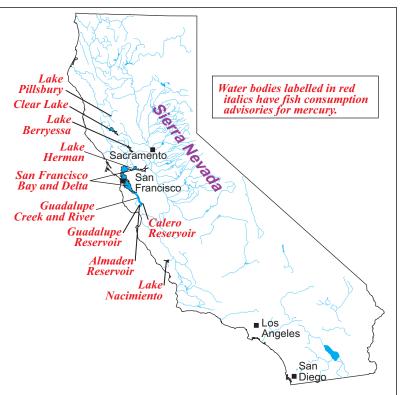
Figure 10. Locations of health advisories for mercury in sport fish consumption in California. Source: California Office of Environmental Health Hazard Assessment, 1999. Lake Pillsbury has interim advisory by Lake County; state advisory pending, as of May 2000.

In California, as of 1999, there were fish consumption advisories for mercury in 13 waterbodies, including the San Francisco Bay and Delta Region and several areas in the Coast Ranges affected by mercury mining (fig. 10; compare with fig. 4). Data on CH_3Hg^+ levels in fish are presently insufficient for public agencies to determine whether advisories are warranted for lakes and rivers in areas affected by historic gold mining, such as the Sierra Nevada foothills.
